DETROIT DIESEL - ALLISON

Palm Beach International Airport
Ok Generator
Unit S/N 5472000372

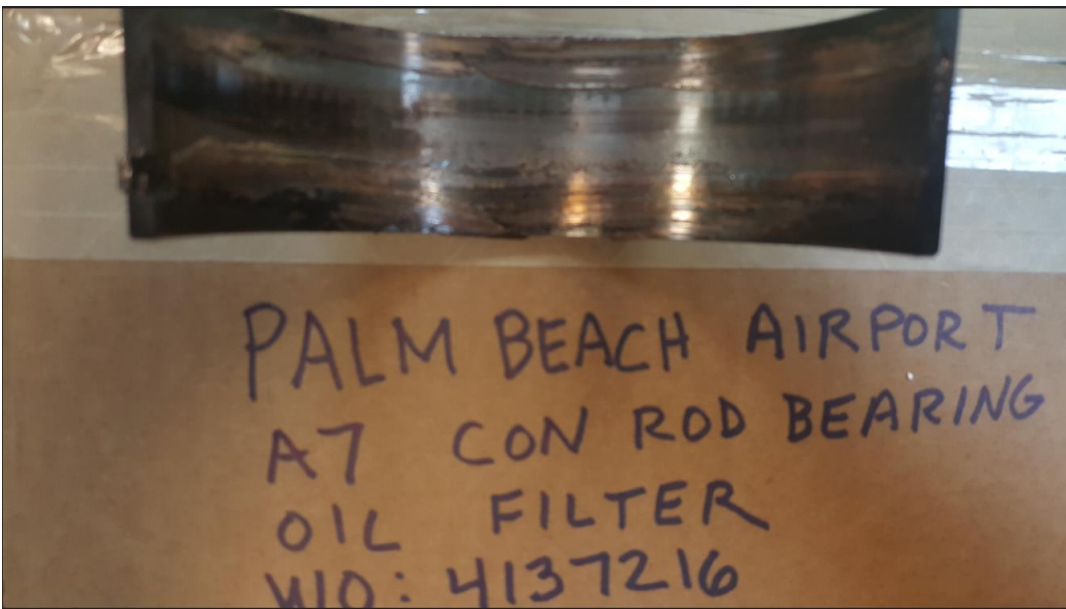
The inspection performed to the unit by our FDDA Ft Lauderdale branch indicated spun bearings. The finding show that the engine had a dry start condition. This failure is consistent with a dry start condition.
