Palm Beach International Airport  
Ok Generator  
Unit S/N 5472000372

Mr. Birdsong based on the data log from the engine ECU and the genset controller no evidence reflects a pre-lubing was performed per MTU guide lines after a unit has had a full PM service performed or if the unit had not been ran once a month.

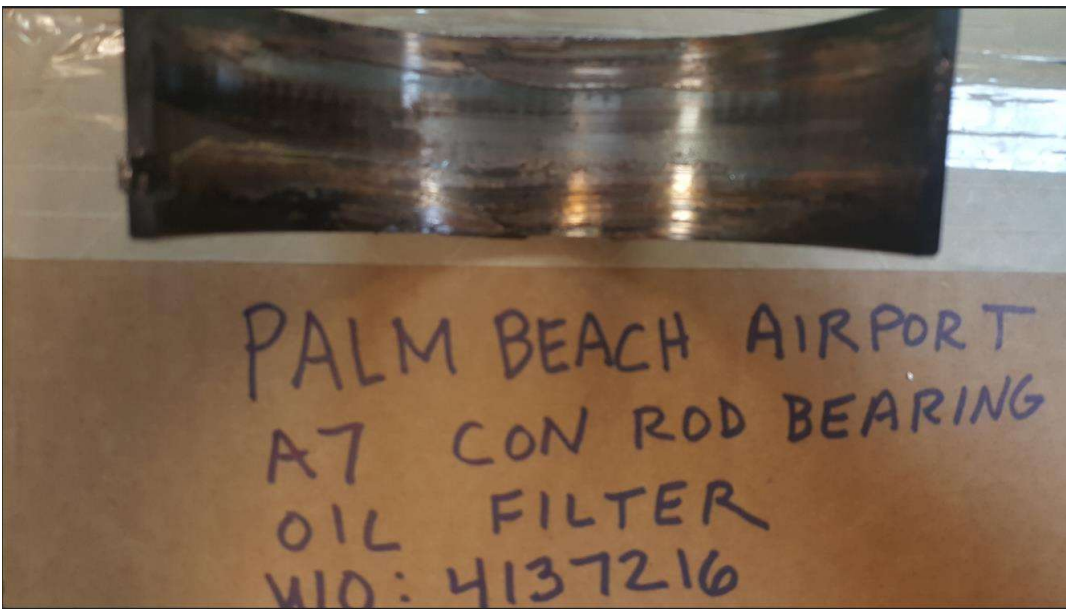
The inspection performed to the unit by our FDDA Ft Lauderdale branch indicated spun bearings. The finding show that the engine had a dry start condition. This failure is consistent with a dry start condition.

The next step for the customer to determine the root cause based on our finding, a failure analysis inspection would have to be performed at our FDDA Ft Lauderdale facility with the MTU Factory Representative. This inspection will have a cost to the customer and FDDA can provide this estimate if requested. FDDA will not move forward with any repairs as a warranty repair until the failure analysis by FDDA and the factory representative is performed, and the factory reports indicates that the failure is a warrantable failure. The customer has the option to proceed with the repairs at a cost pending the final report by the factory.
