Drainage (Pipe Replacements)

Additional Funding Request

Infrastructure Sales Tax Oversight Committee November 16, 2023

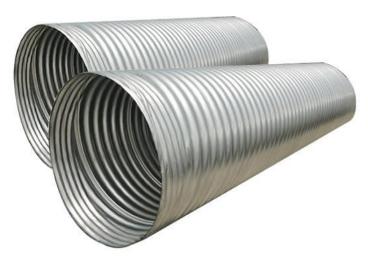
New Corrugated Metal Pipe (CMP)

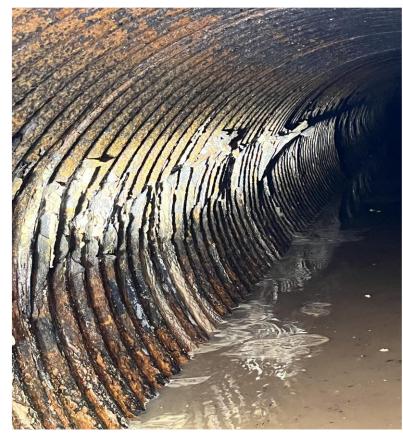
CMP spring line failing weakening pipe structural integrity

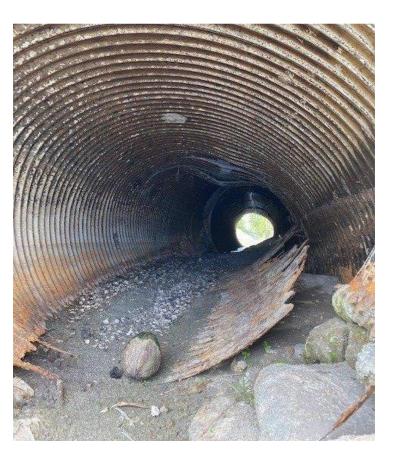
CMP spring line failing weakening pipe structural integrity

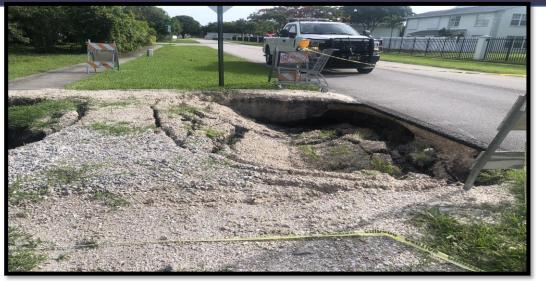
Historically, pipe deficiencies result in ground or pavement failures commonly seen as potholes, cave-ins, and sinkholes. Also, more pipe deficiencies are being identified as we (Stormwater Section) increase and improve our maintenance and inspection services (e.g. CCTV). Failures also cause flooding upstream. Any failing pipes need to be replaced or repaired (e.g. cured-in-place pipe lining) in order to properly drain and maintain our roads in a safe operating condition.

CMP sinkhole

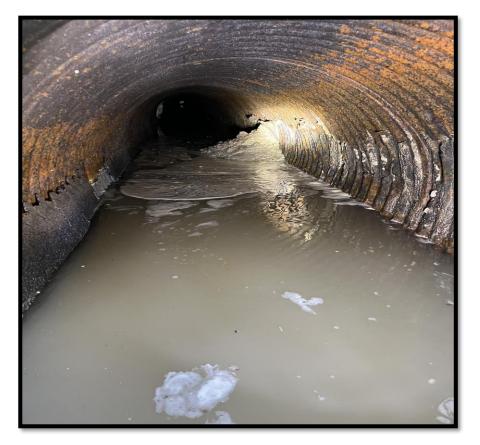
Most prevailing failure is caused by aged and failing countywide CMP

Corroded CMP sinkhole

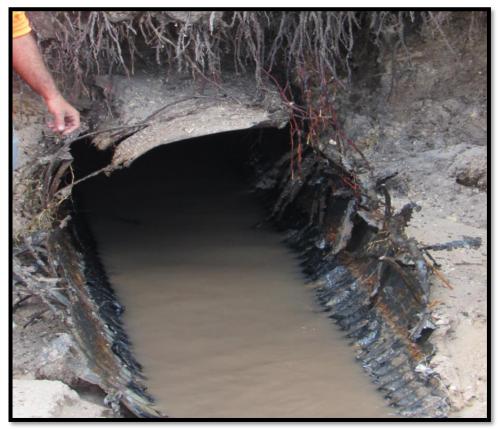
CMP spring line section loss

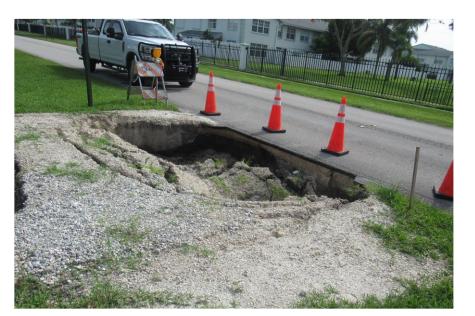
CMP failure – collapse / blockage

Unlike most other pipe materials, CMP failures involve flow-line or springline corrosion that affect its load carrying capacity. When this occurs, the CMP collapses on itself, creating a sinkhole and flow line blockage that also reduces stormwater flow.

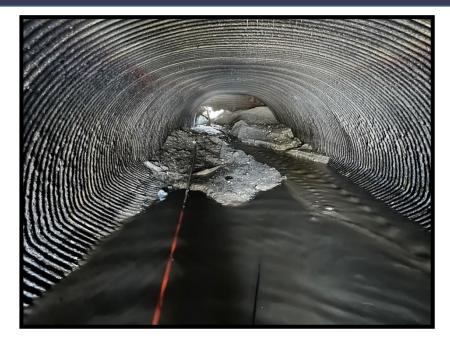
CMP failure - sinkhole

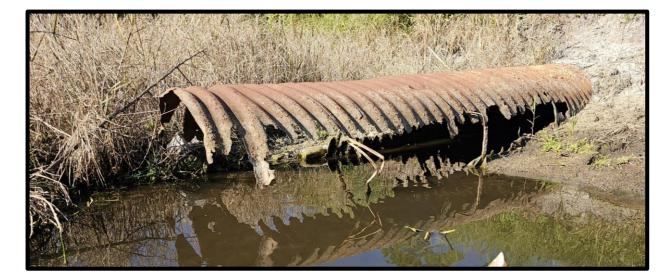
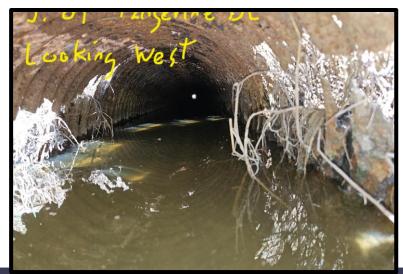
Royal Palm Beach Boulevard - Aged / Failing CMP

- 67th Place N 24" CMP
- Approximately (20) additional 24" CMP culverts in similar condition.

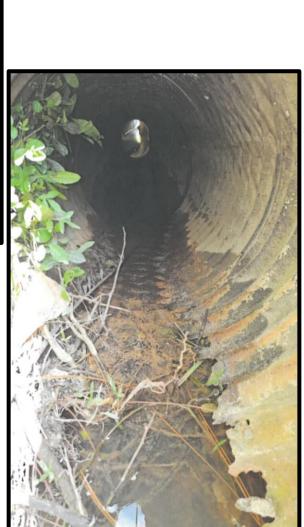
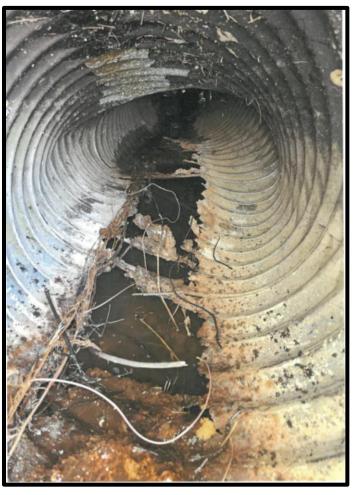
Jupiter Farms – Aged / Failing CMP

- 130th Ave N & 125th @
 Canal 4 24" CMP
- Jupiter Farms Community wide CMP evaluation / estimate to be attained

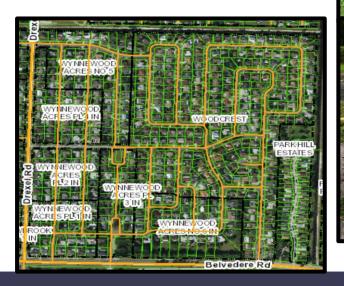
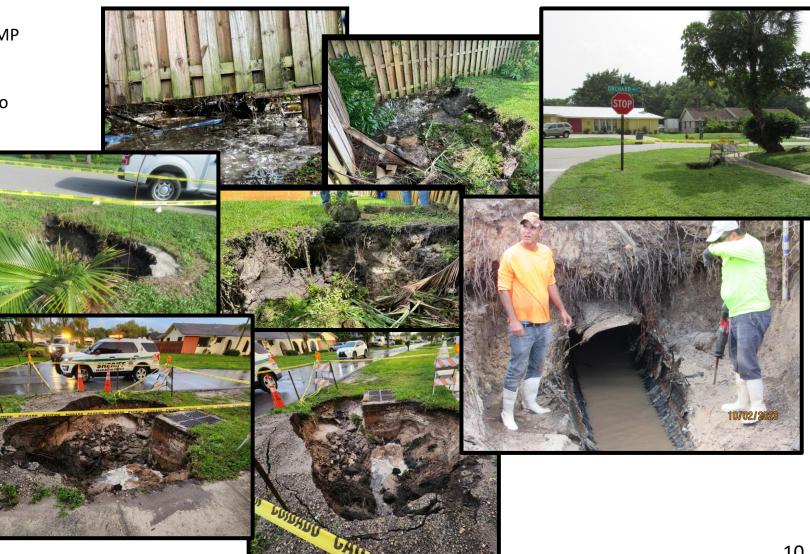
Wynnewood Acres - Subdivision Wide Aged / Failing CMP

- 5632 Lafayette Street Approximate 48" CMP near Upland Way and Woodcrest Road -Active-Failure extends from swale area - into easement / residential backyard. Currently investigating via a diver.
- Lafayette Street and Woodcrest Road
- Orchard Way and Wynnedale Road

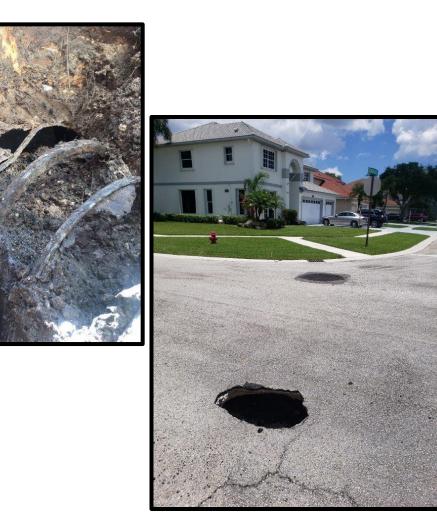
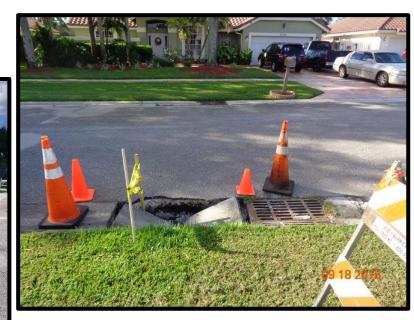
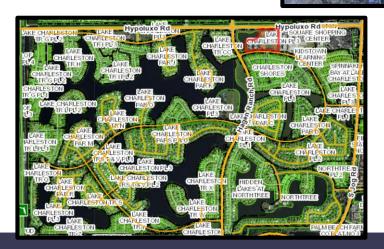
Lake Charleston Subdivision – Subdivision Wide Aged / Failing CMP

- 7153 Catalina Isle
 Drive 15" & 24" CMP
- 6383, 6663, 6706,
 6754, & 6808 Hatteras
 Drive 18" & 24" CMP
- Subdivision wide CMP evaluation / estimate to be attained
