Palm Beach County

RENEWAL/REPLACEMENT PROGRAM ASSESSMENT STUDY STRUCTURAL ELEMENTS

December, 2015

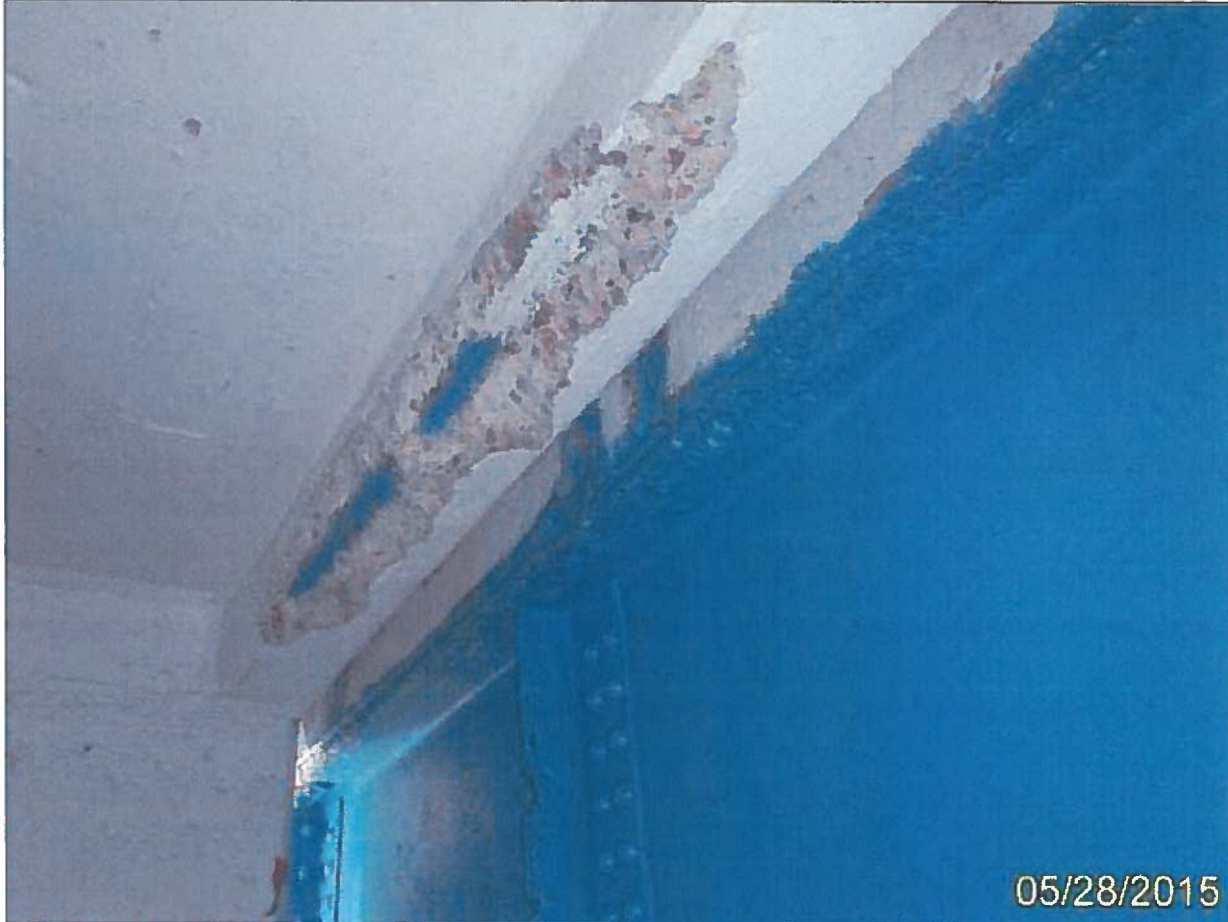
Photo 1 - Unit 0 Element 29 Steel Deck/Conc Grid

Spall with exposed rebar in the underside of the left (north) sidewalk in Bascule Pier 4

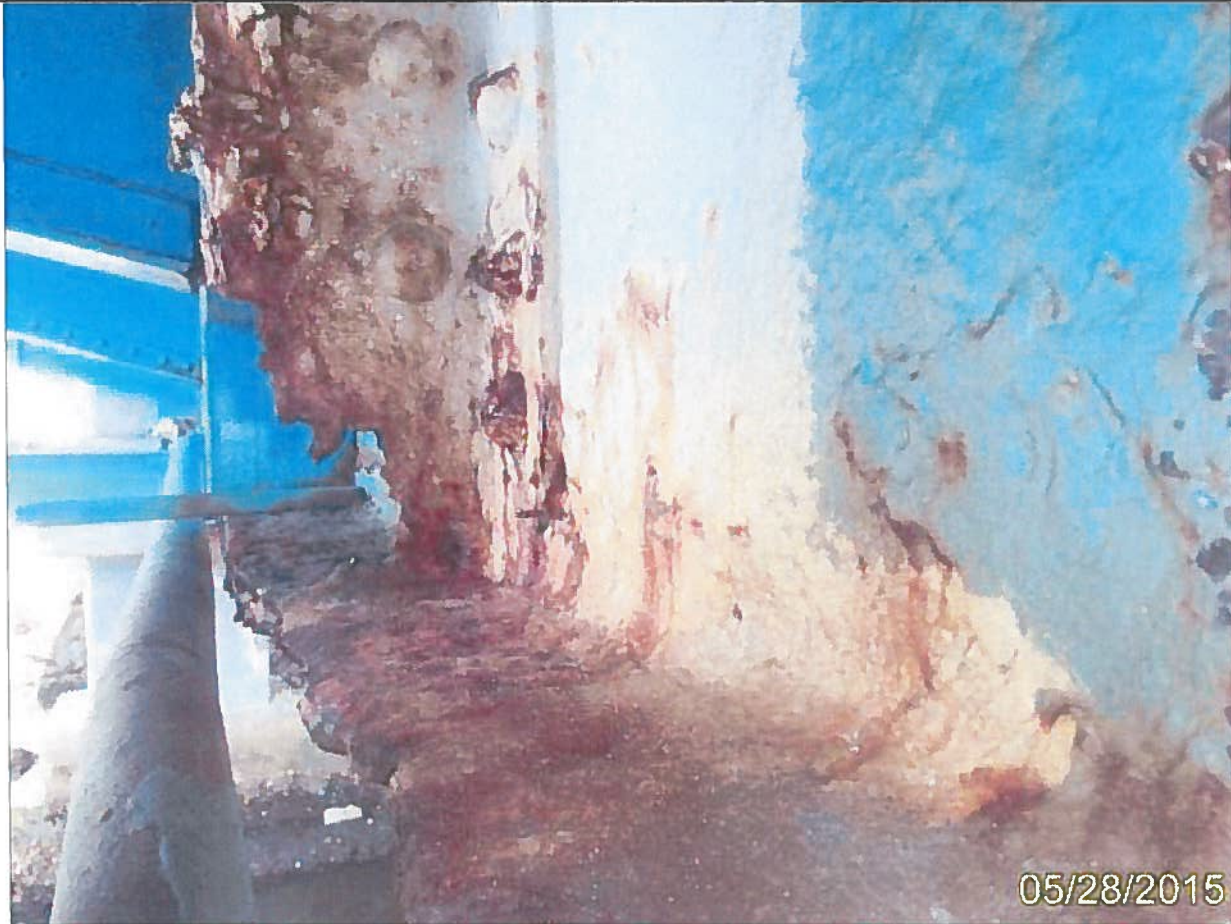
Photo 2 - Unit 0 Element 107 Paint Stl Open Girder

Typical corrosion and section loss to the bottom flange rivet heads

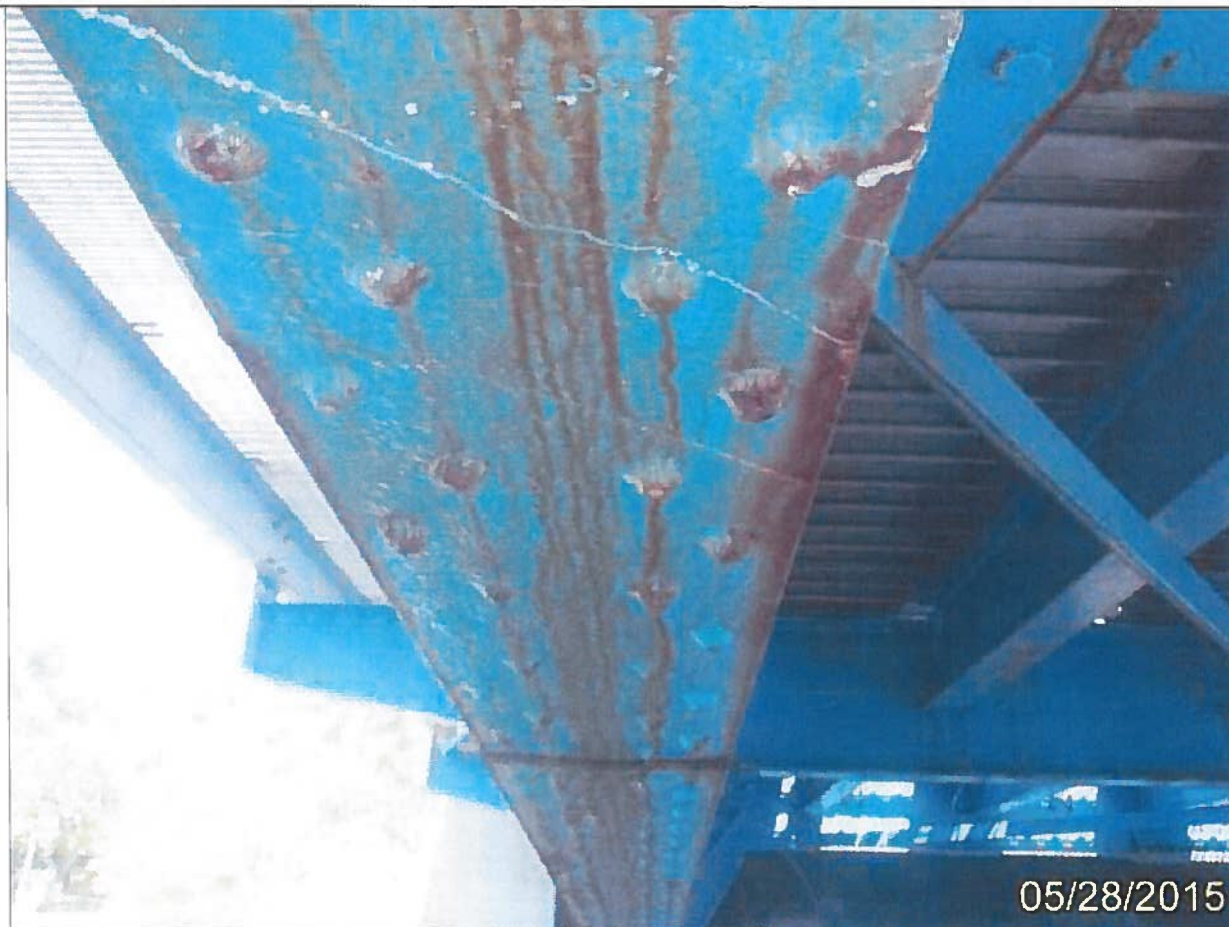
Photo 3 – Unit 0 Element 107 Paint Stl Open Girder

Corrosion and section loss to the rivet heads on the bottom face of Main Girder 3-2 at Bascule Pier 3

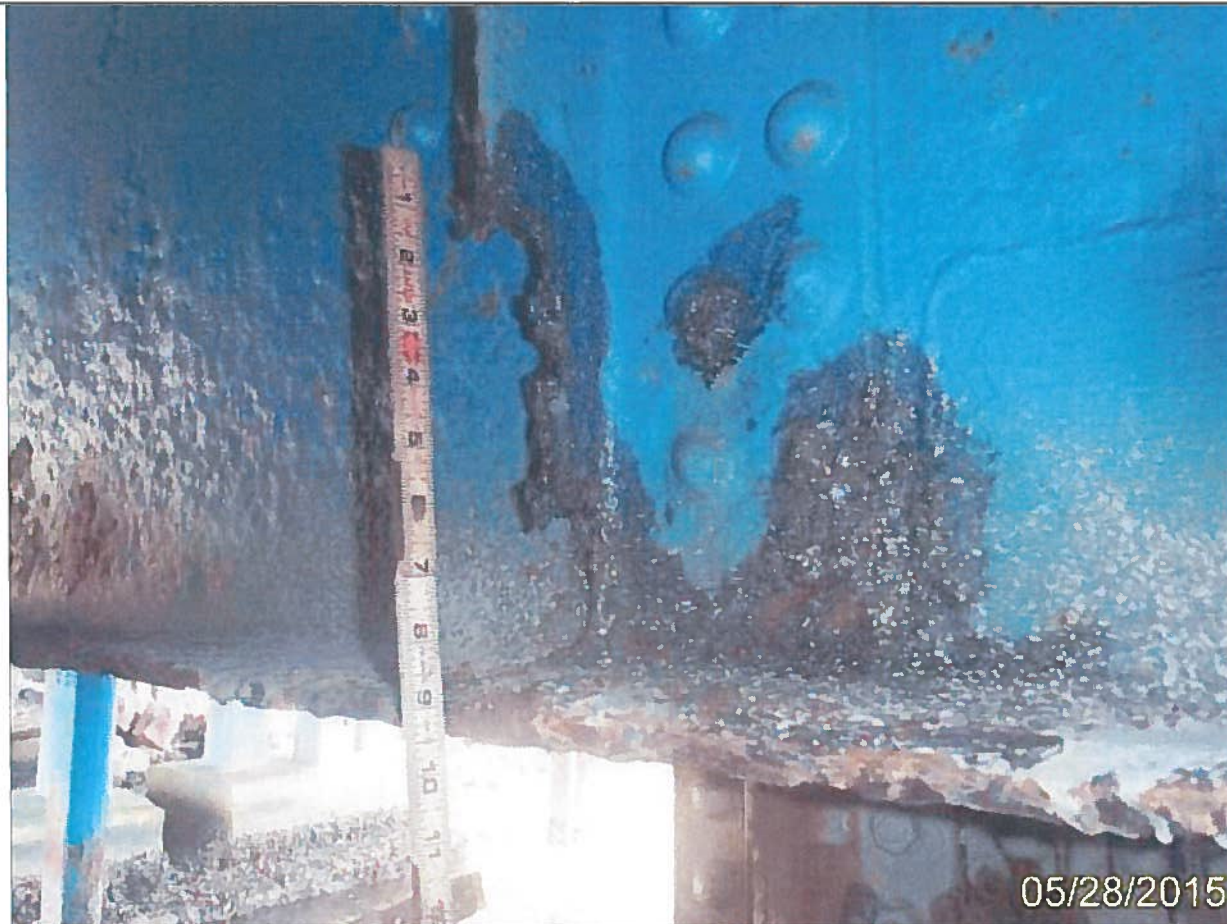
Photo 4 - Unit 0 Element 107 Paint Stl Open Girder

Typical corrosion at vertical stiffeners

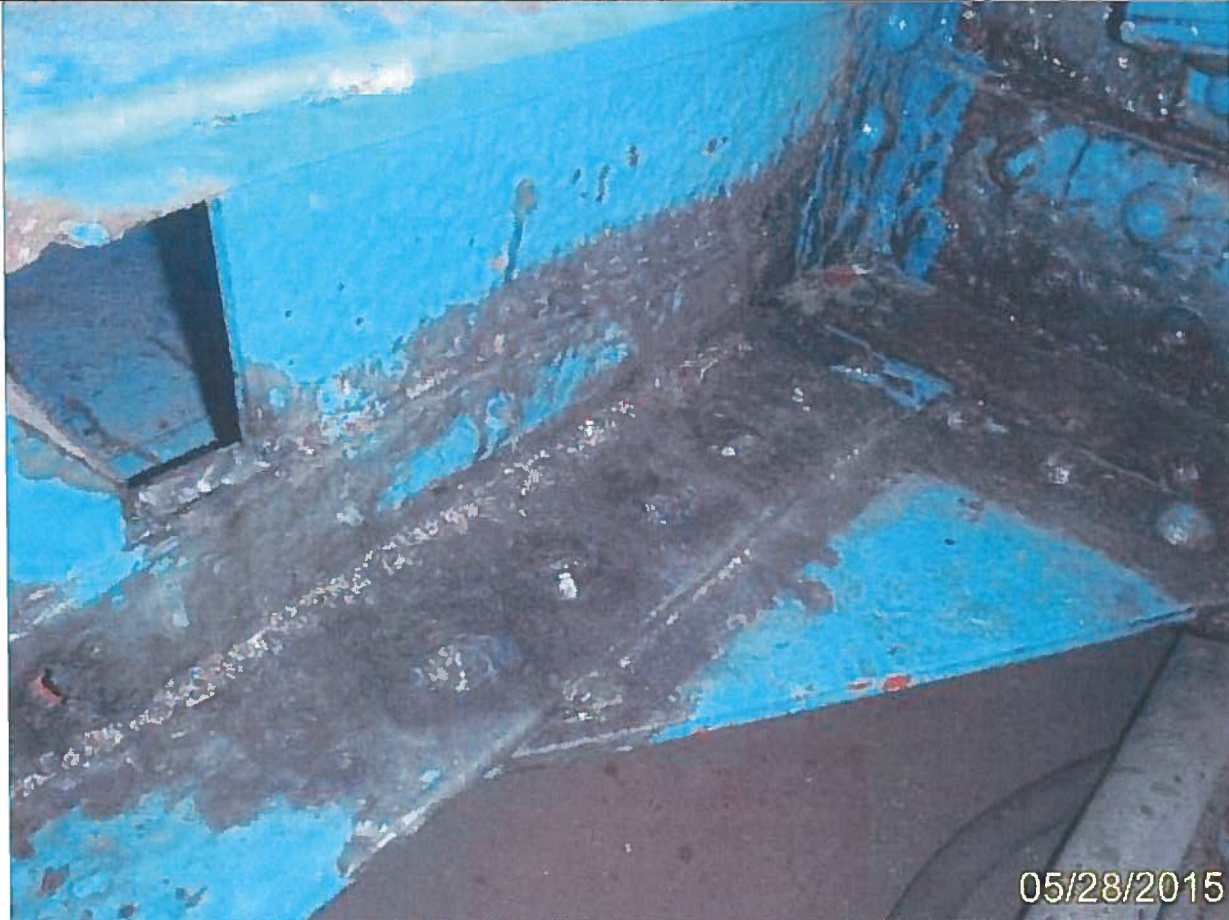
Photo 5 - Unit 0 Element 107 Paint Stl Open Girder

Typical deteriorated rivets at main girder connections

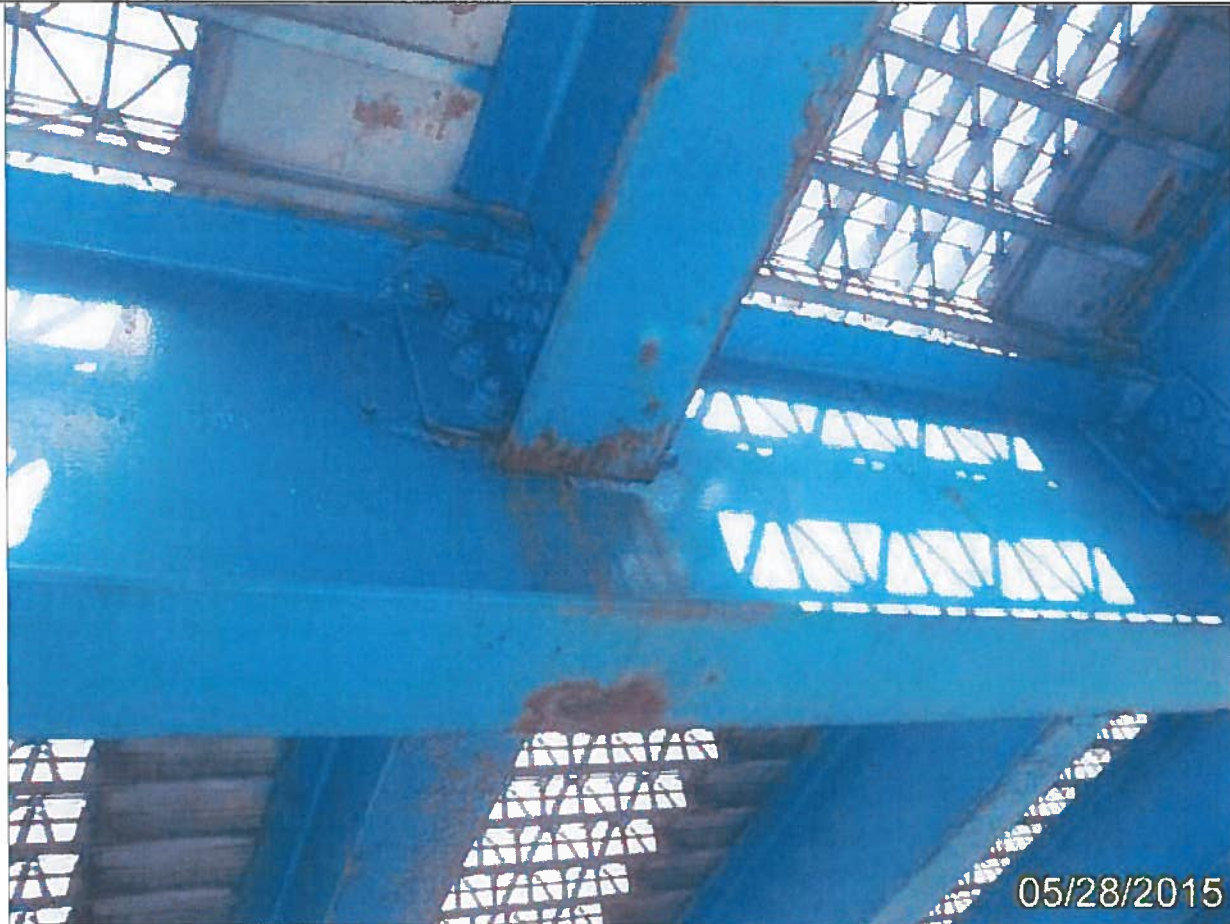
Photo 6 – Unit 0 Element 113 Paint Stl Stringer

Stringer 3-2 corrosion at the east side of Floor Beam 3-3

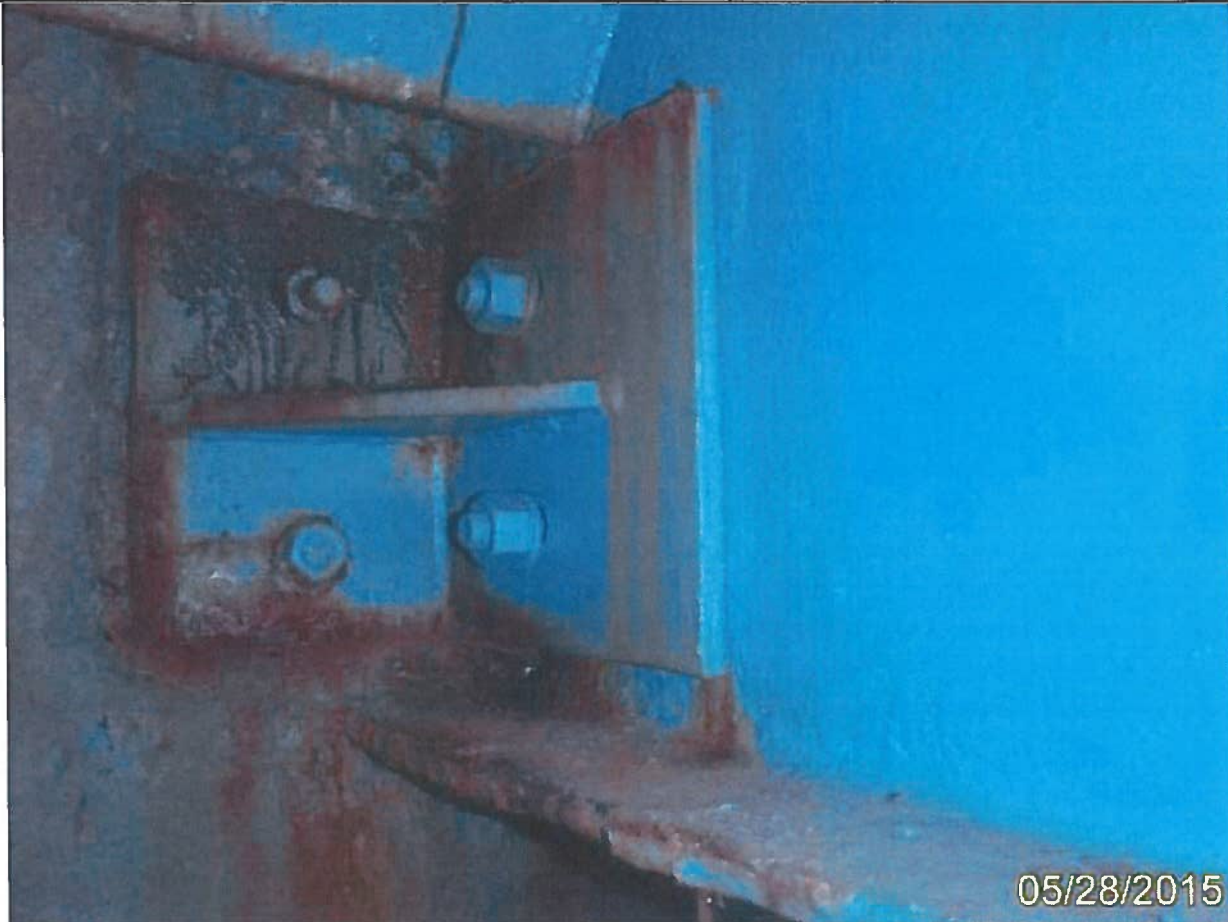
Photo 7 - Unit 0 Element 113 Paint Stl Stringer

Corrosion at the end of Stringer 3-1 inside Bascule Pier 4

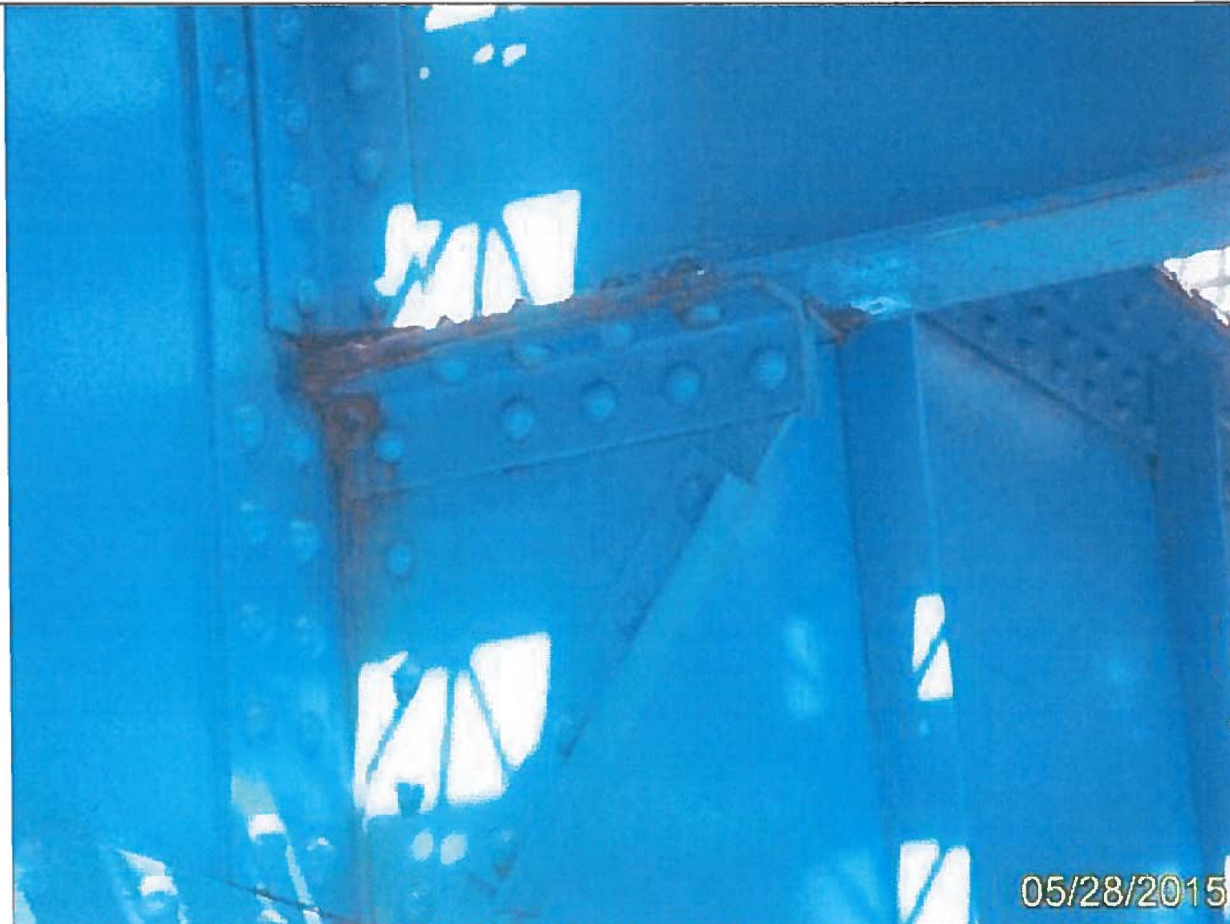
Photo 8 – Unit 0 Element 152 Paint Stl Floor Beam

Typical pitting and corrosion of Floor Beam 3-1

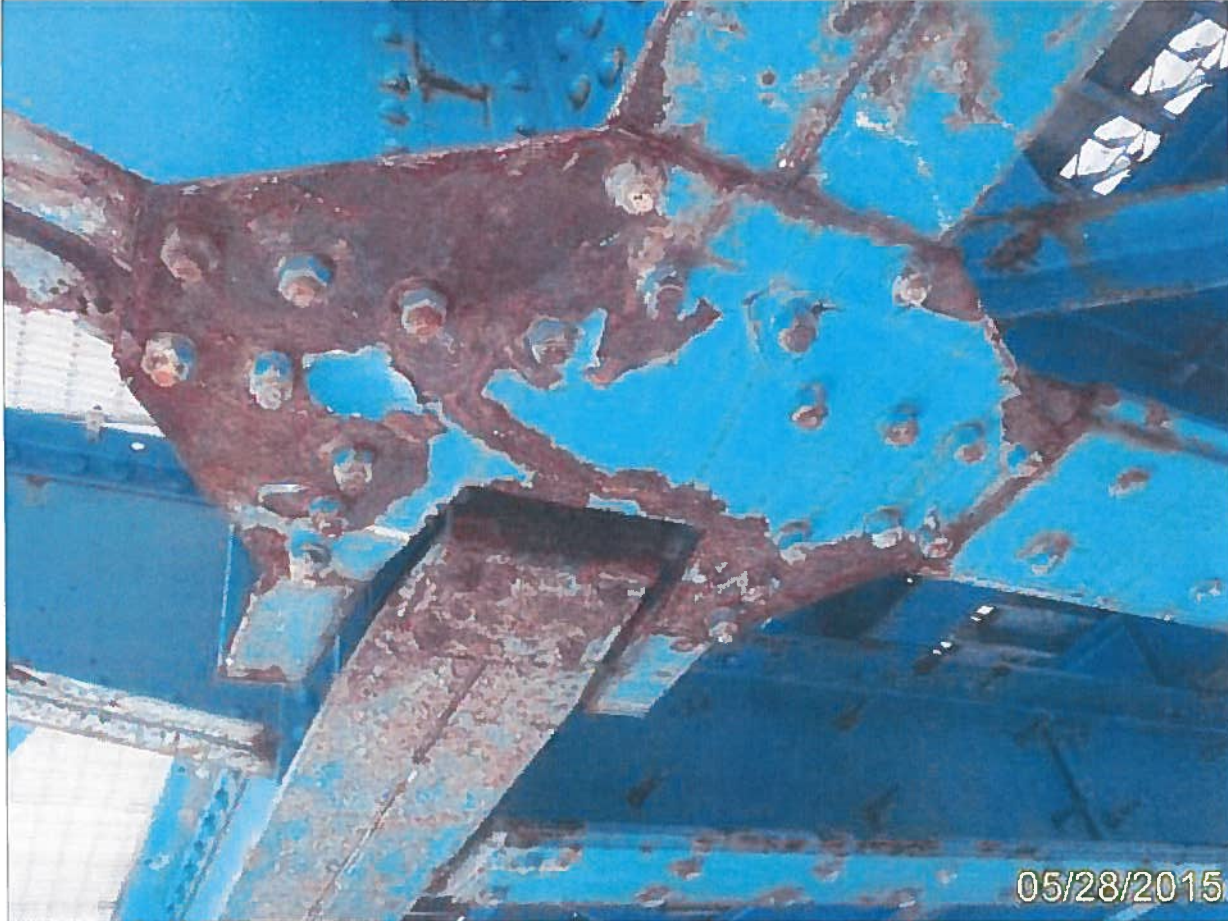
Photo 9 – Unit 0 Element 152 Paint Stl Floor Beam

Corrosion on the south gusset plate of Floor Beam 3-4

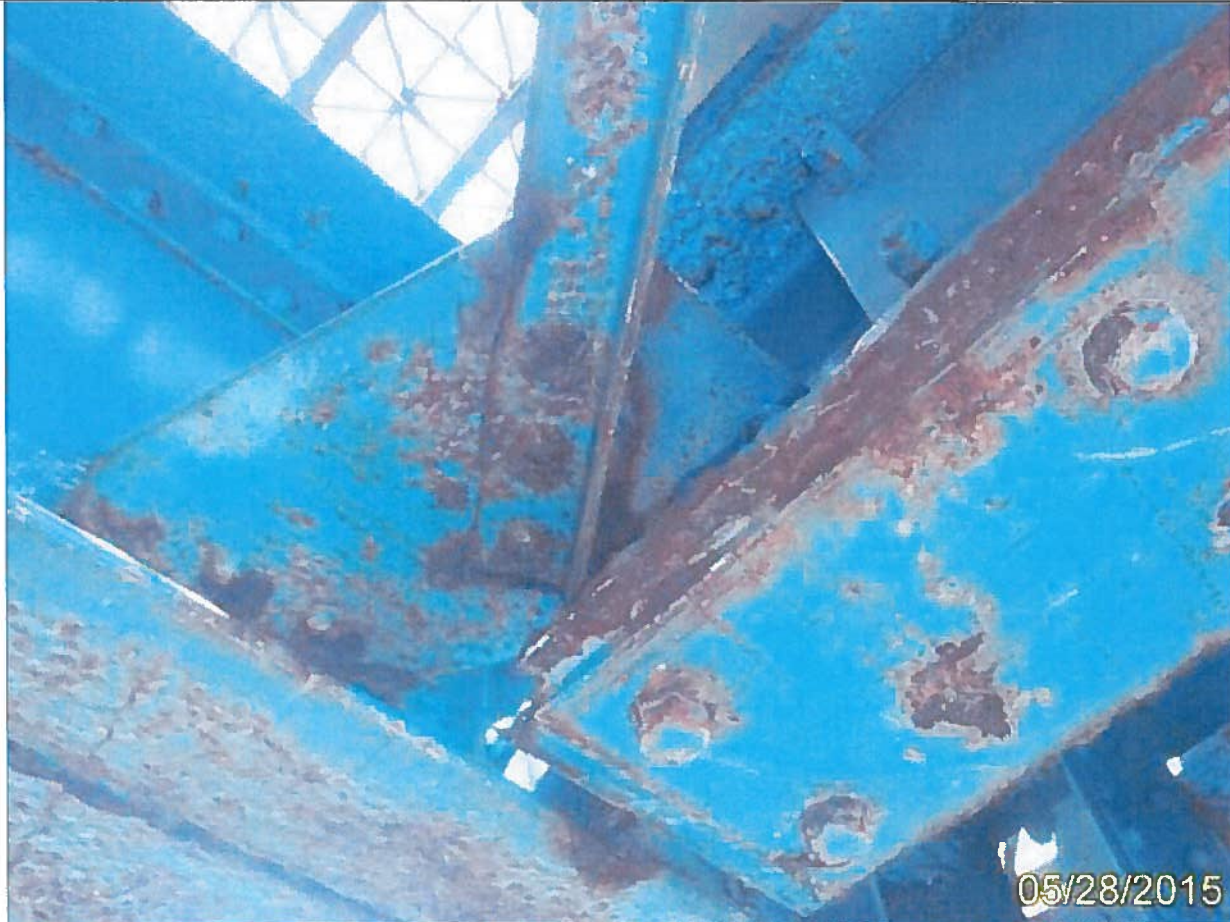
Photo 10 – Unit 0 Element 152 Paint Stl Floor Beam

Corrosion hole in the east gusset plate at the south end of Floor Beam 3-5

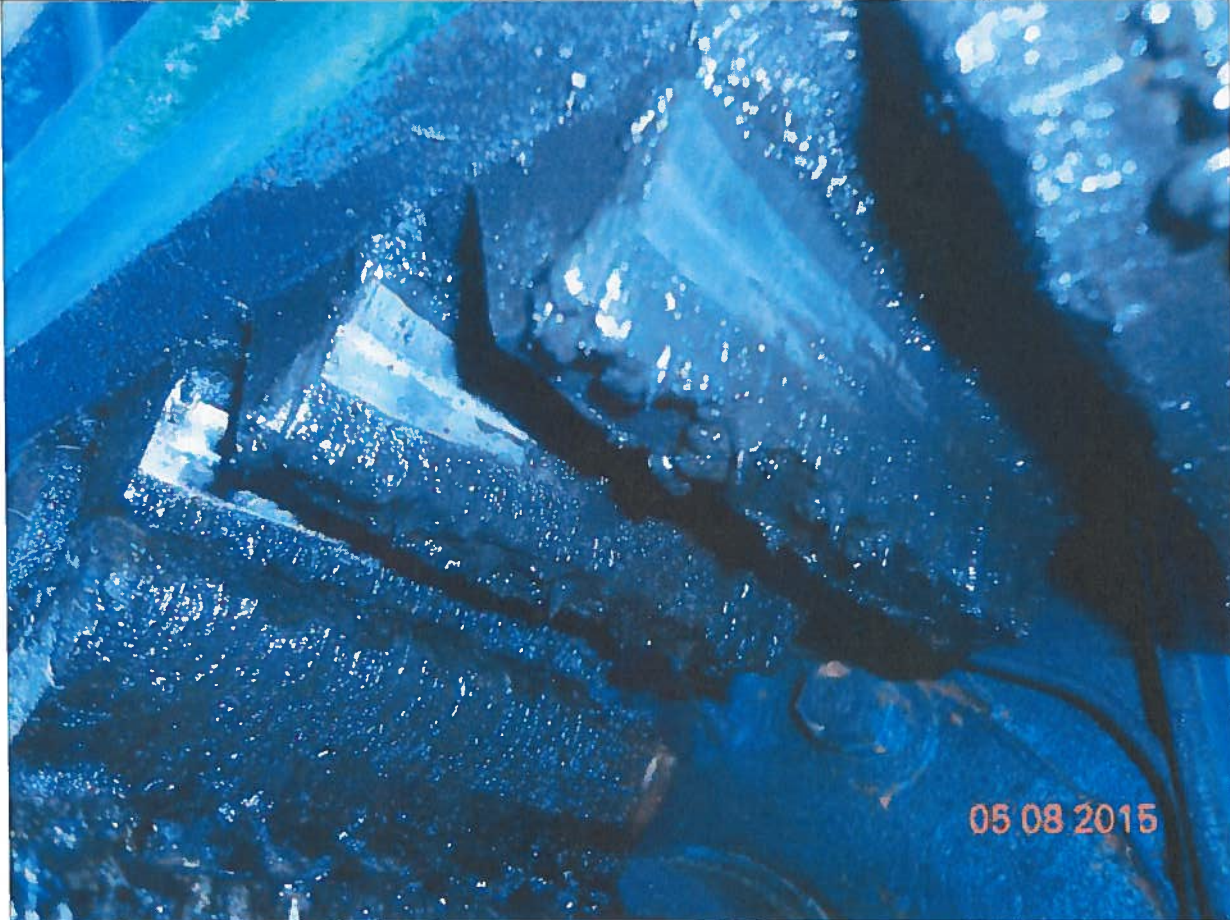
Photo 11 – Unit 0 Element 540 Open Gearing

Grease on all pinion and rack gear teeth is light. Sections of teeth are exposed and slight corrosion is present. Grease pattern on rack depicts slight cross mesh misalignment with pinion. Near leaf adjacent side shown, others similar

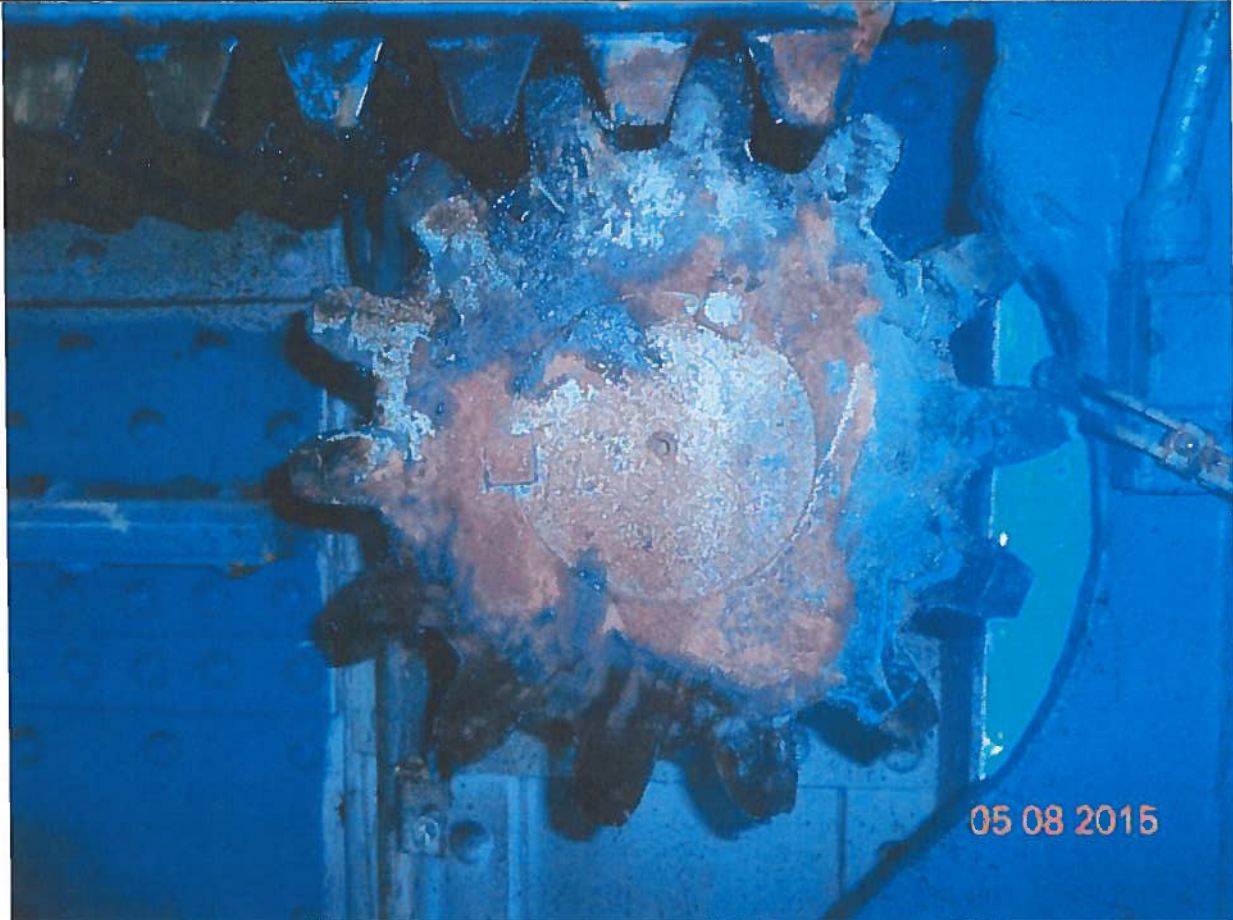
Photo 12 – Unit 0 Element 540 Open Gearing

Paint loss and corrosion is present on the sides of all pinions and racks. Far leaf adjacent side shown, others similar

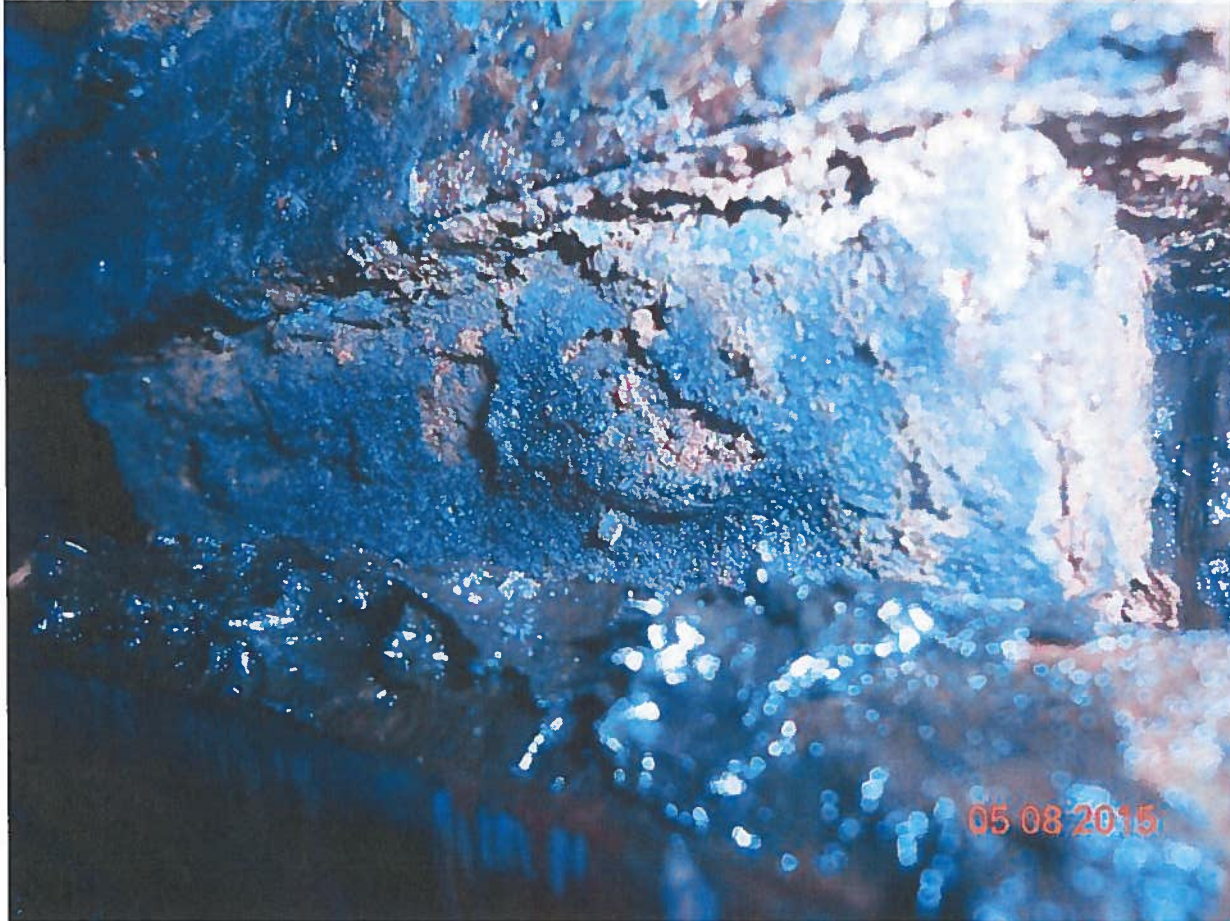
Photo 13 – Unit 0 Element 540 Open Gearing

The far faces of the first and last tooth of all racks exhibit corrosion and section loss. Far leaf opposite side shown, others similar

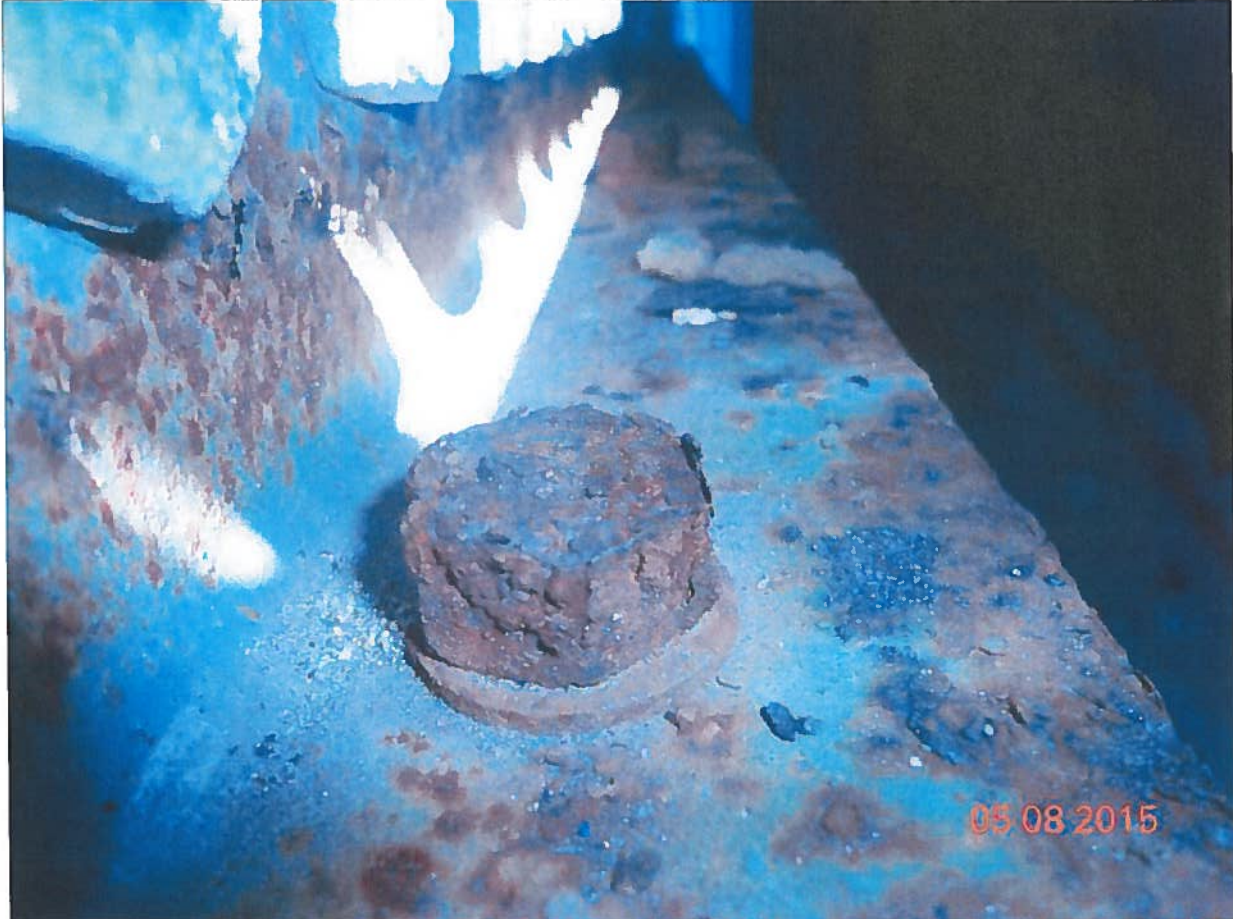
Photo 15 – Unit 0 Element 540 Open Gearing

All rack inboard mounting bolts exhibit moderate corrosion and minor section loss. Near leaf opposite side shown, others similar

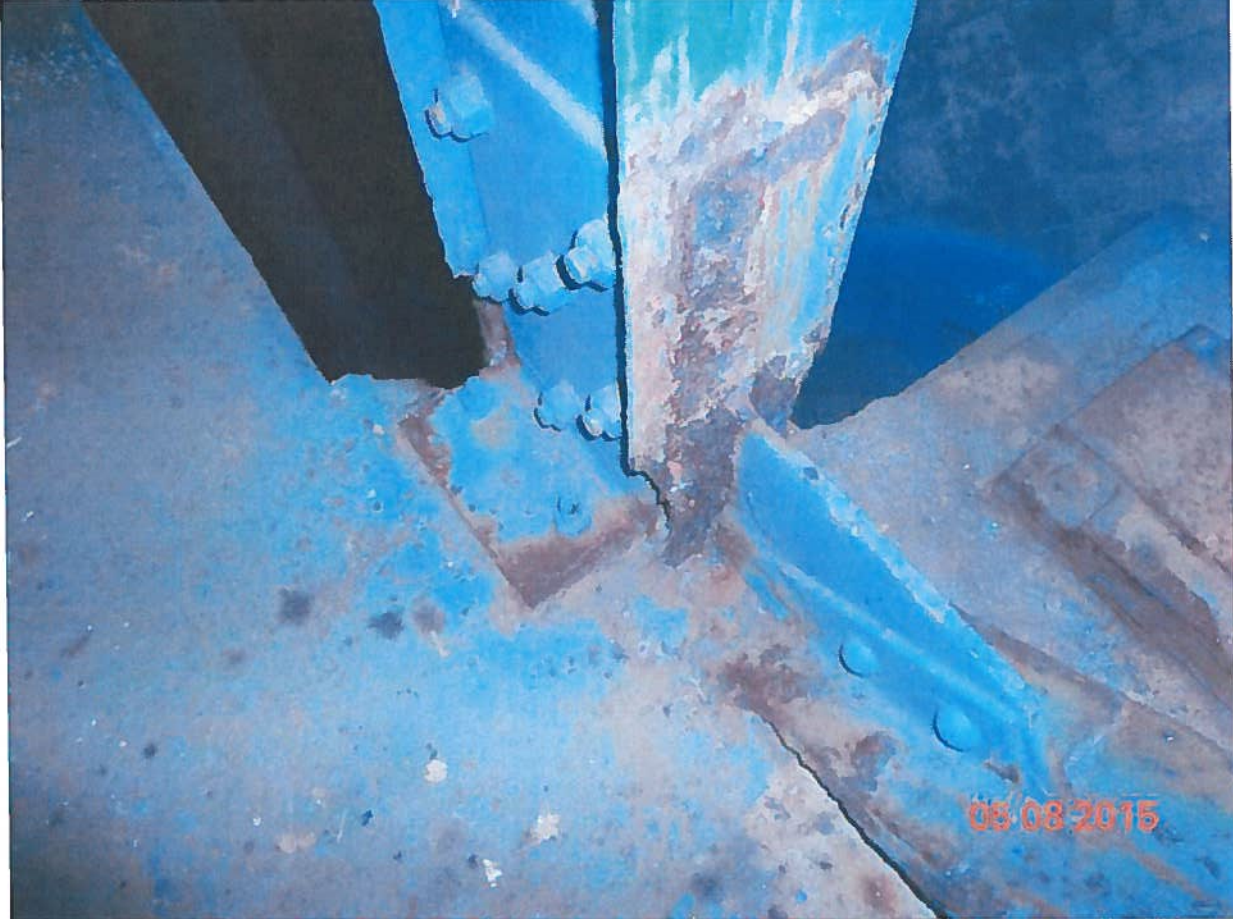
Photo 16 – Unit 0 Element 540 Open Gearing

Sections of all rack supports exhibit paint loss, corrosion, and moderate section loss. Far leaf adjacent side shown, others similar

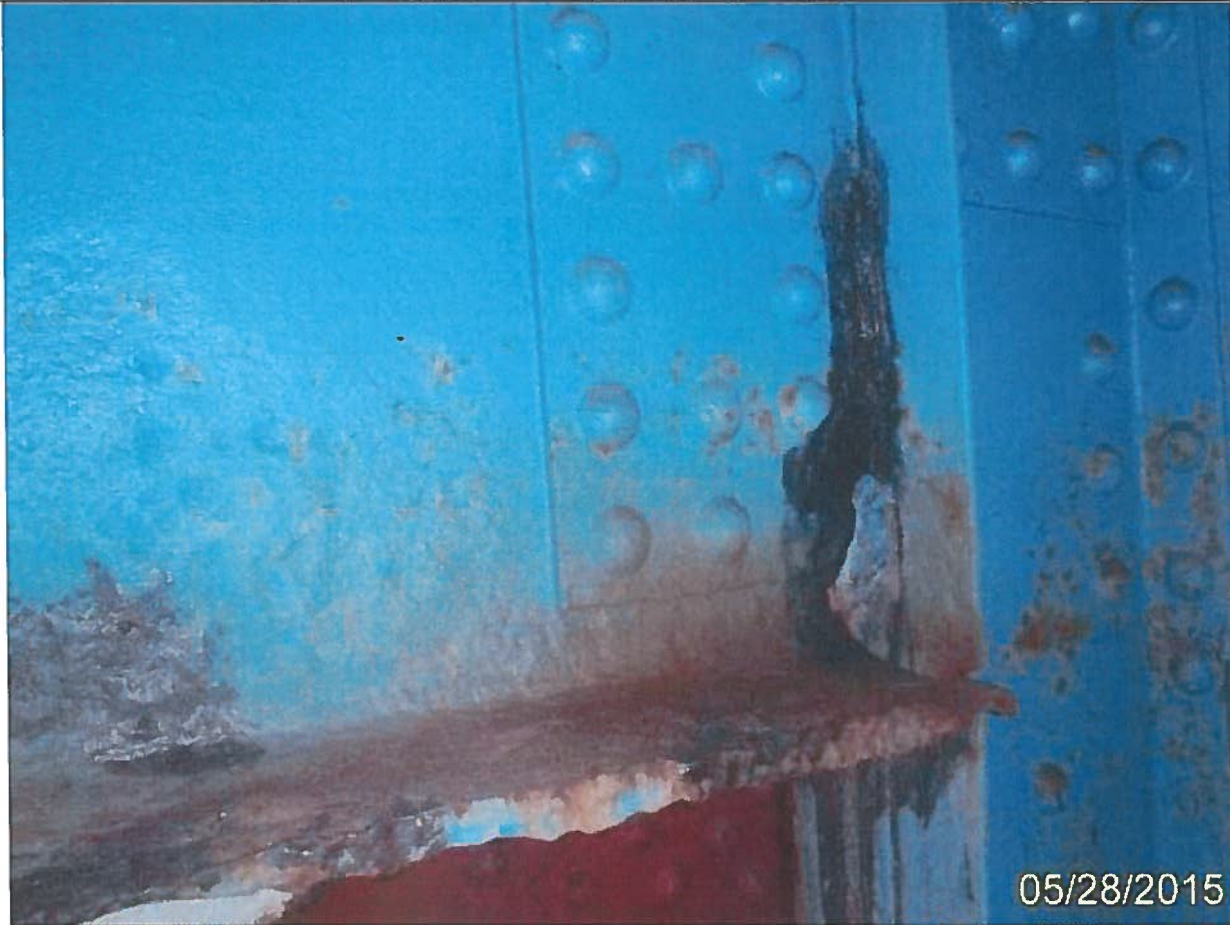
Photo 18 - Unit 0 Element 540 Open Gearing

Corrosion hole in main transverse machinery support at main girder connections in Bascule Pier 4

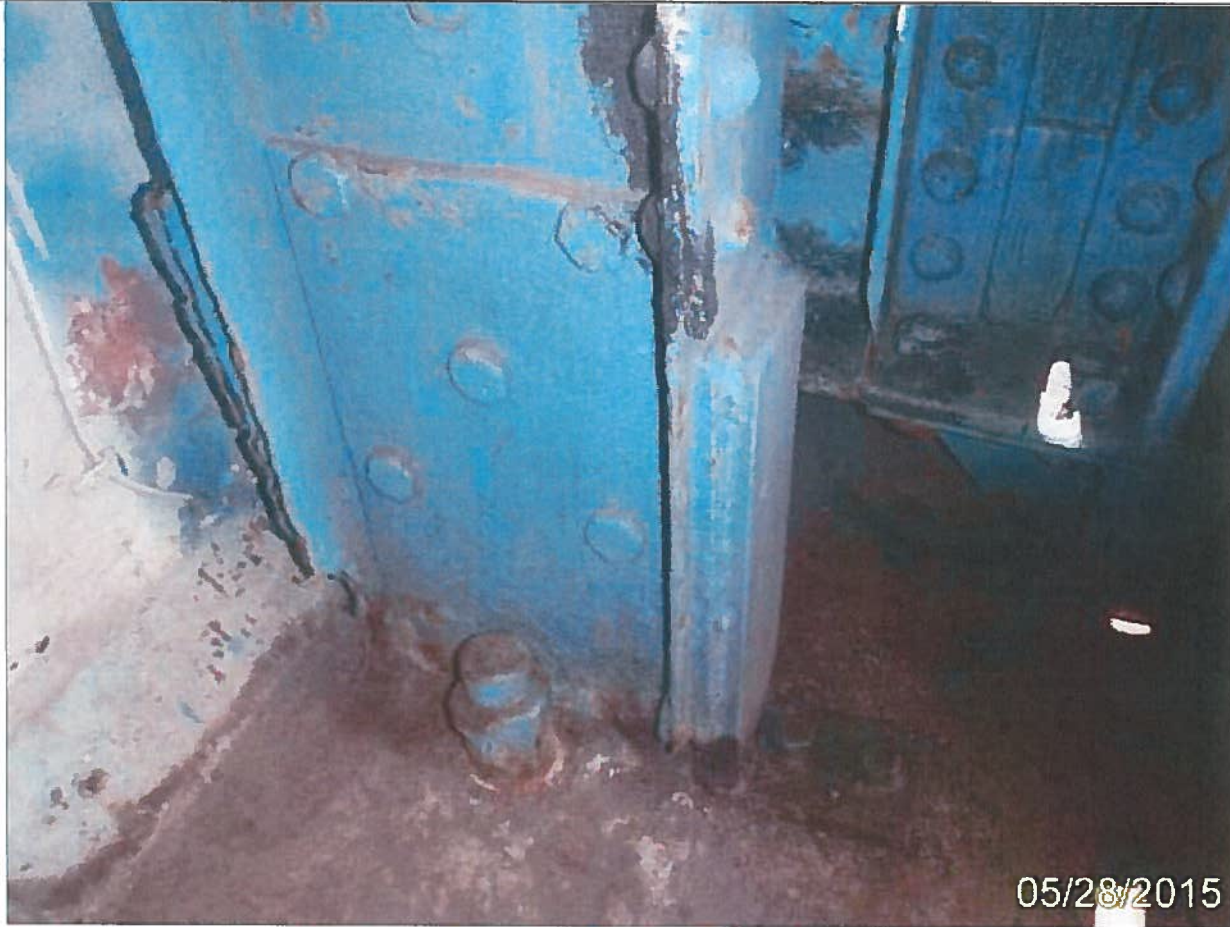
Photo 19 - Unit 0 Element 540 Open Gearing

Corrosion at the bases and connection points at the machinery supports

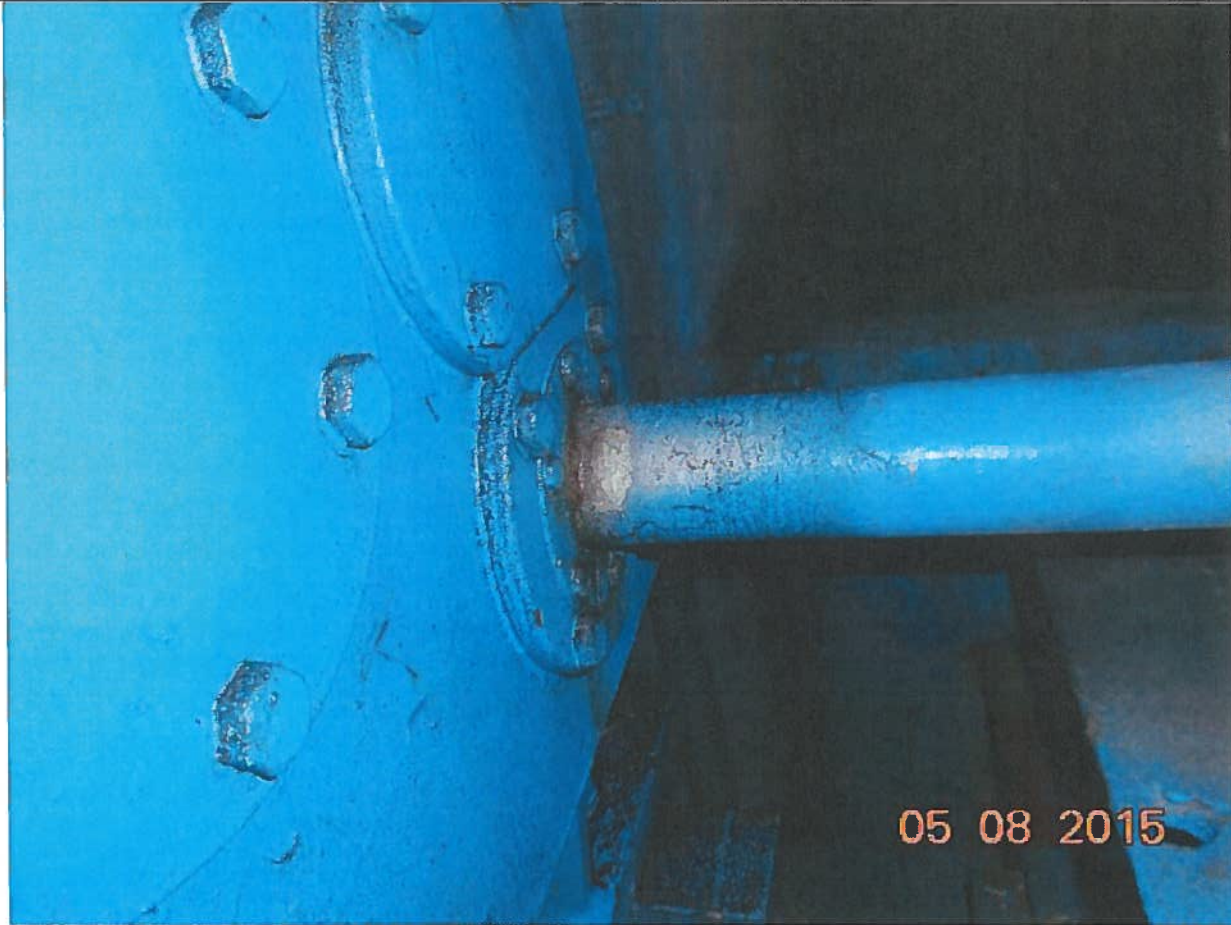
Photo 20 – Unit 0 Element 541 Speed Reducers

Both near leaf input shafts exhibit light leakage. Adjacent side shown

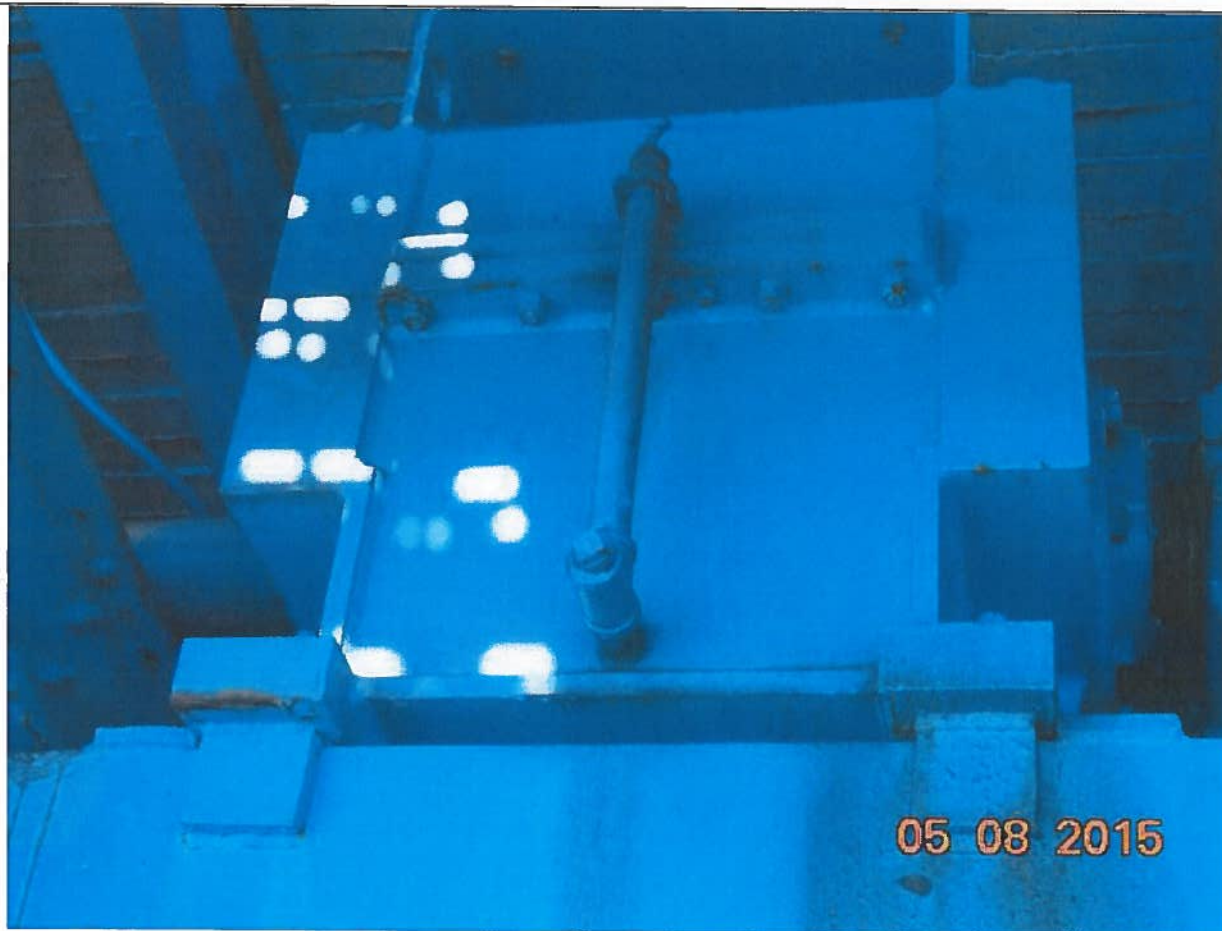
Photo 21 – Unit 0 Element 541 Speed Reducers

Slight debris and corrosion is present on all reducer housings. Far leaf shown, near leaf similar
