Palm Beach County

RENEWAL/REPLACEMENT PROGRAM ASSESSMENT STUDY STRUCTURAL ELEMENTS

December, 2015

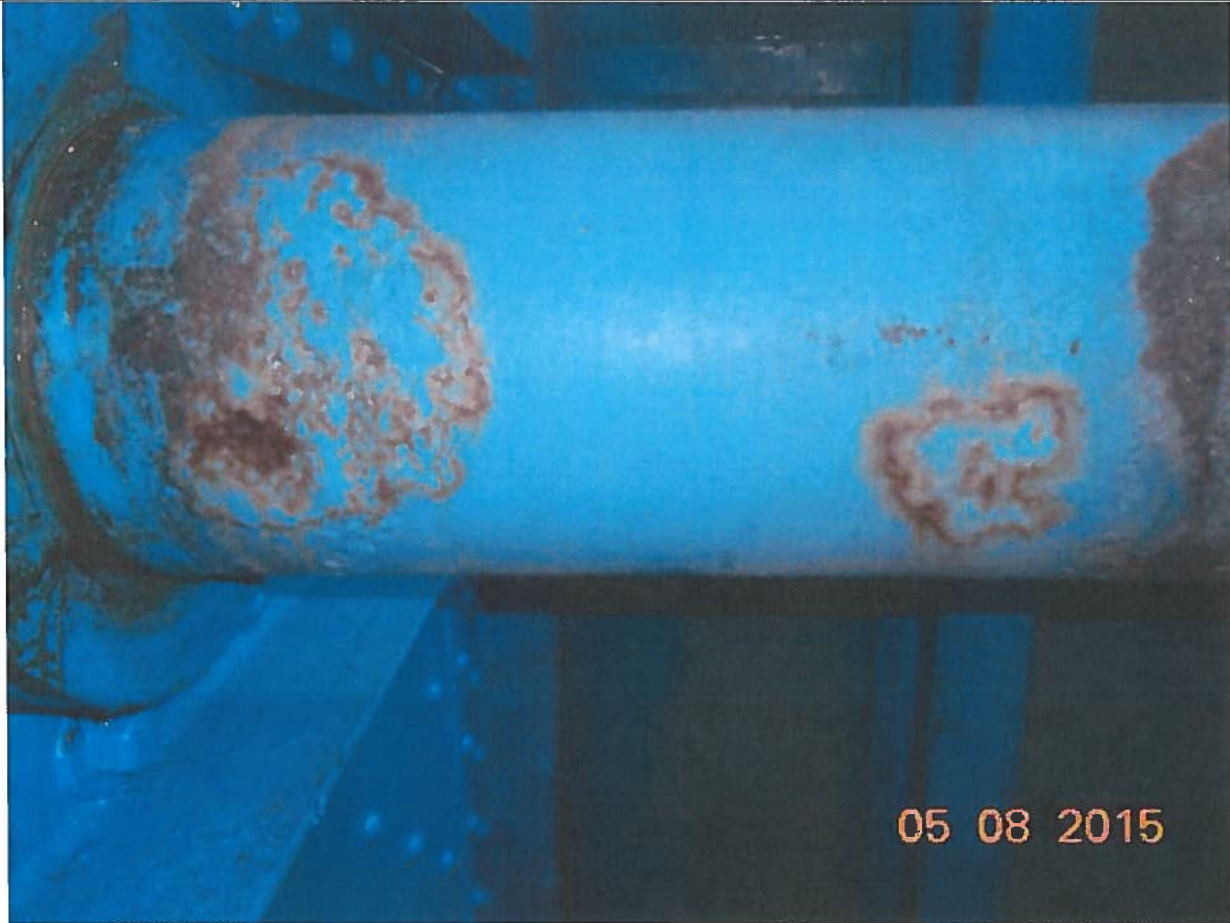
Photo 22 - Unit 0 Element 542 Shafts

Typical paint cracks and corrosion on the pinion shafts

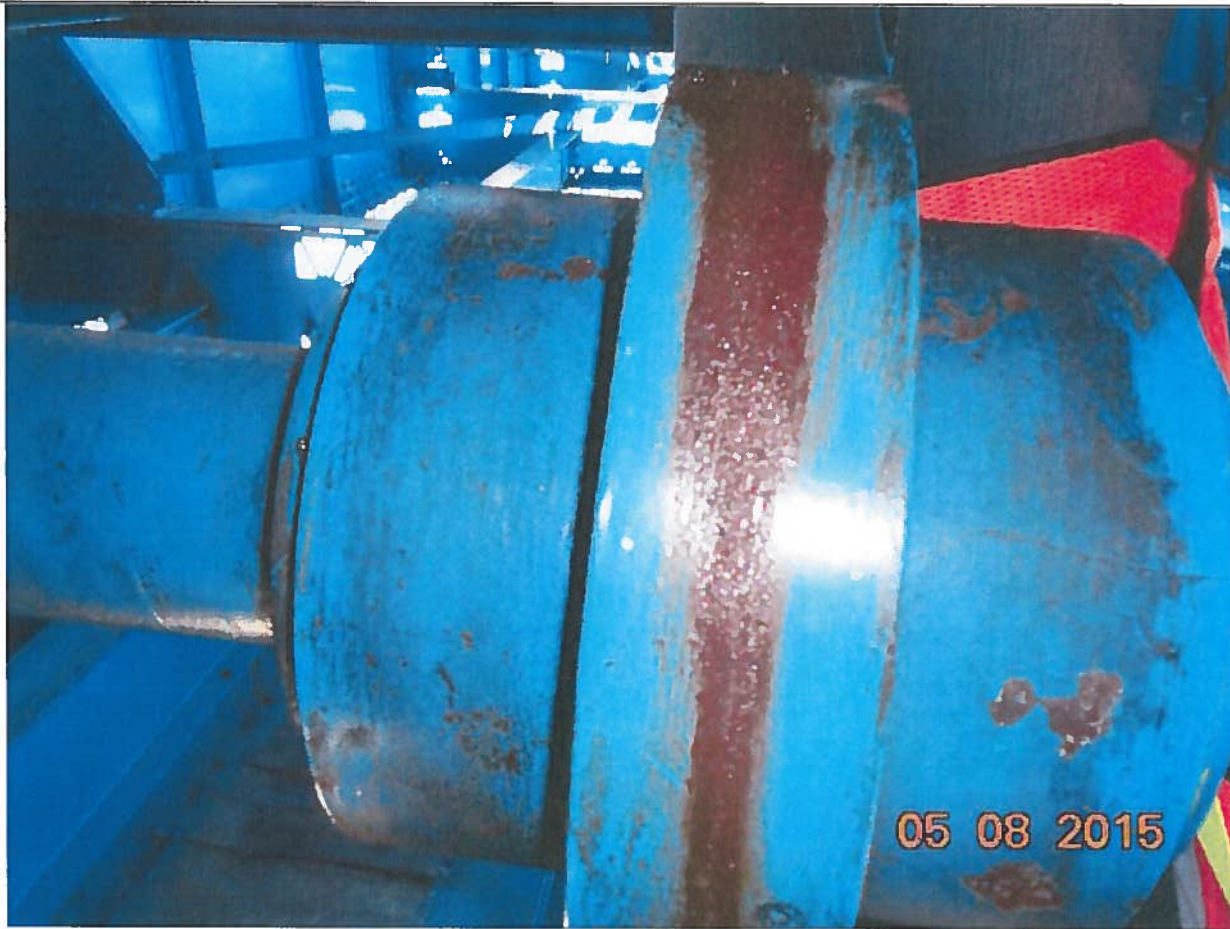
Photo 25 – Unit 0 Element 543 Shaft Brgs and Coupl

All couplings have a minor to moderate layer of grease and debris present. Near leaf coupling C3 shown, others similar

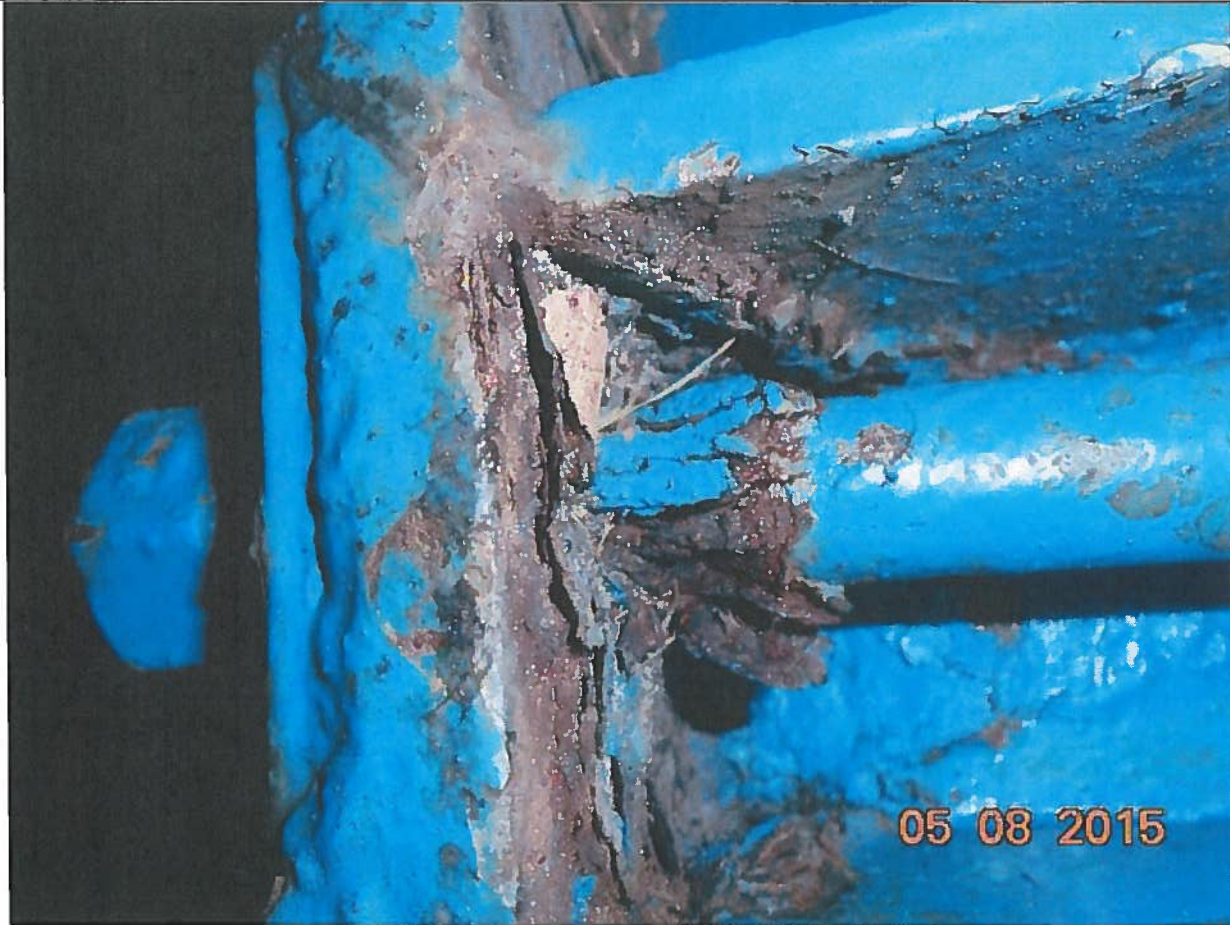
Photo 26 – Unit 0 Element 543 Shaft Brqs and Coupl

Corrosion and section loss are present on both near and far leaves' Bearing B3 mounting bolts at the nut. Near leaf shown, far leaf similar

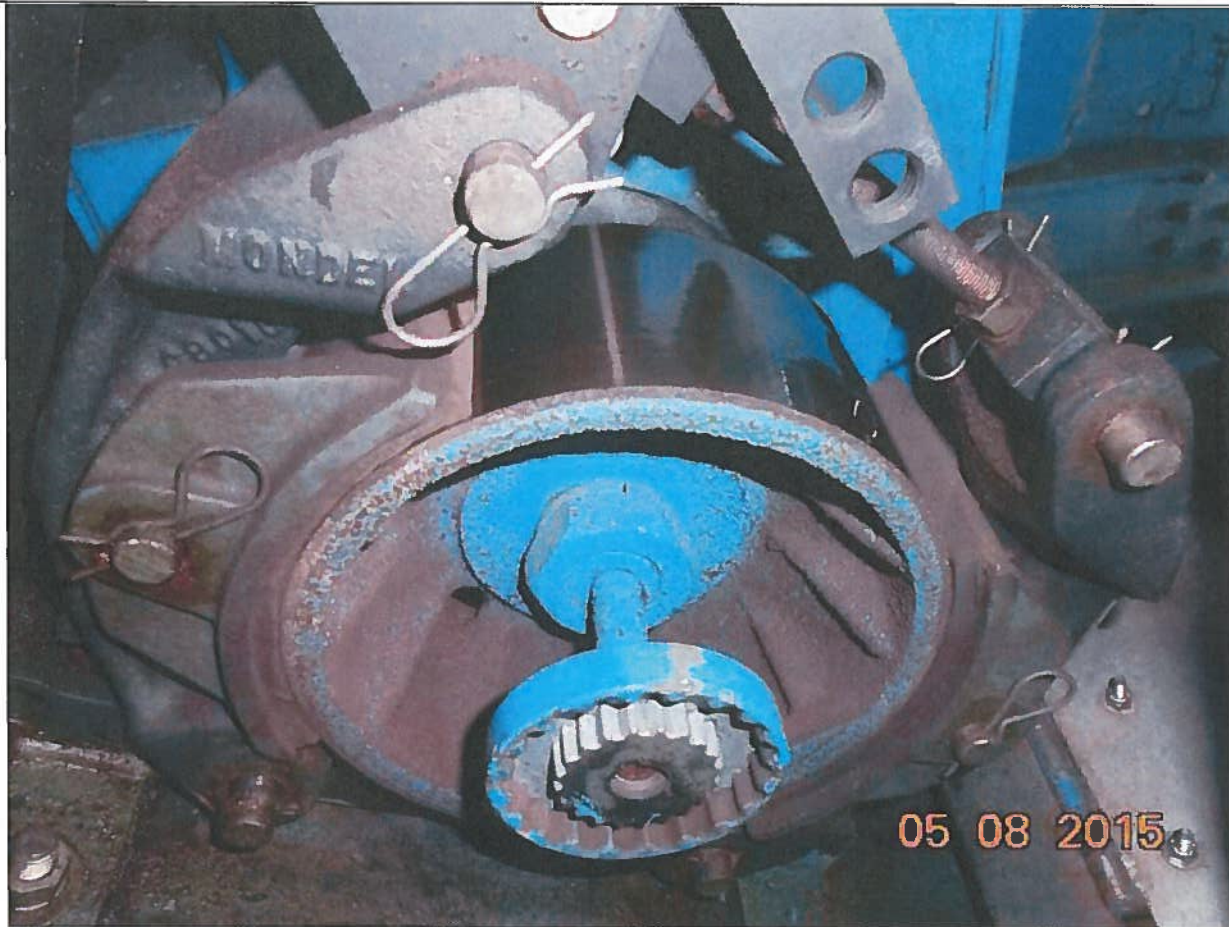
Photo 27 – Unit 0 Element 544 Brakes

All brakes exhibit minor corrosion and moderate debris on all brake drums and hubs. Far leaf motor brake shown, others similar

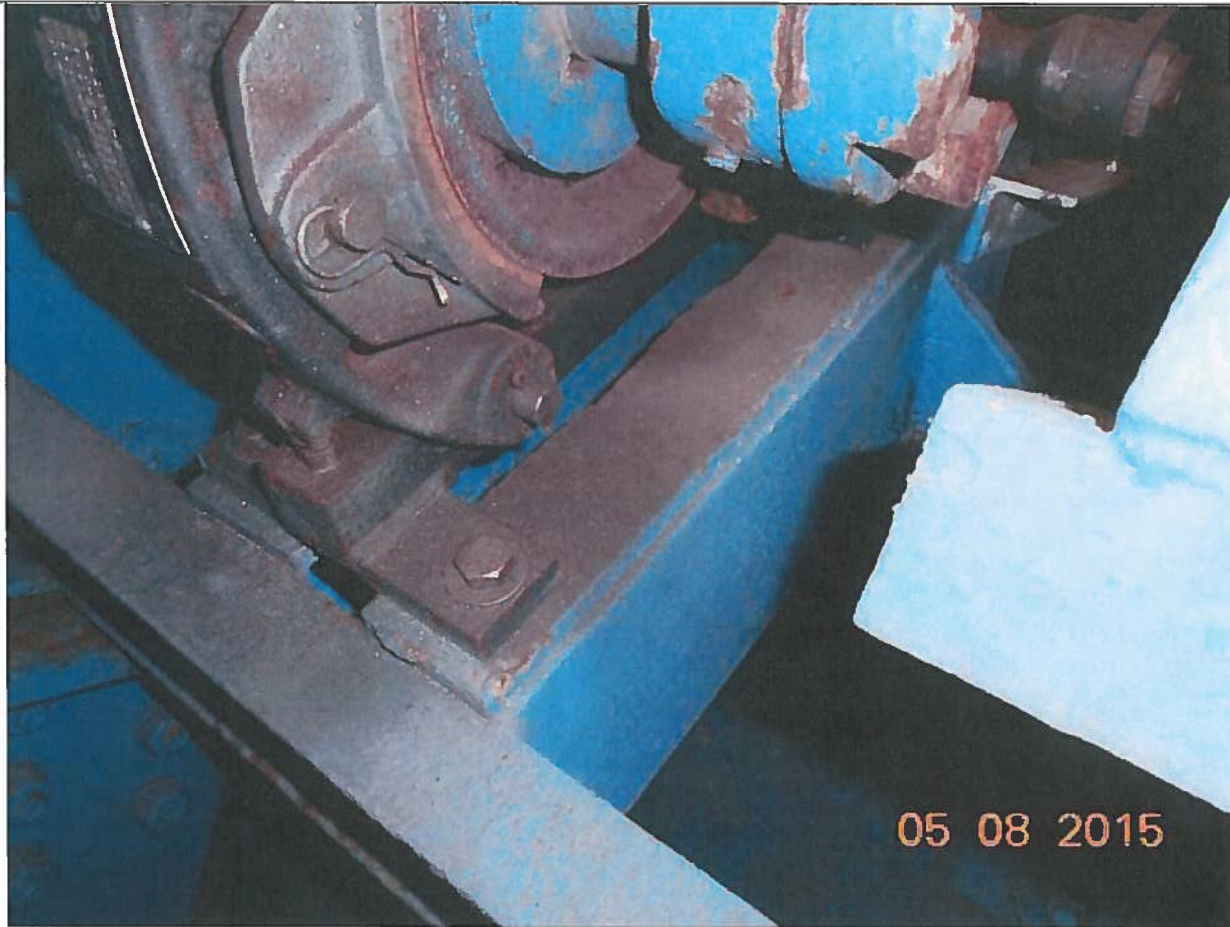
Photo 30 – Unit 0 Element 544 Brakes

All brake mounting support exhibit light corrosion and debris. Far leaf machinery brake shown

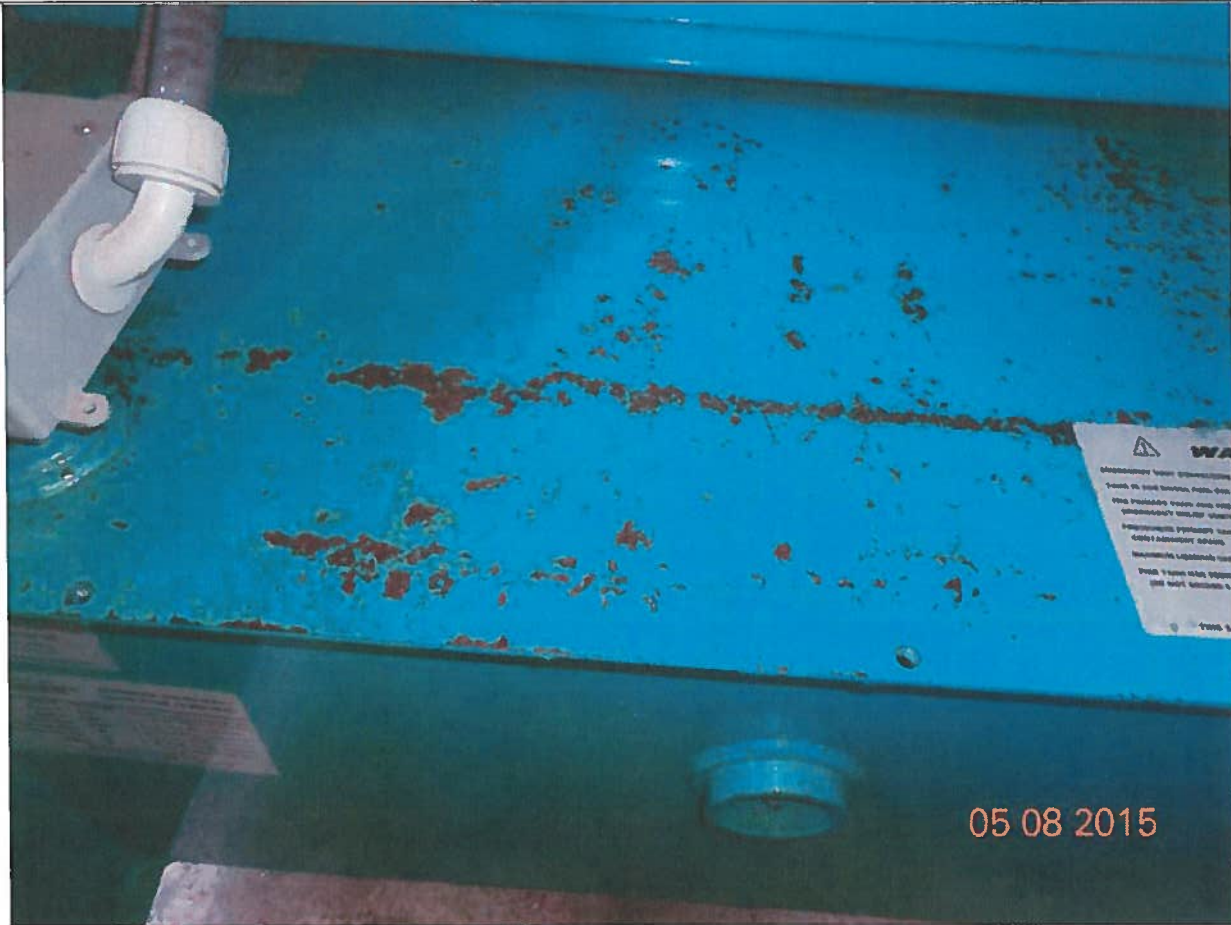
Photo 31 – Unit 0 Element 545 Emergency Drive

The top surface of the load bank has areas of spotty surface corrosion

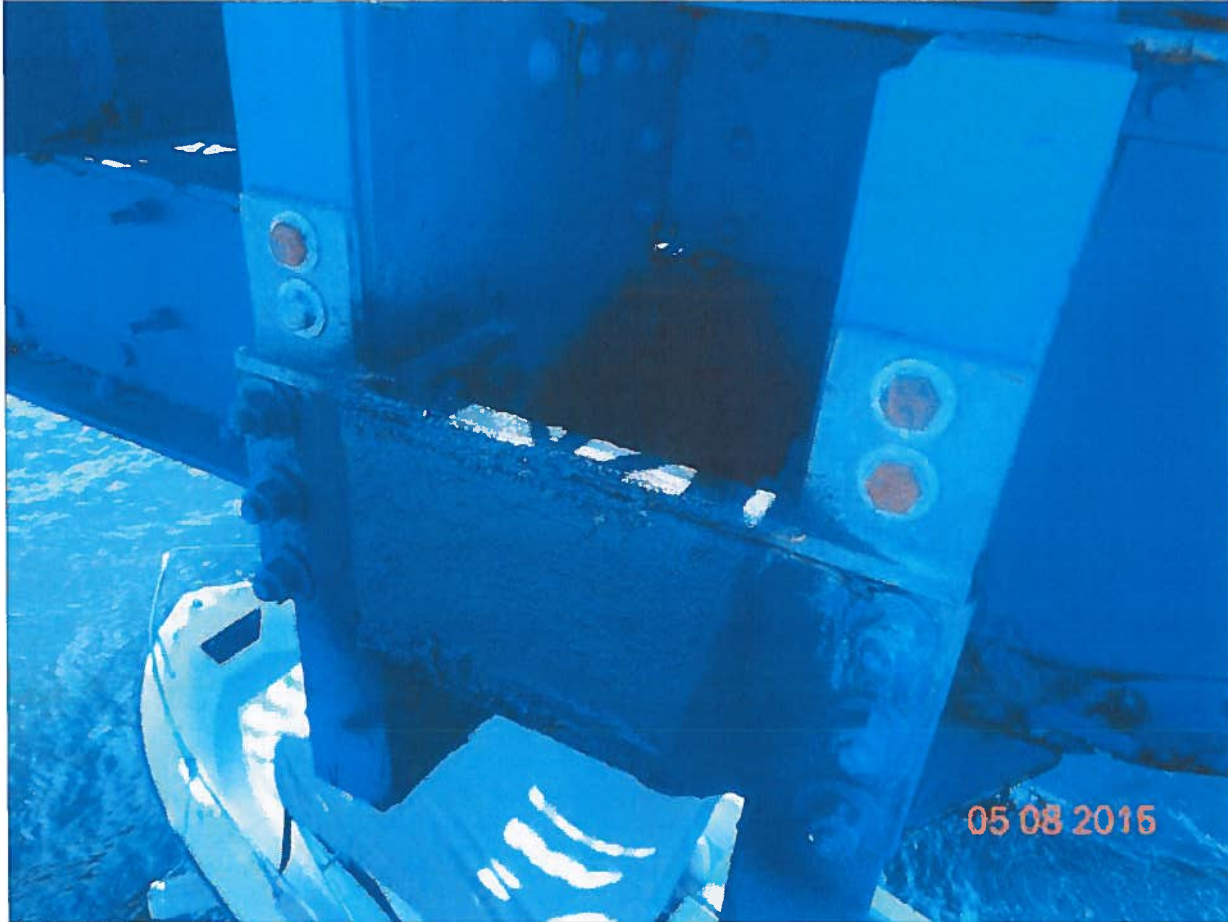
Photo 32 – Unit 0 Element 560 Locks

The mounting bolts for the rigid lock plate are not painted and corrosion is present. Opposite side shown, adjacent similar

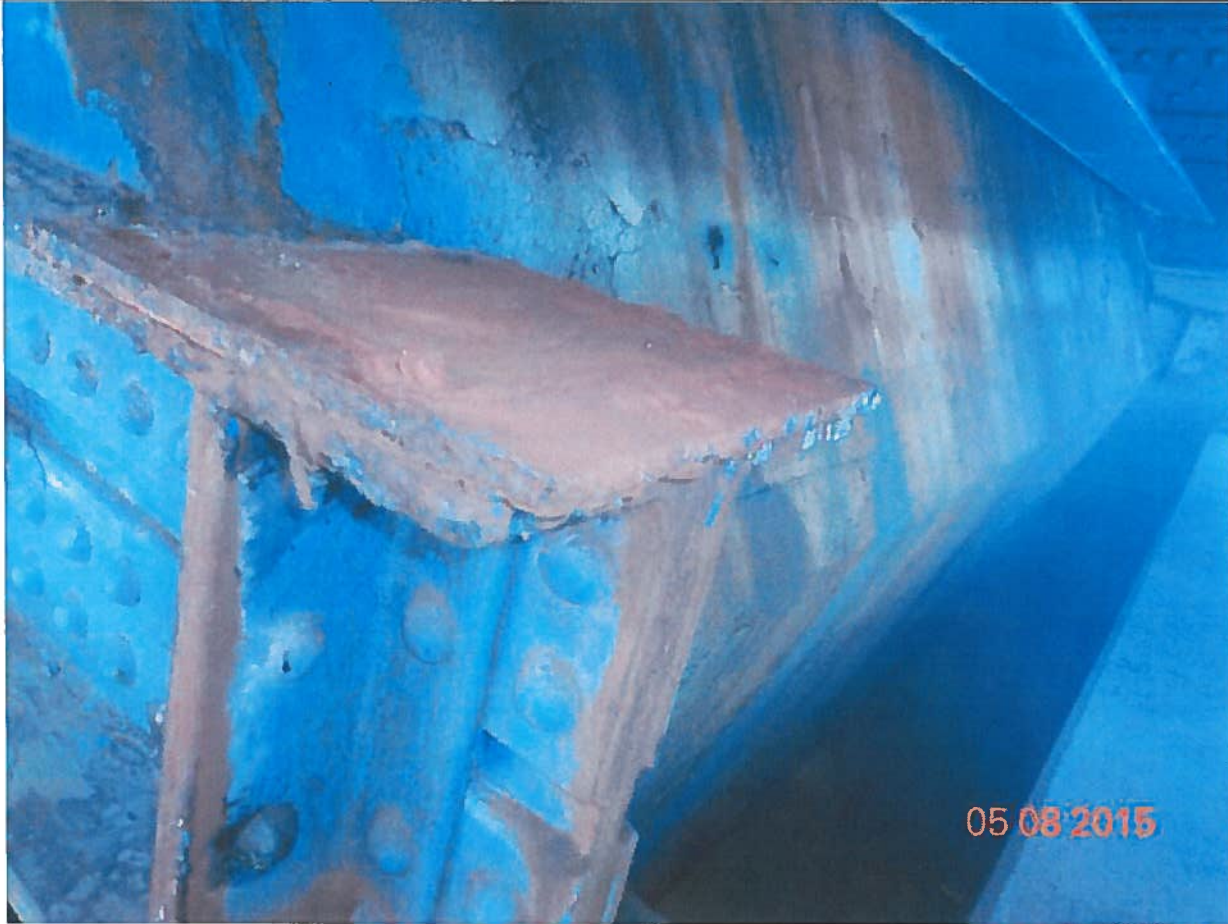
Photo 33 – Unit 0 Element 560 Locks

Moderate corrosion is present on all heel stops. Near leaf opposite side shown, others similar

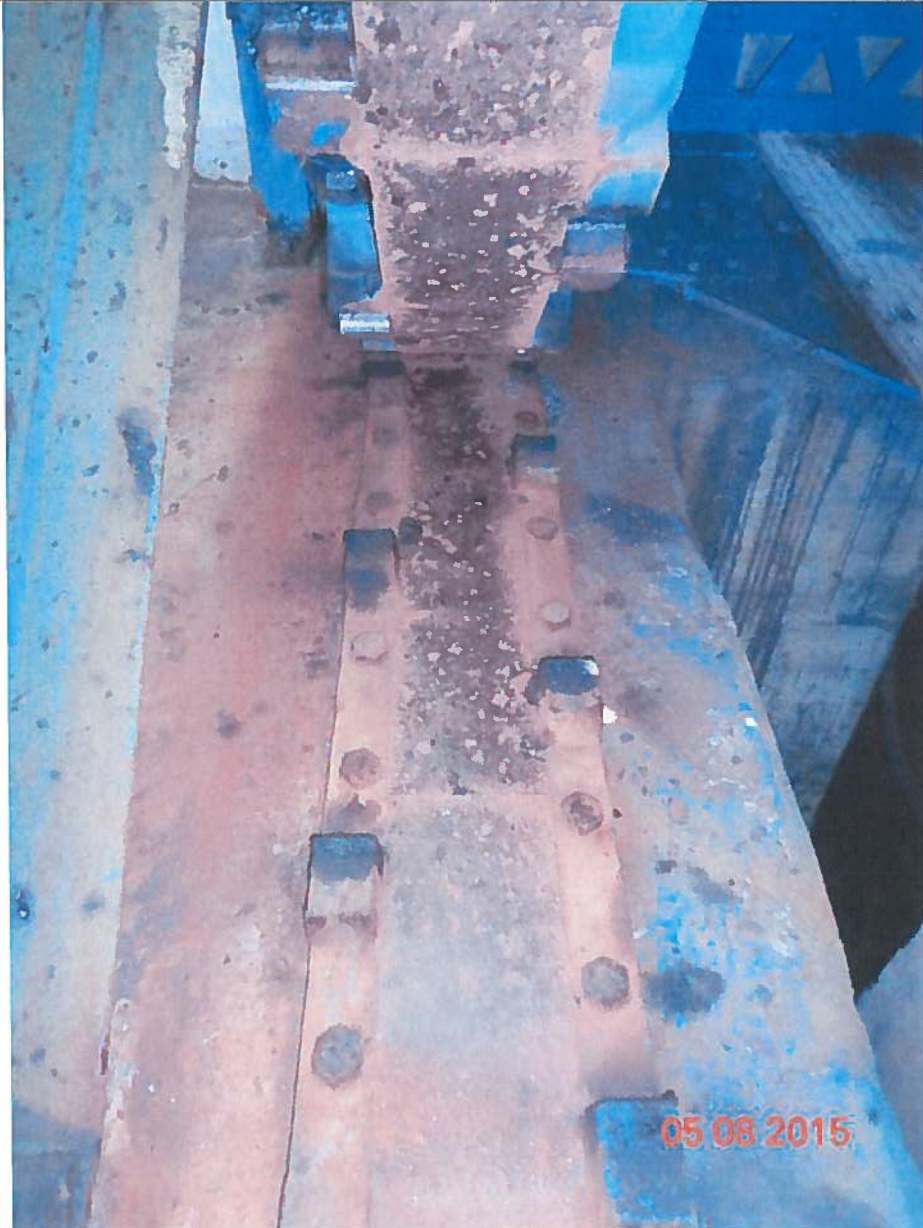
Photo 34 – Unit 0 Element 565 Trun/Str and Cur Trk

Moderate corrosion and light debris are present on all tread and track plates. Near leaf opposite side shown, others similar

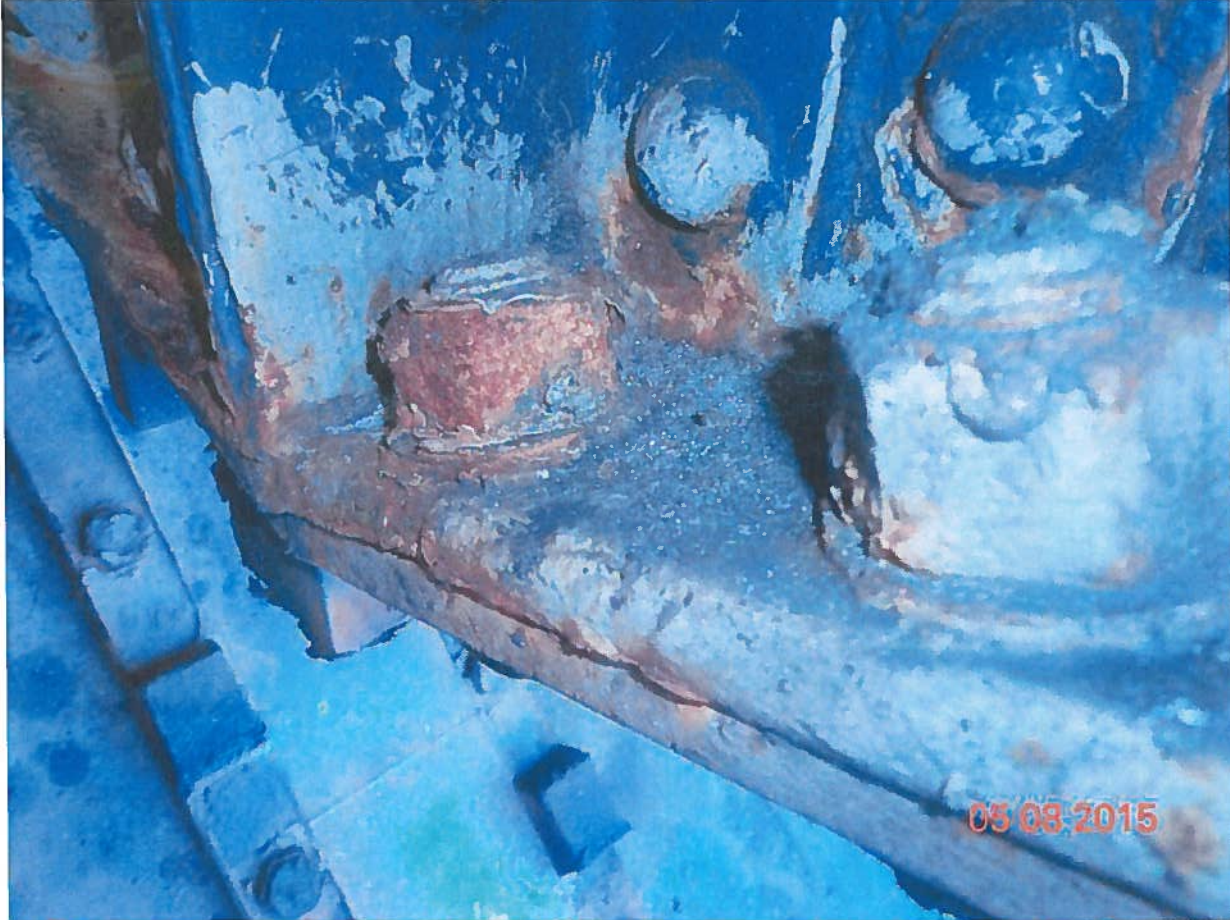
Photo 35 – Unit 0 Element 565 Trun/Str and Cur Trk

All tread and track plate mounting bolts lack paint and exhibit minor to moderate corrosion. Far leaf opposite side track plate shown, others similar

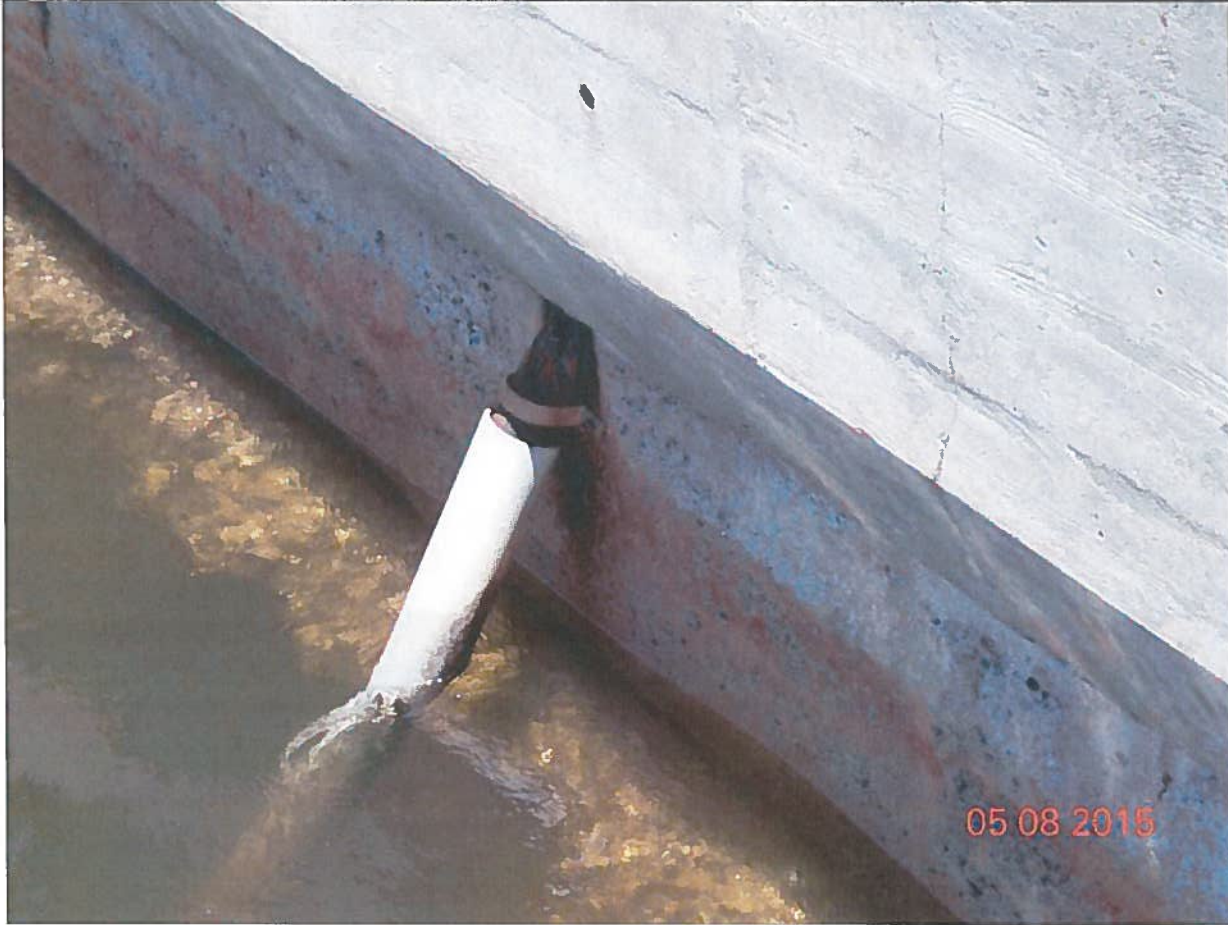
Photo 36 – Unit 0 Element 571 Submarine Cable

The armor for the two abandoned cables at the north end of Piers 3 and 4 has severe corrosion with 100% deterioration, in the splash zone

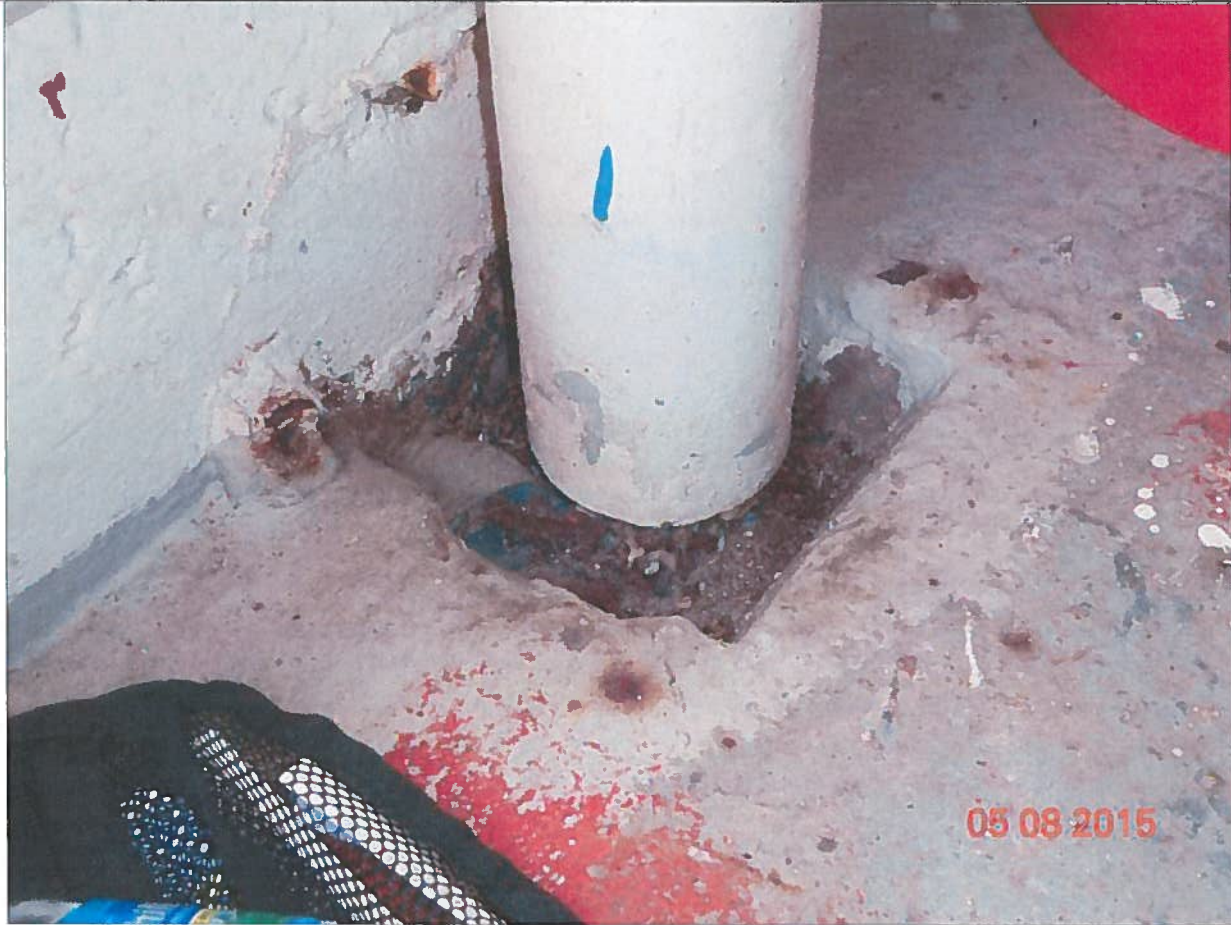
Photo 37 – Unit 0 Element 571 Submarine Cable

The insulation for the in-service submarine cable at the south end of Bascule Piers 3 and 4 have light to moderate deterioration with corrosion staining where it enters the bascule pier

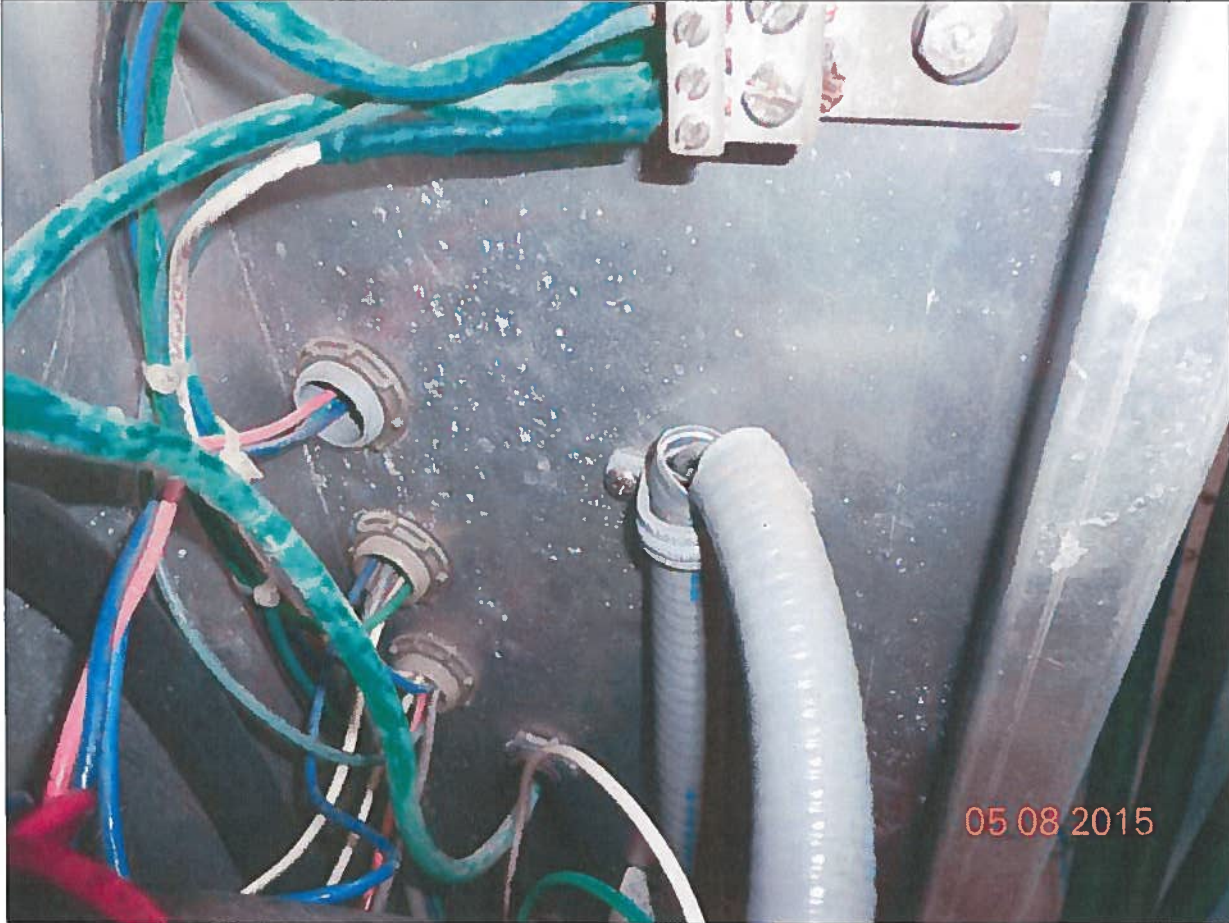
Photo 38 – Unit 0 Element 572 Conduit and Junct. Box

There is a broken length of flexible conduit in the junction box at the southwest corner of the near bascule pier/track area

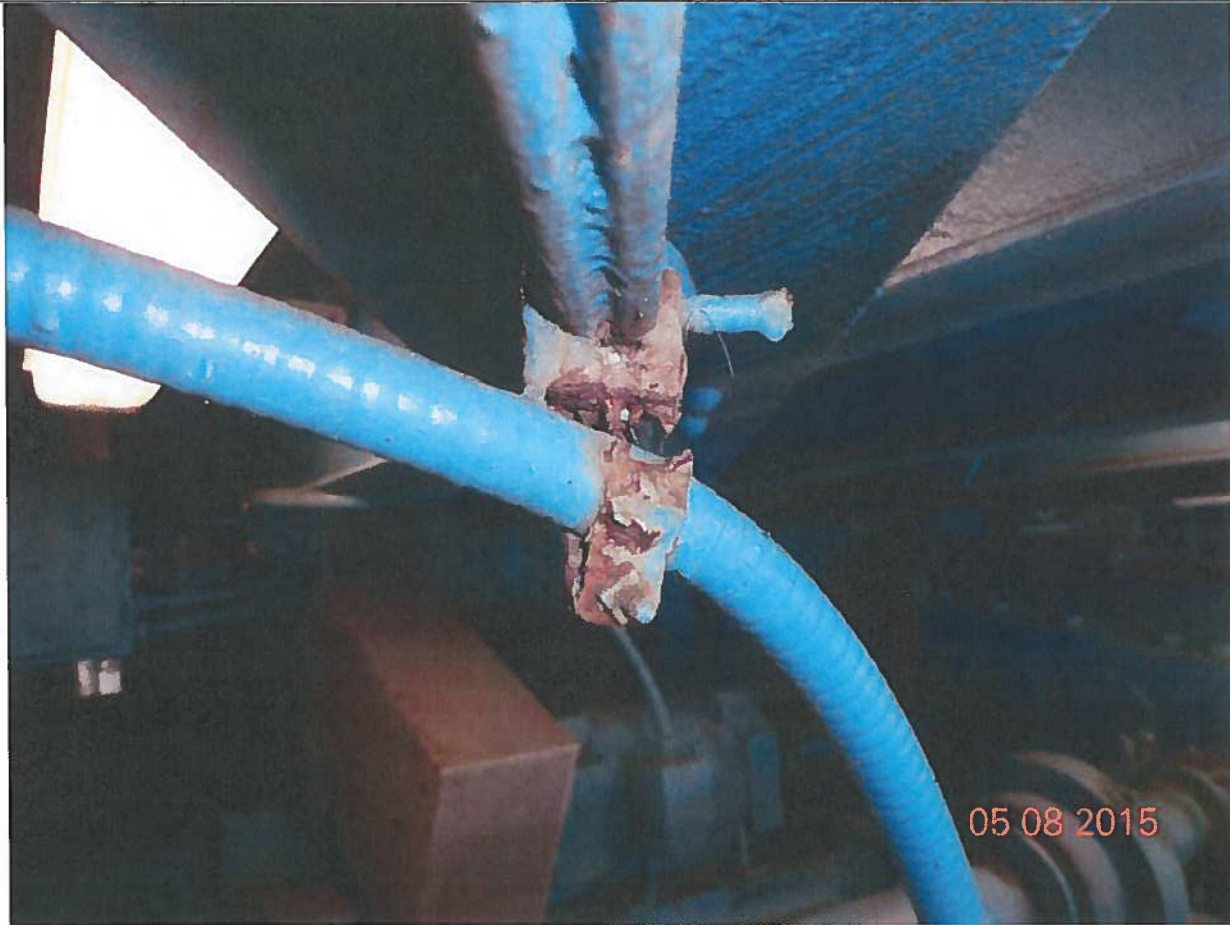
Photo 39 – Unit 0 Element 572 Conduit and Junct.

The support for the length of flexible conduit in the near machinery area is corroded with significant section loss

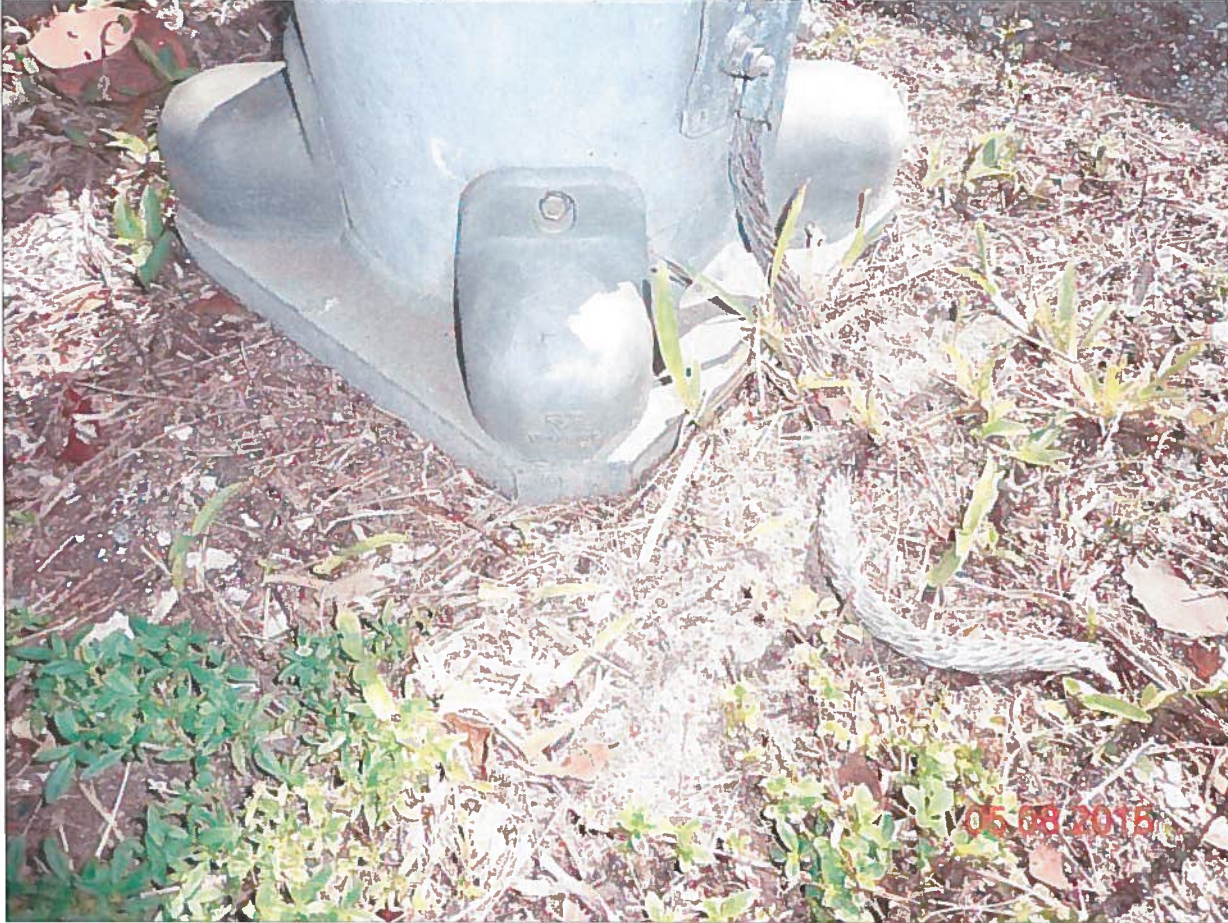
Photo 43 – Unit 0 Element 592 Traffic Signals

Both traffic signals have dirt covering the foundations and packed under the base plates

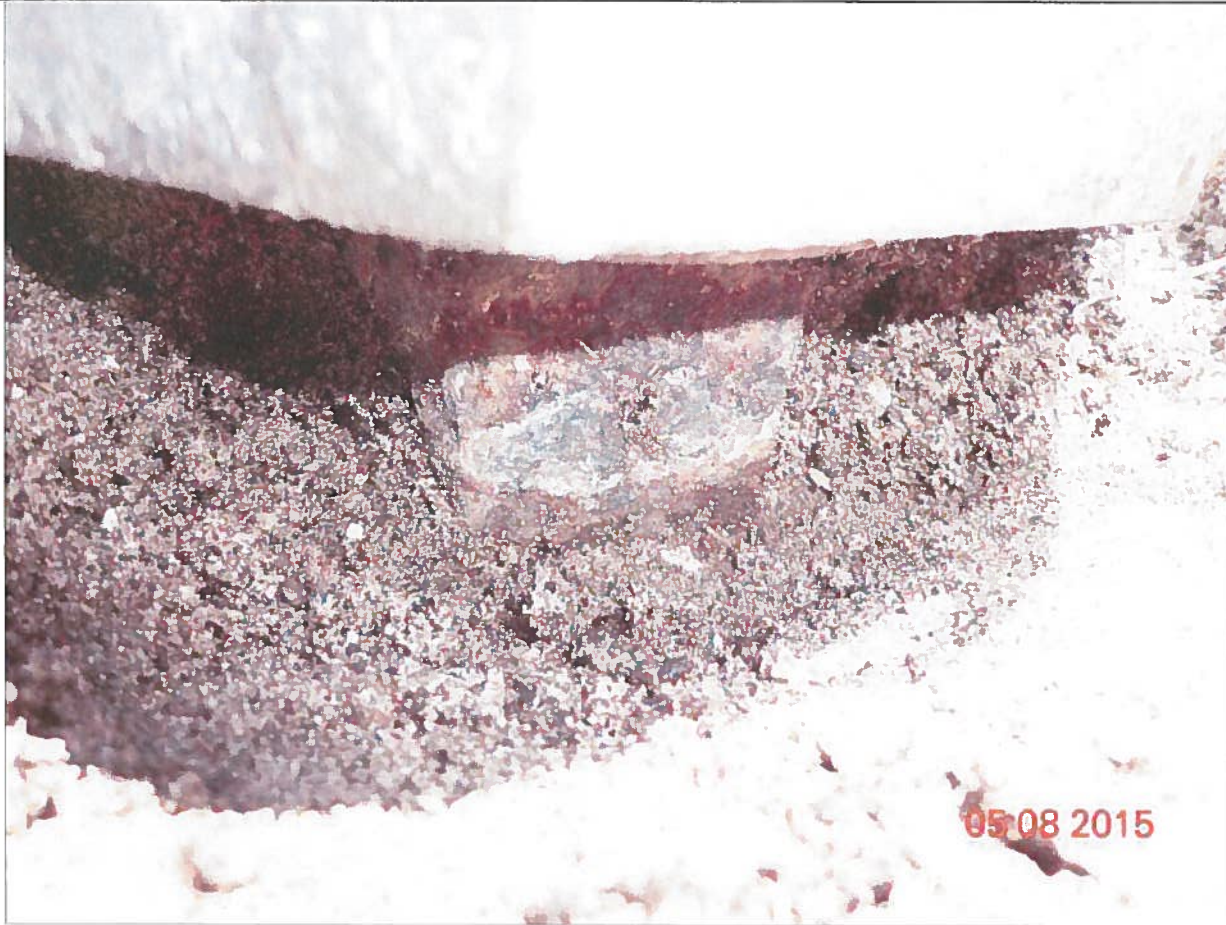
Photo 44 – Unit 0 Element 592 Traffic Signals

The anchor bolts and leveling nuts have heavy flaking corrosion and there are no grout pads or critter screens below the base plates

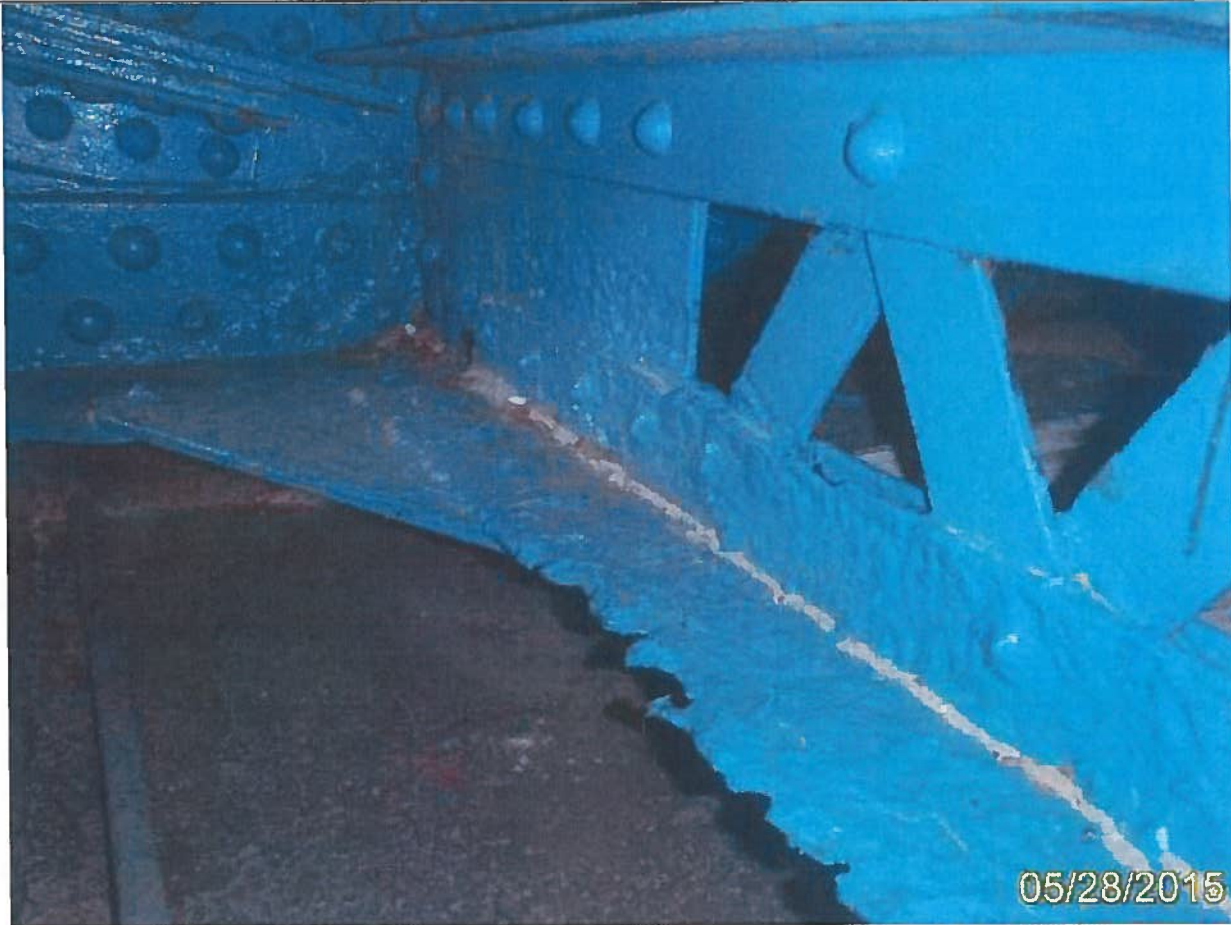
Photo 45 – Unit 0 Element 202 Paint Stl Column

Painted over section loss with recurring corrosion on the southeast column in Bascule Pier 4

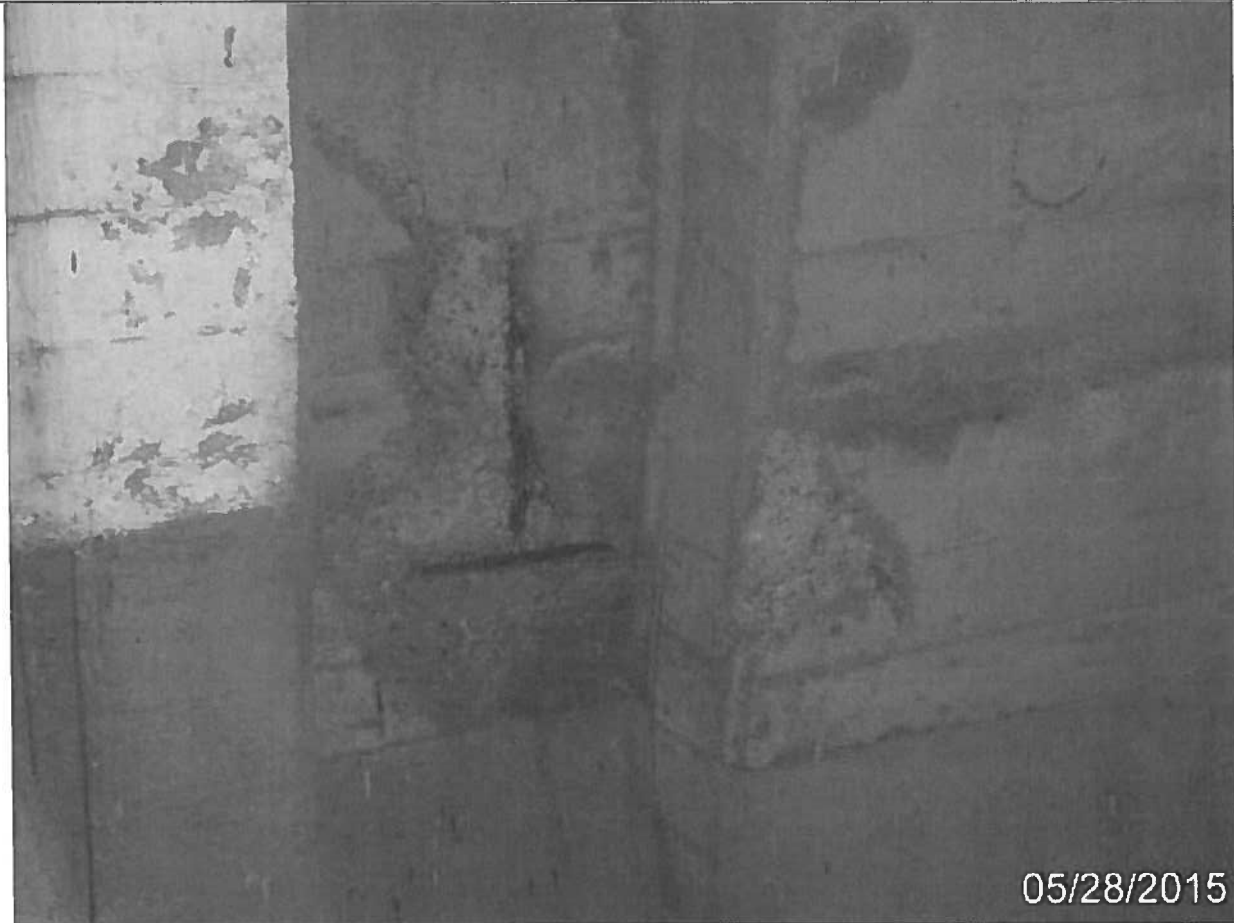
Photo 46 – Unit 0 Element 210 R/Conc Pier Wall

Spall/delamination with exposed steel in the west face of the east wall at Bascule Pier 4

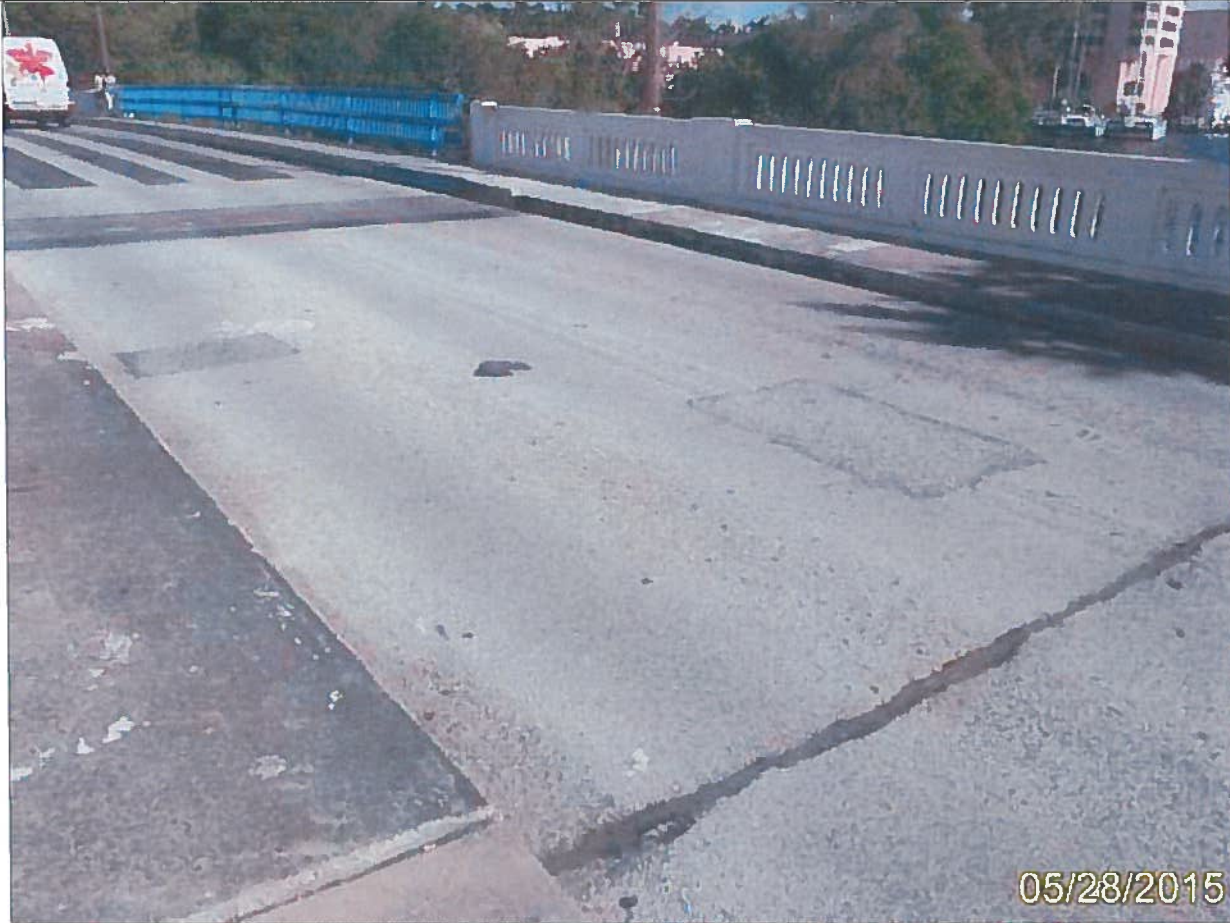
Photo 48 – Unit 1 Element 13 Unp Conc Deck/Asp Ovl

Deteriorated roadway striping
