ADDENDUM #5
Date issued: March 31, 2023

INVITATION TO RE-BID: House Replacement Program

PRE-DEMOLITION ASBESTOS IDENTIFICATION SURVEY FOR

**Residential Structure
3760 Serubi Avenue
Palm Springs, FL**

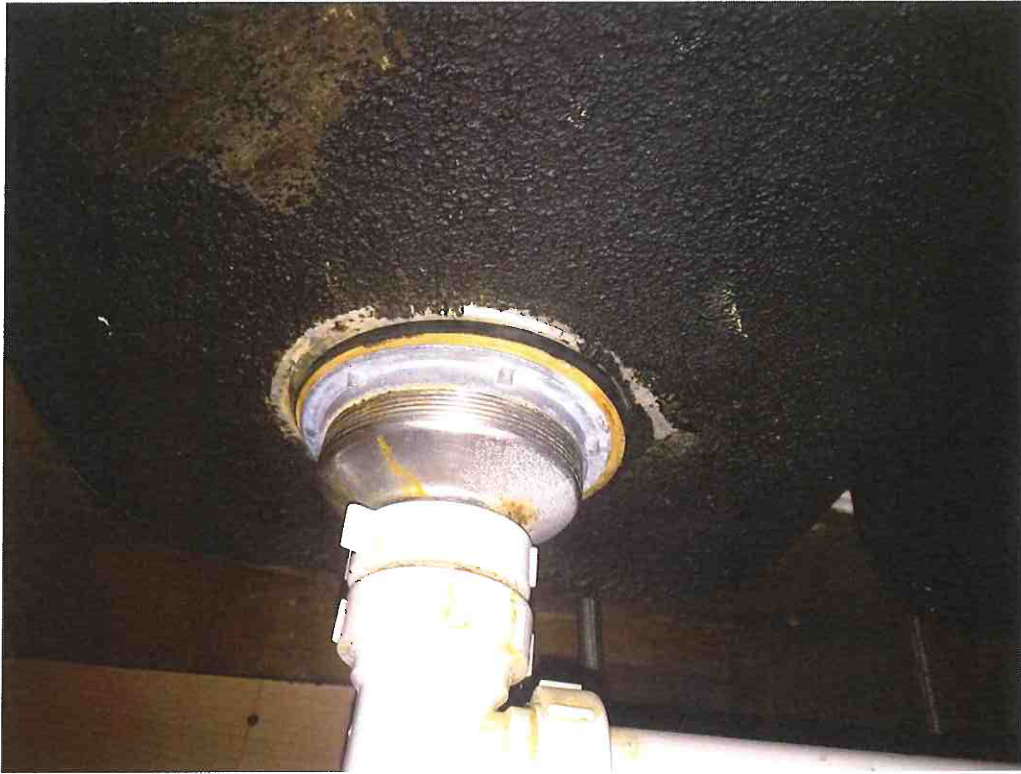
Sample #	Material Tested	Location	Qty	Asbestos Content	Friable Y/N	Condition	NESHAP Category
2032-04	Sink Undercoat (black)	Kitchen	4 s.f. (1-sink)	2% Chrysotile	N	Good	I
2032-06, 07	Exterior Transite Siding	Throughout Exterior	1,100 s.f.	15% Chrysotile 20% Chrysotile	N	Good	II

Asbestos Containing Sink Undercoat (Black), Kitchen

The Category I sink undercoat (black) is located in the kitchen and must be removed prior to demolition activities by a Florida licensed Asbestos Abatement Contactor under the direction of a Florida Licensed Asbestos Consultant. All with shall be performed in accordance with all Local, State and Federal regulations.

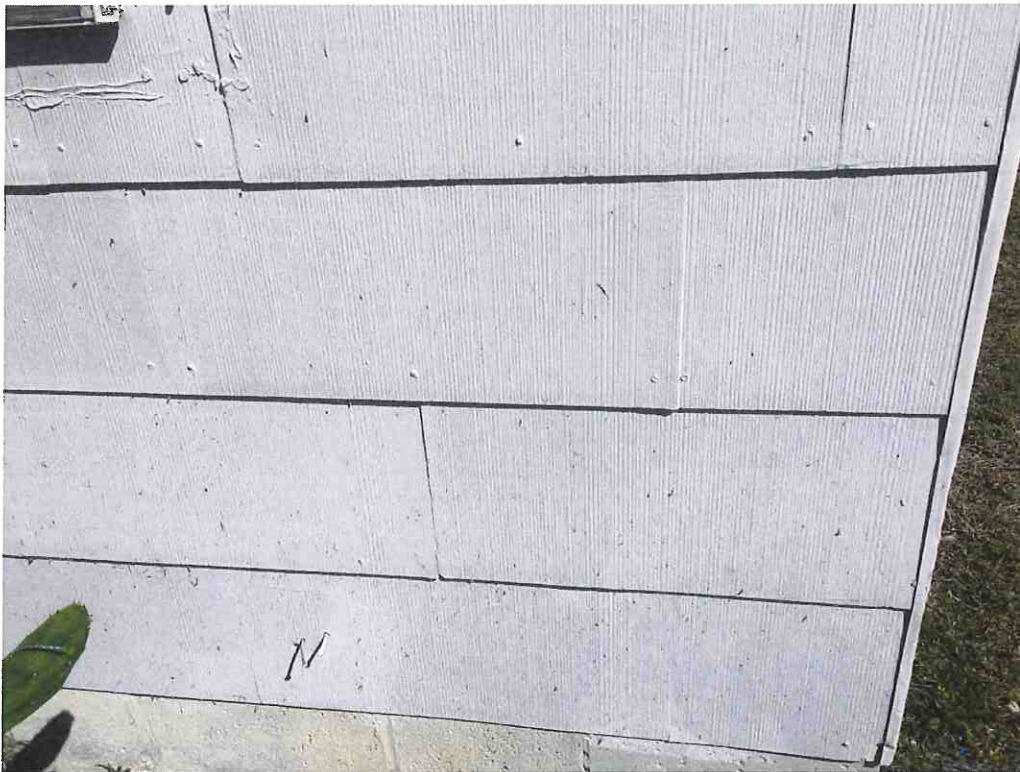
Asbestos Containing Exterior Transite Siding, throughout Exterior

The Category II exterior transite siding is located throughout the exterior of the house and must be removed prior to demolition activities by a Florida Licensed Asbestos Abatement Contractor under the direction of a Florida Licensed Asbestos Consultant. All work shall be performed in accordance with all local, state and federal regulations.
