6TH AVE SOUTH OVER LAKE OSBORNE DR

Infrastructure Sales Tax Oversight Committee

Feb 17, 2022

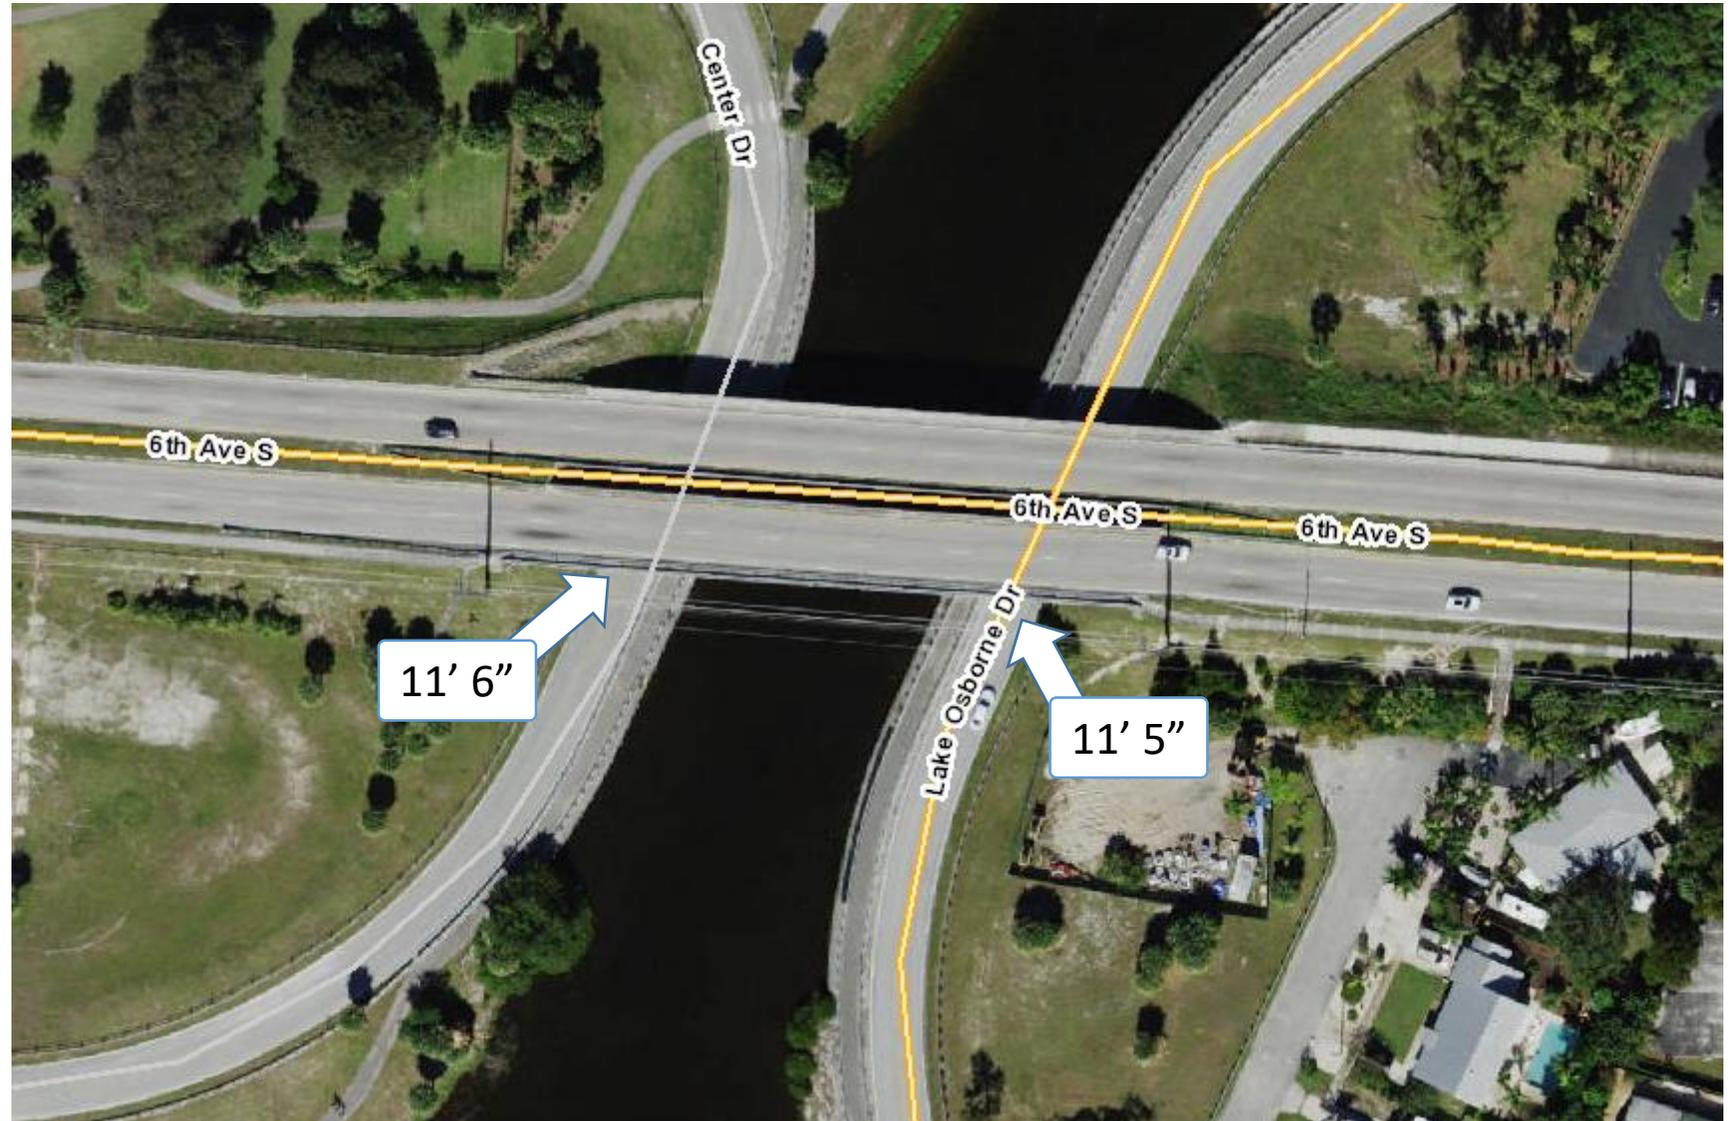
Existing Bridge

- Bridge composed of two identical independent structures (One for each direction)
- Crosses two roads in addition to Lake Osborne
 - Center Dr (25 MPH)
 - Lake Osborne Dr (30 MPH)
- Structures are functionally obsolete
- Both road crossings do not provide the AASHTO minimum clearance of 14'

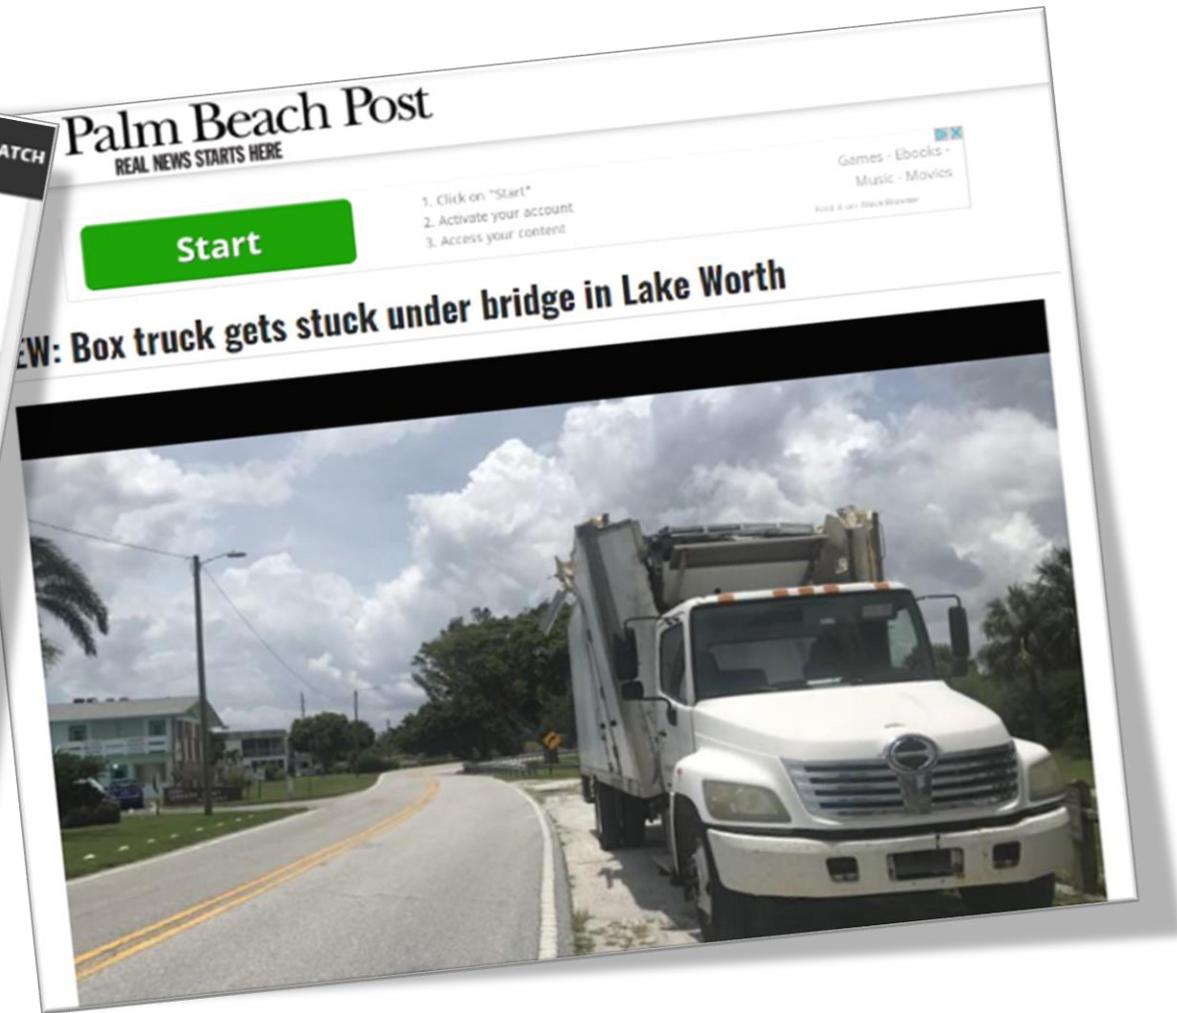
Source: <https://cbs12.com/news/local/truck-stuck-under-bridge-in-lake-worth-beach>

Source: <https://www.palmbeachpost.com/news/local/new-box-truck-gets-stuck-under-bridge-lake-worth/Tgw33JbgkGo9lw82mbLEYI/>

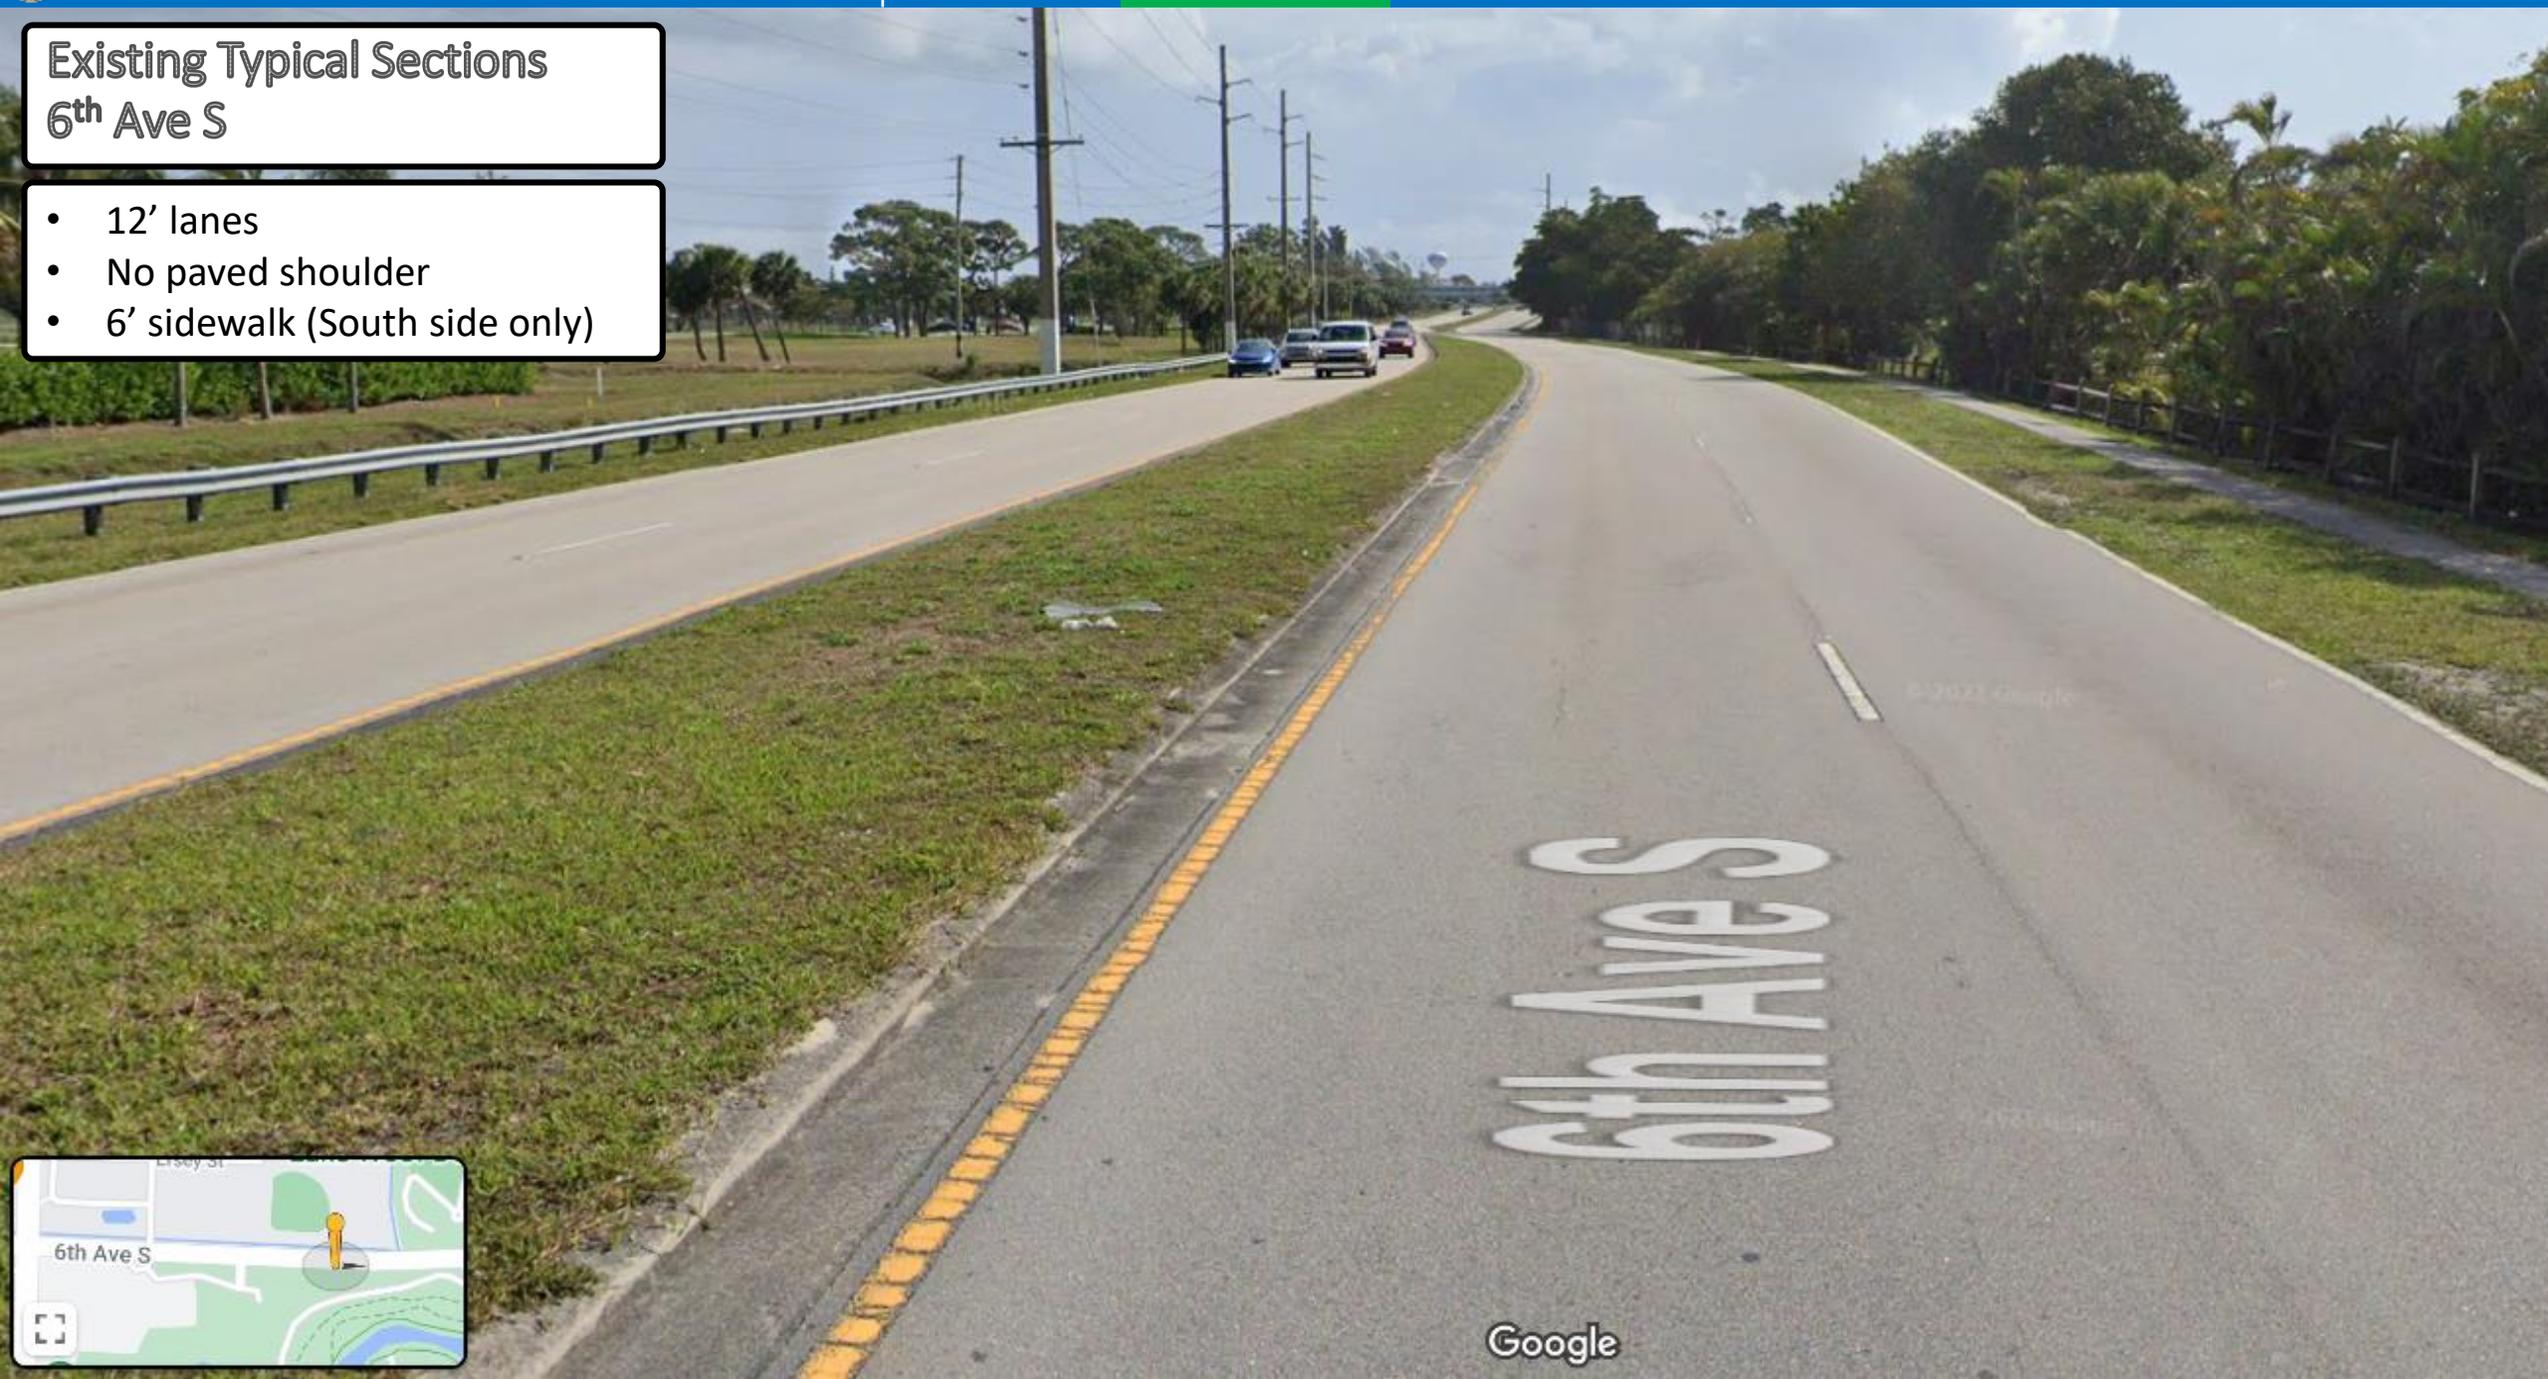
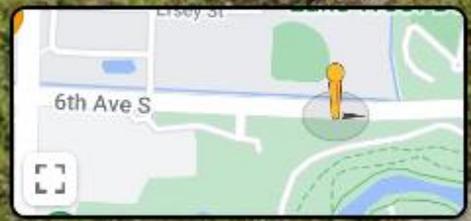
Existing Typical Sections 6th Ave S

- 12' lanes
- No paved shoulder
- 6' sidewalk (South side only)

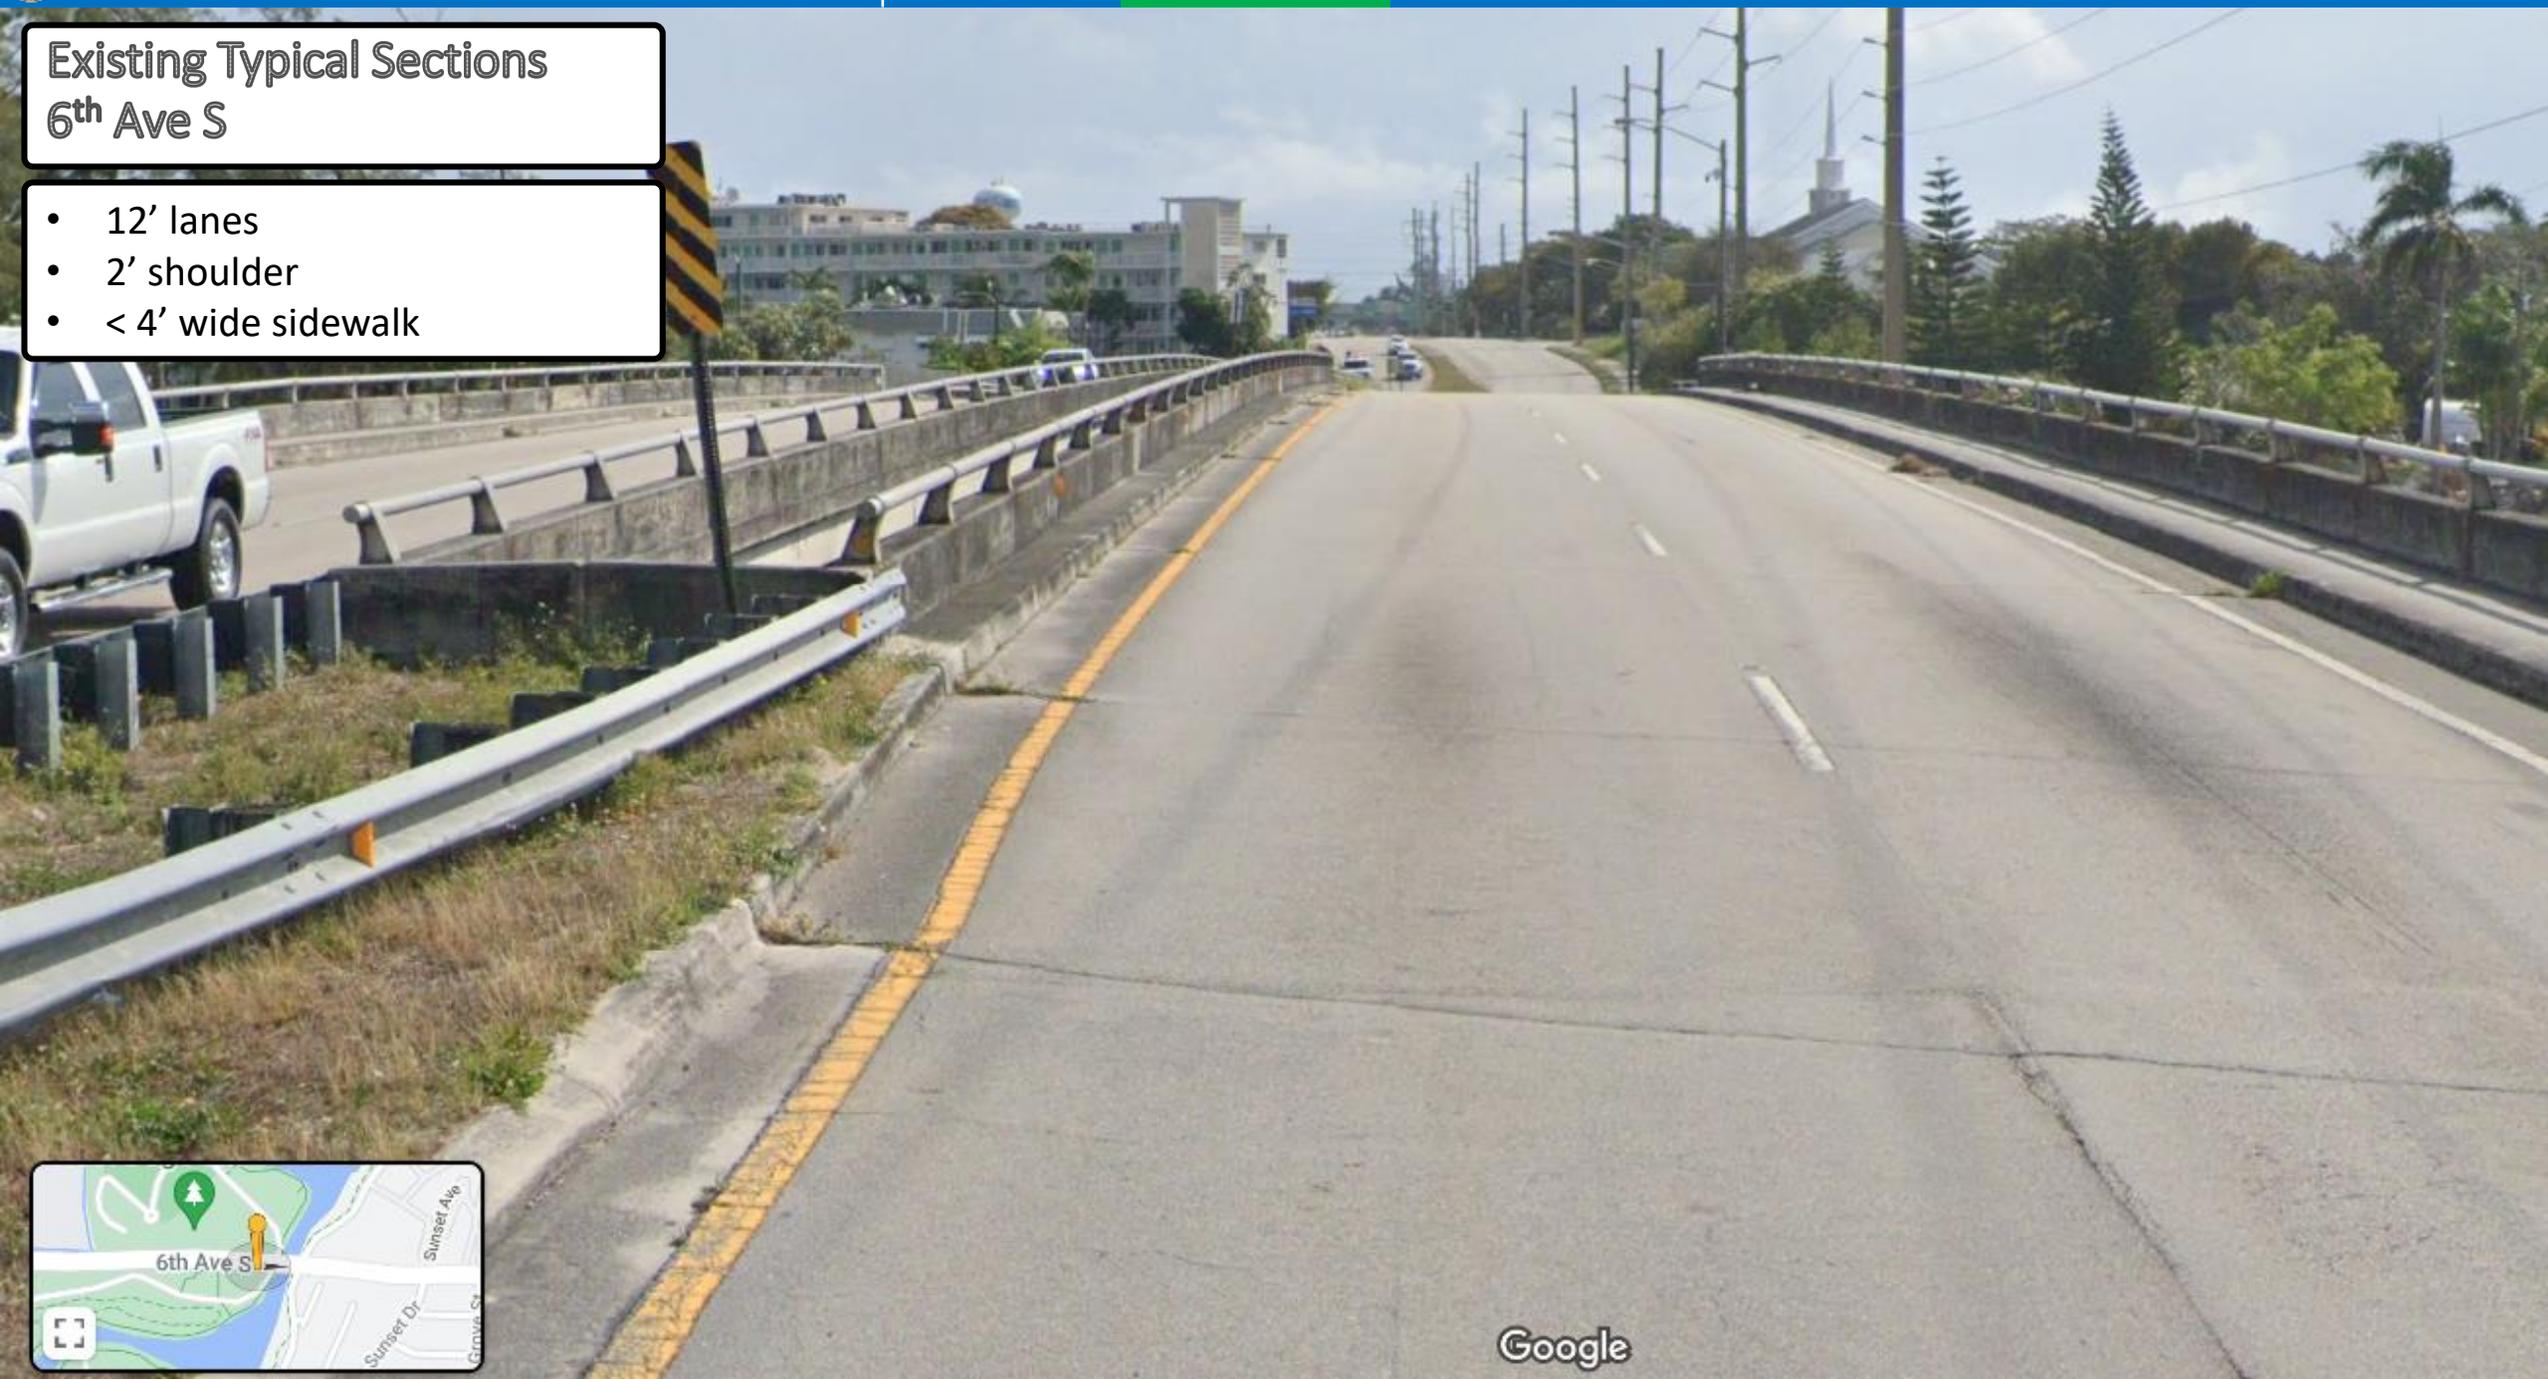
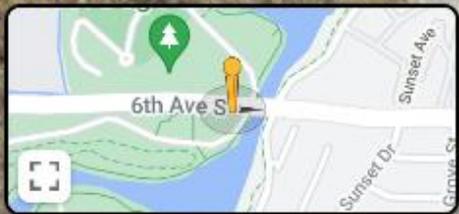
Existing Typical Sections 6th Ave S

- 12' lanes
- 2' shoulder
- < 4' wide sidewalk

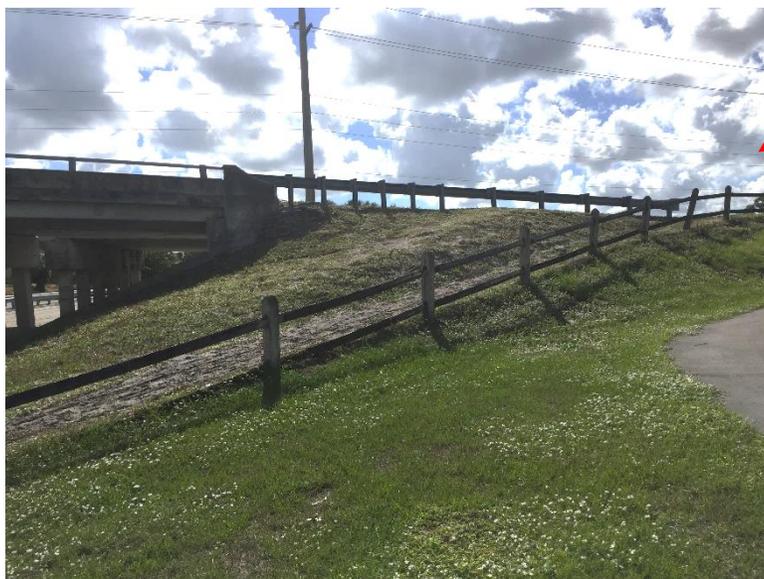
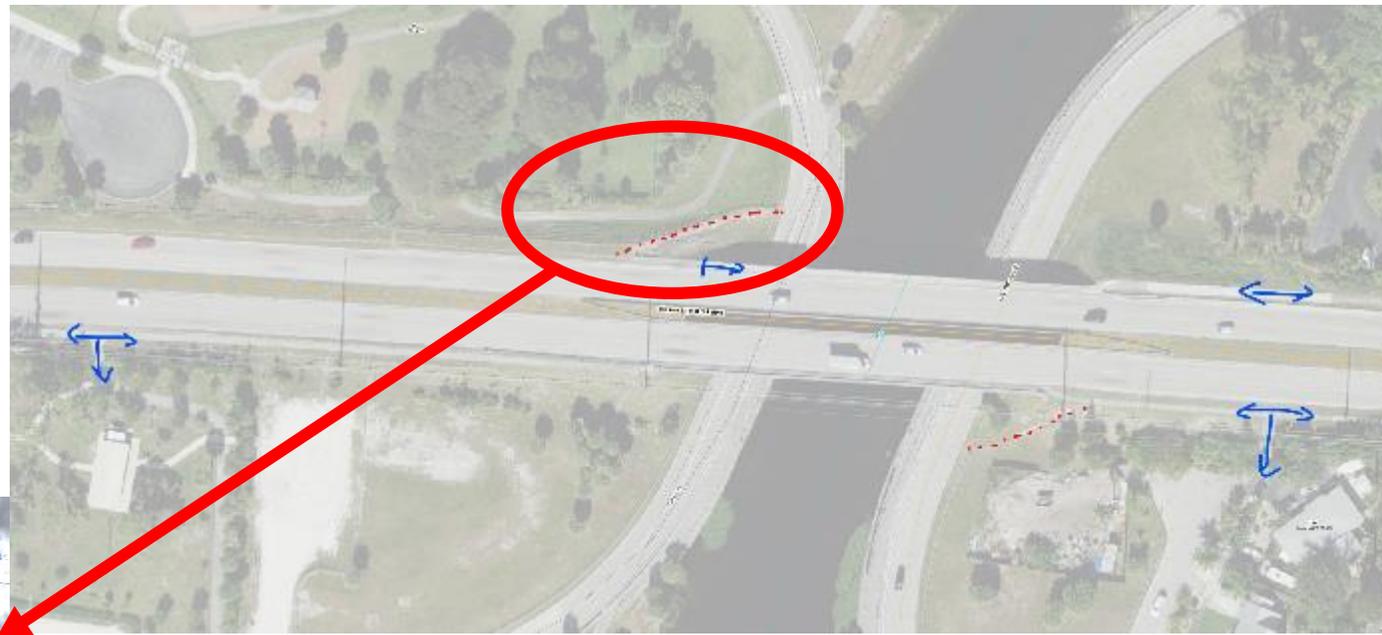
Pedestrian Accessibility

- Limited ability to access Center St and Park Dr from all 4 quadrants of the bridge
- North sidewalk ends on west side of bridge

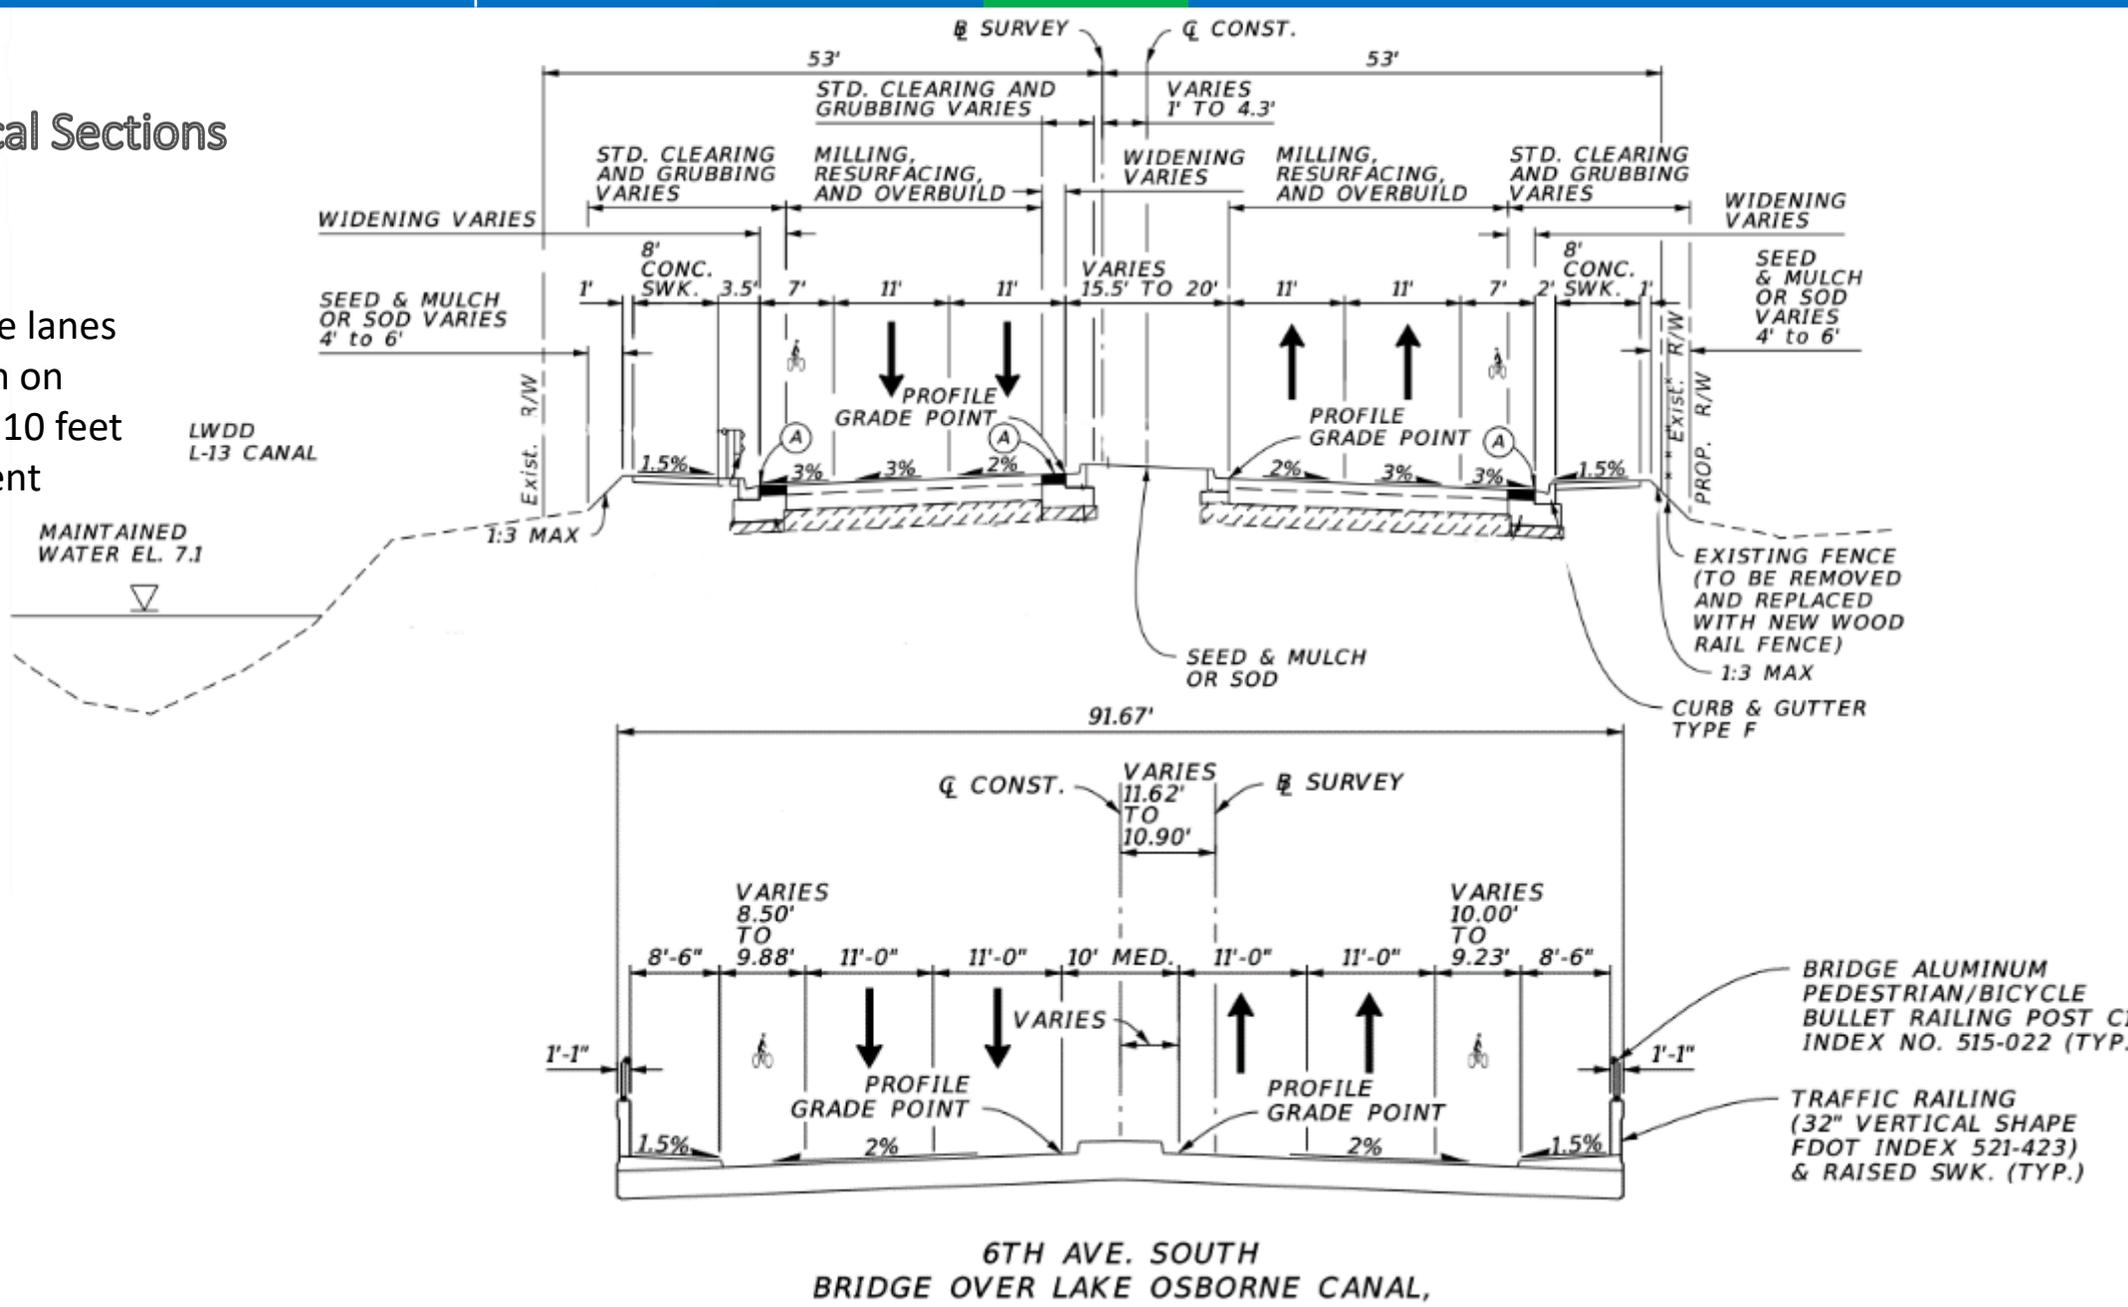
Proposed Typical Sections 6th Ave S

- 11' lanes
- 7' buffered bike lanes
- Shoulder width on bridge is up to 10 feet due to alignment

BRIDGE ALUMINUM PEDESTRIAN/BICYCLE BULLET RAILING POST C1 INDEX NO. 515-022 (TYP.)

TRAFFIC RAILING (32" VERTICAL SHAPE FDOT INDEX 521-423) & RAISED SWK. (TYP.)

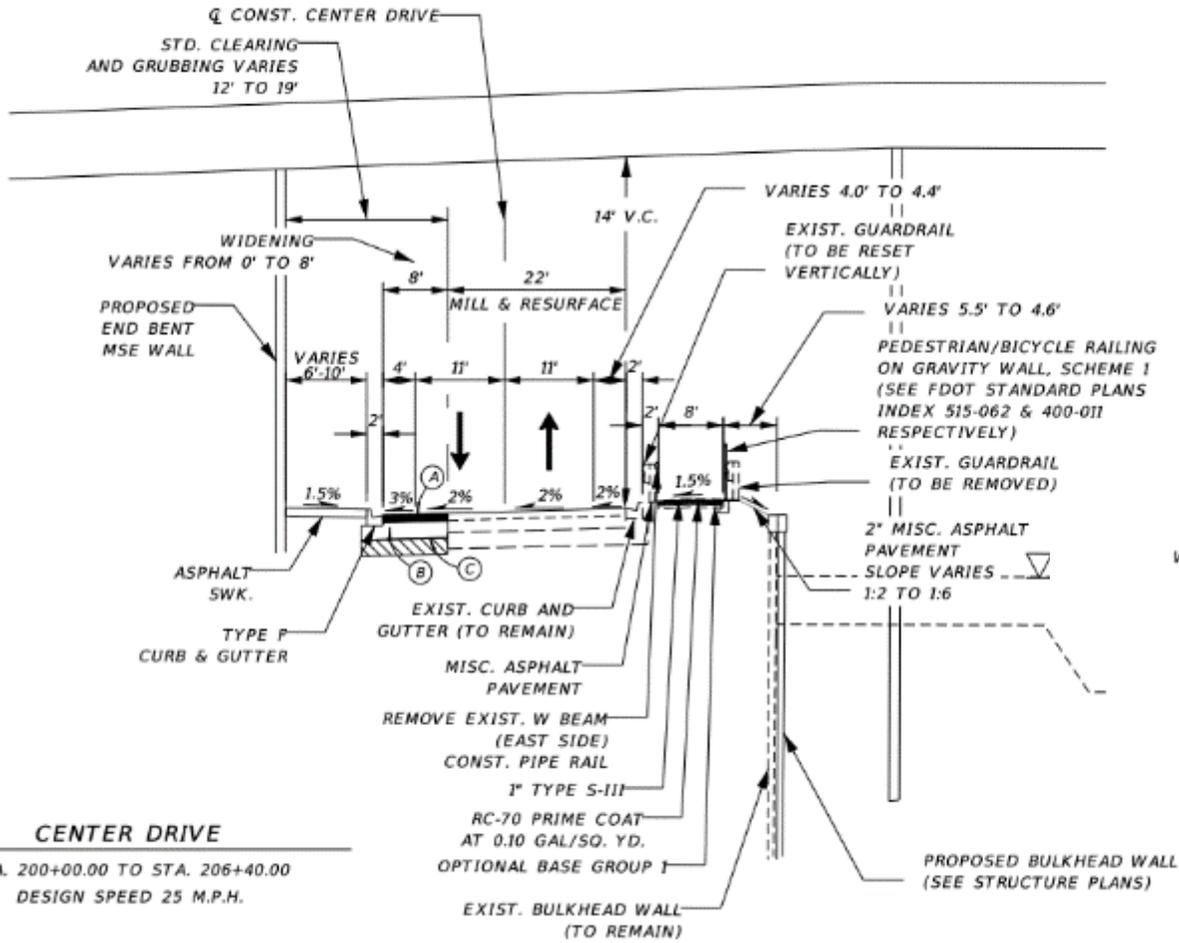
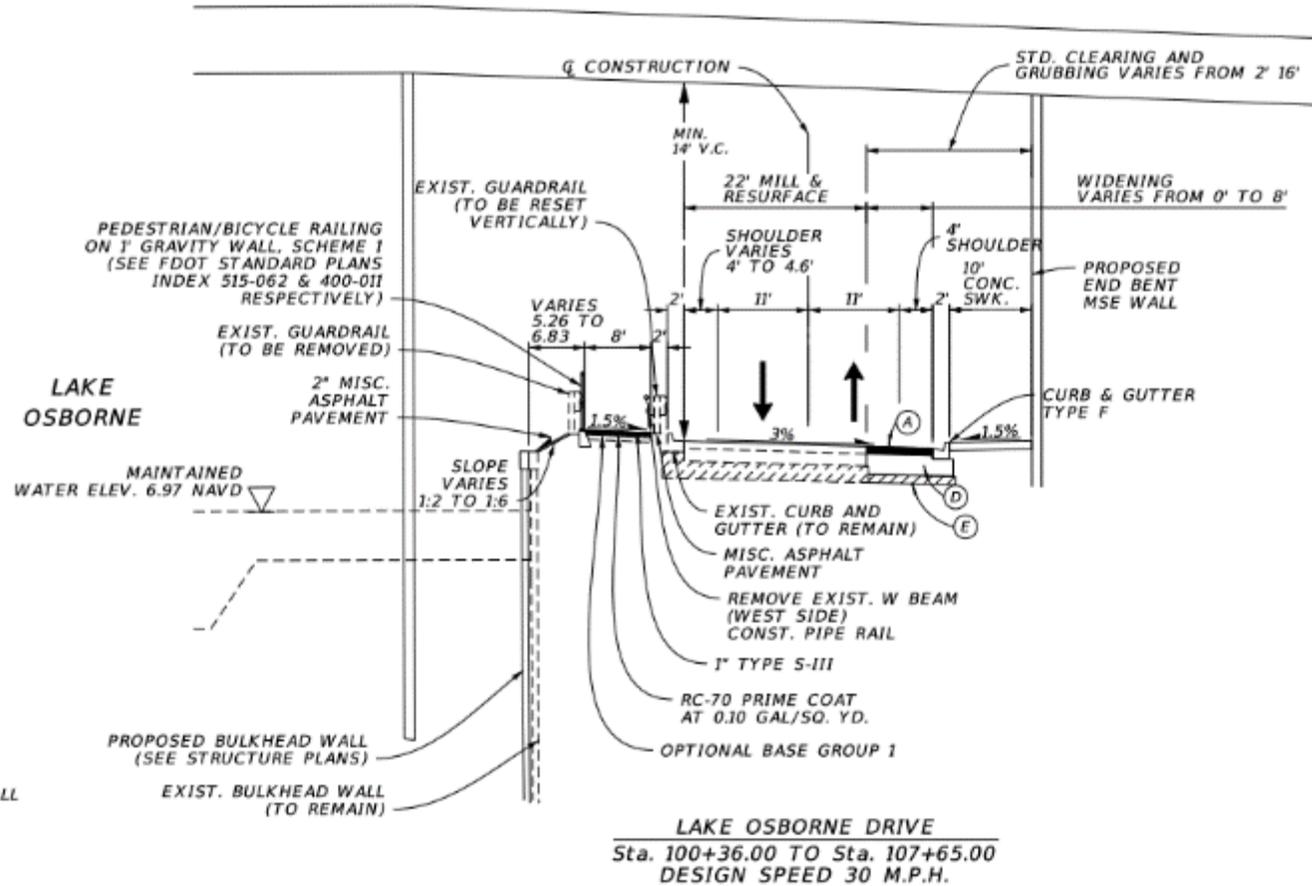
Proposed Typical Sections Center Dr & Lake Osborne Dr

- 11' lanes
- 4' bike lanes
- 8' Pathway along water

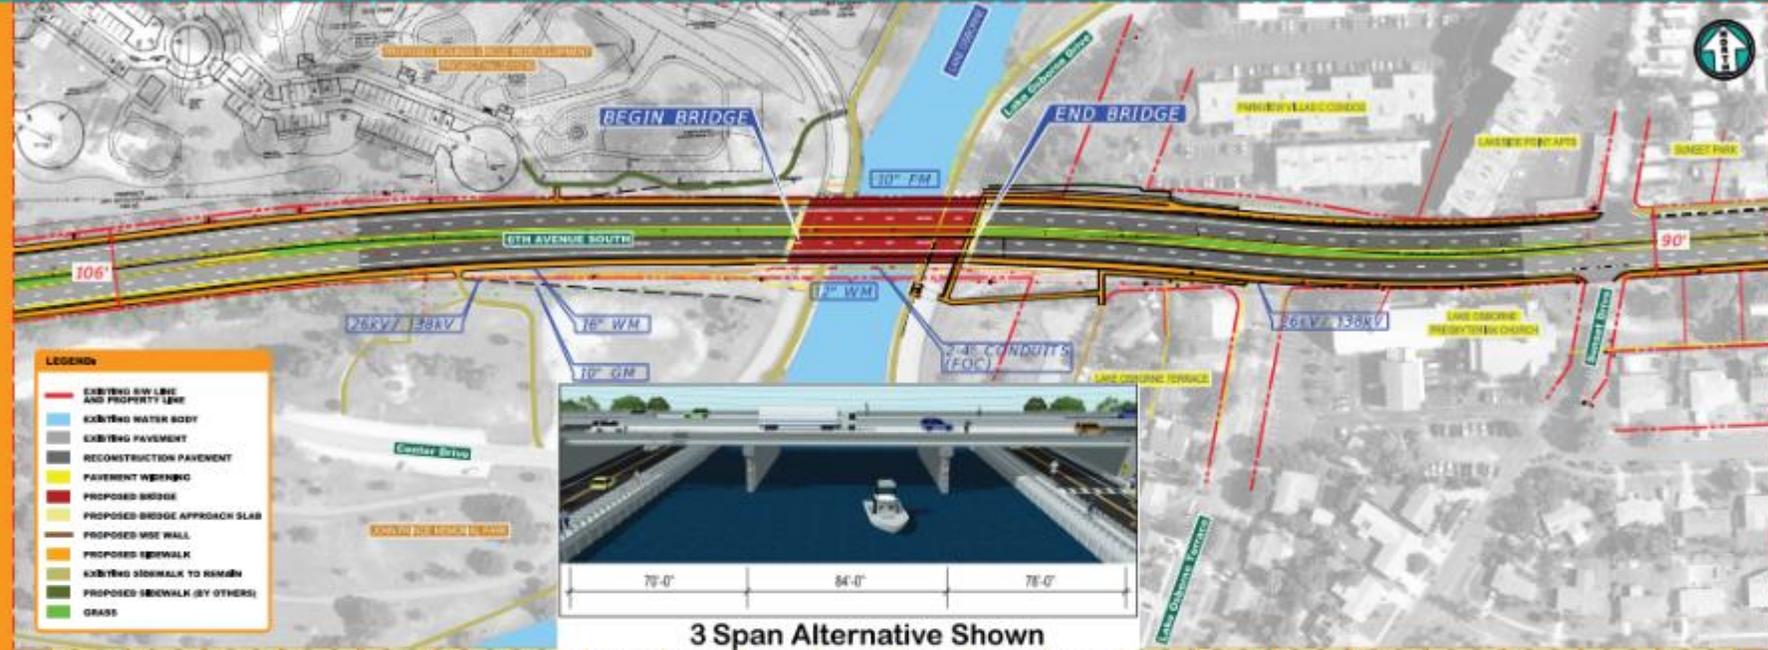
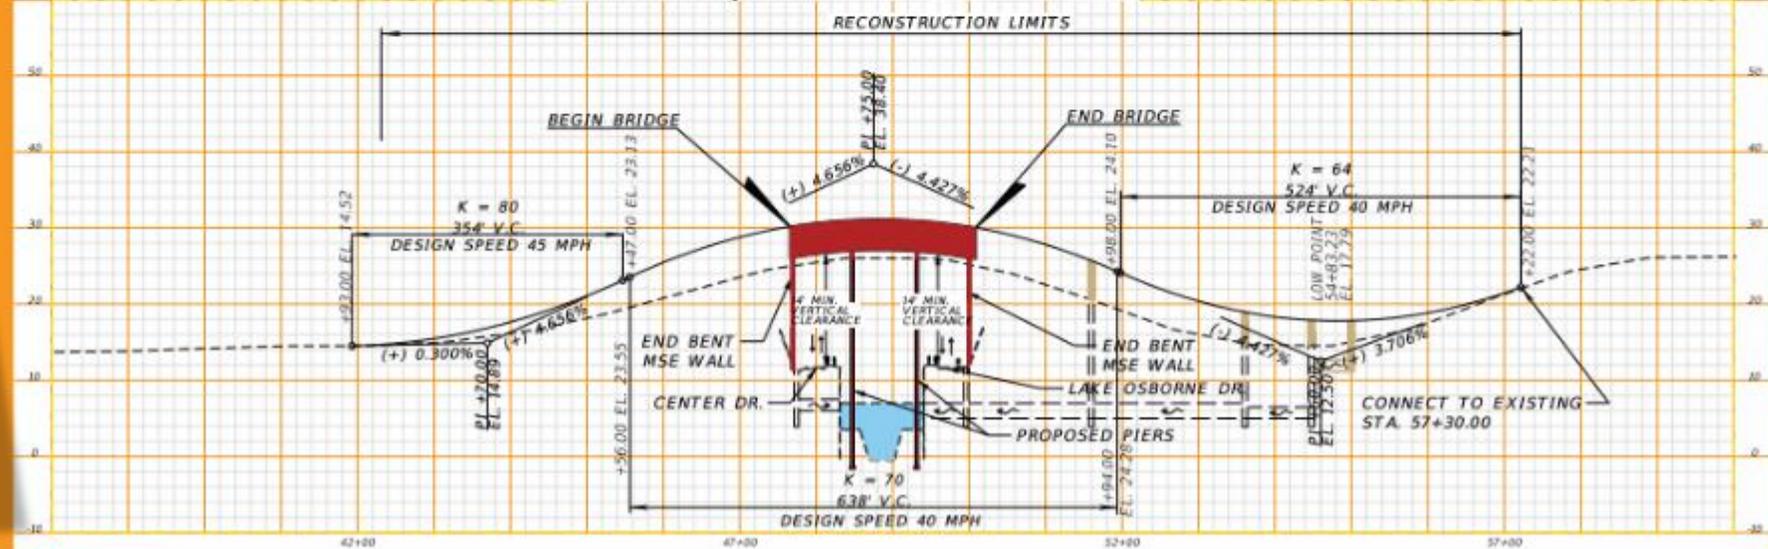
6th Avenue South Over Lake Osborne Drive - Bridge Replacement

14' Vertical Clearance

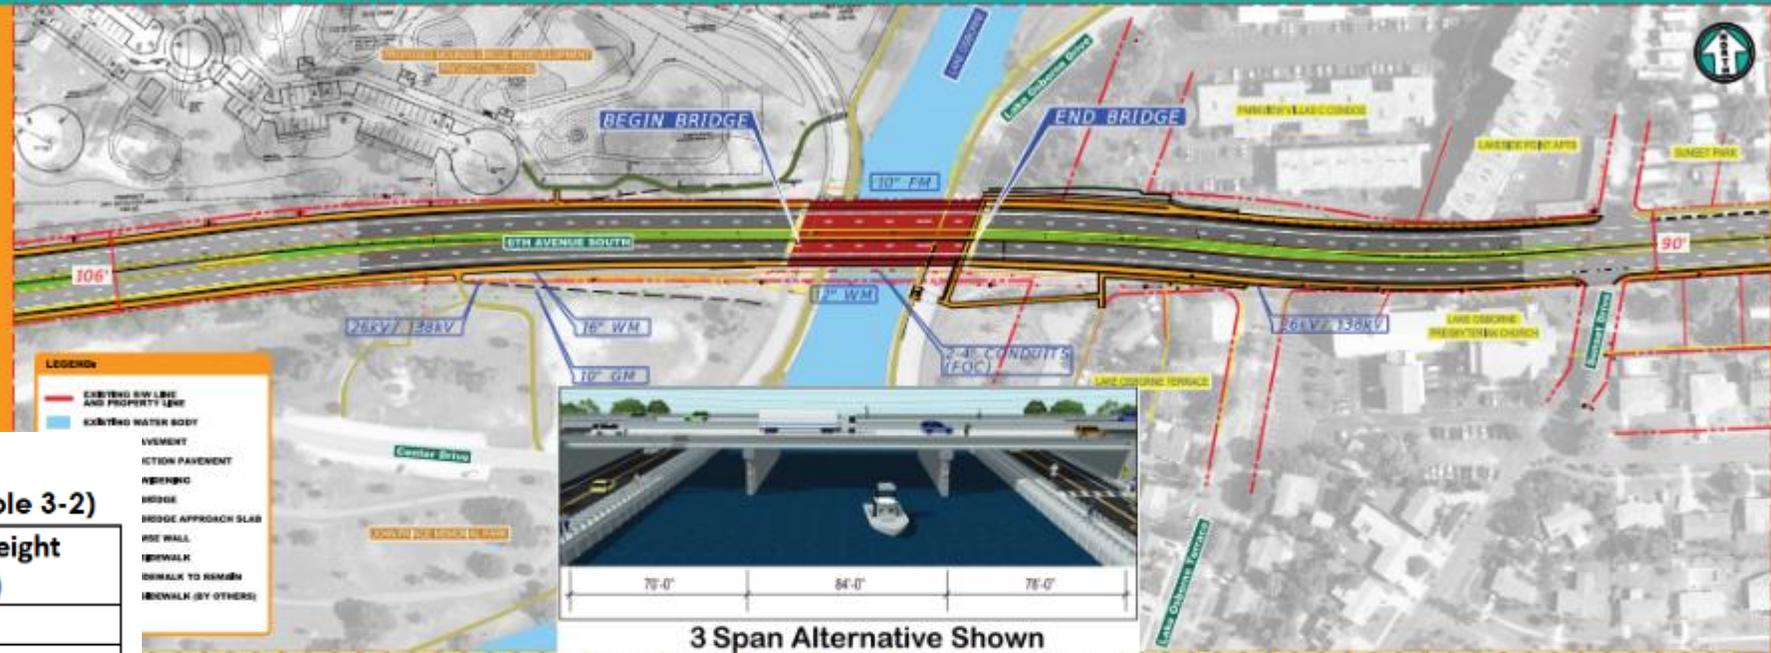
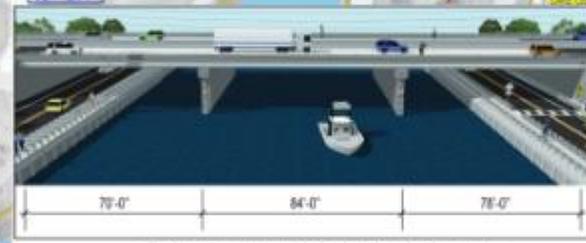
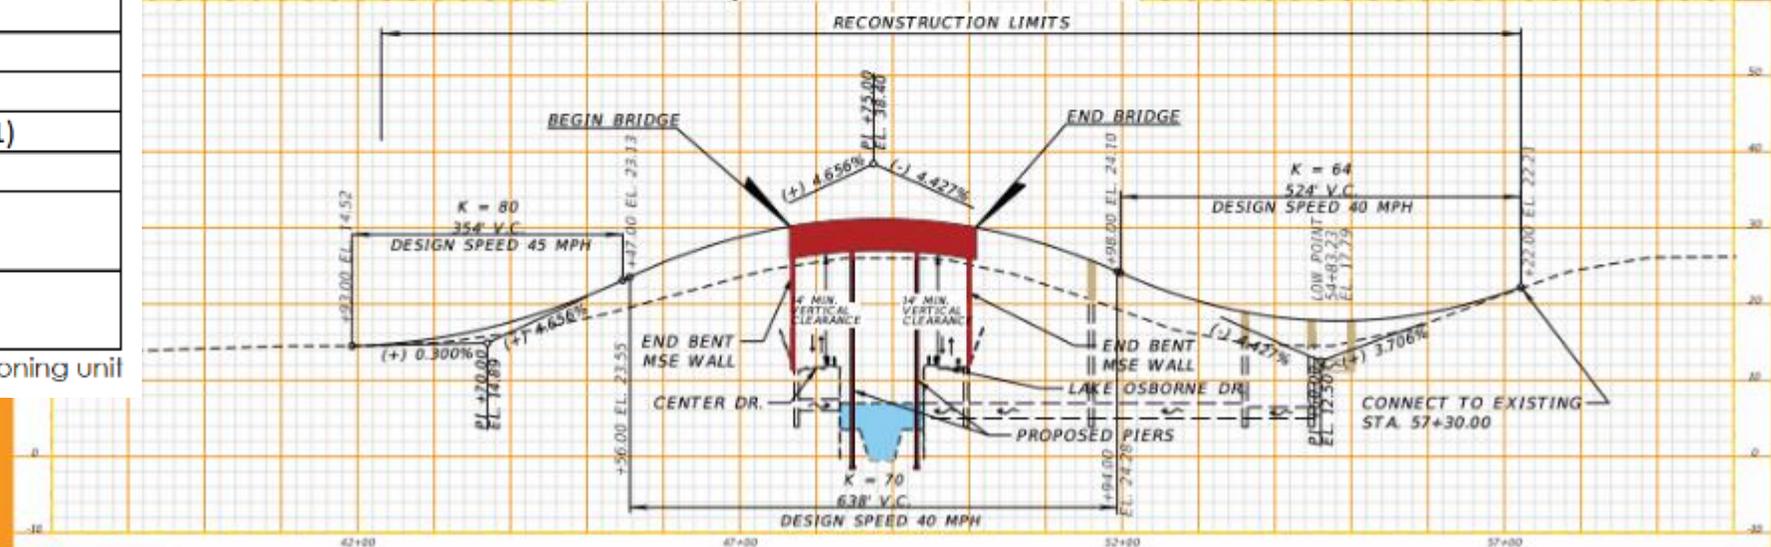
3 Span Alternative Shown

- Several alternative bridge designs were evaluated

14' Vertical Clearance
