6TH AVE SOUTH OVER LAKE OSBORNE DR

Infrastructure Sales Tax Oversight Committee

Feb 17, 2022

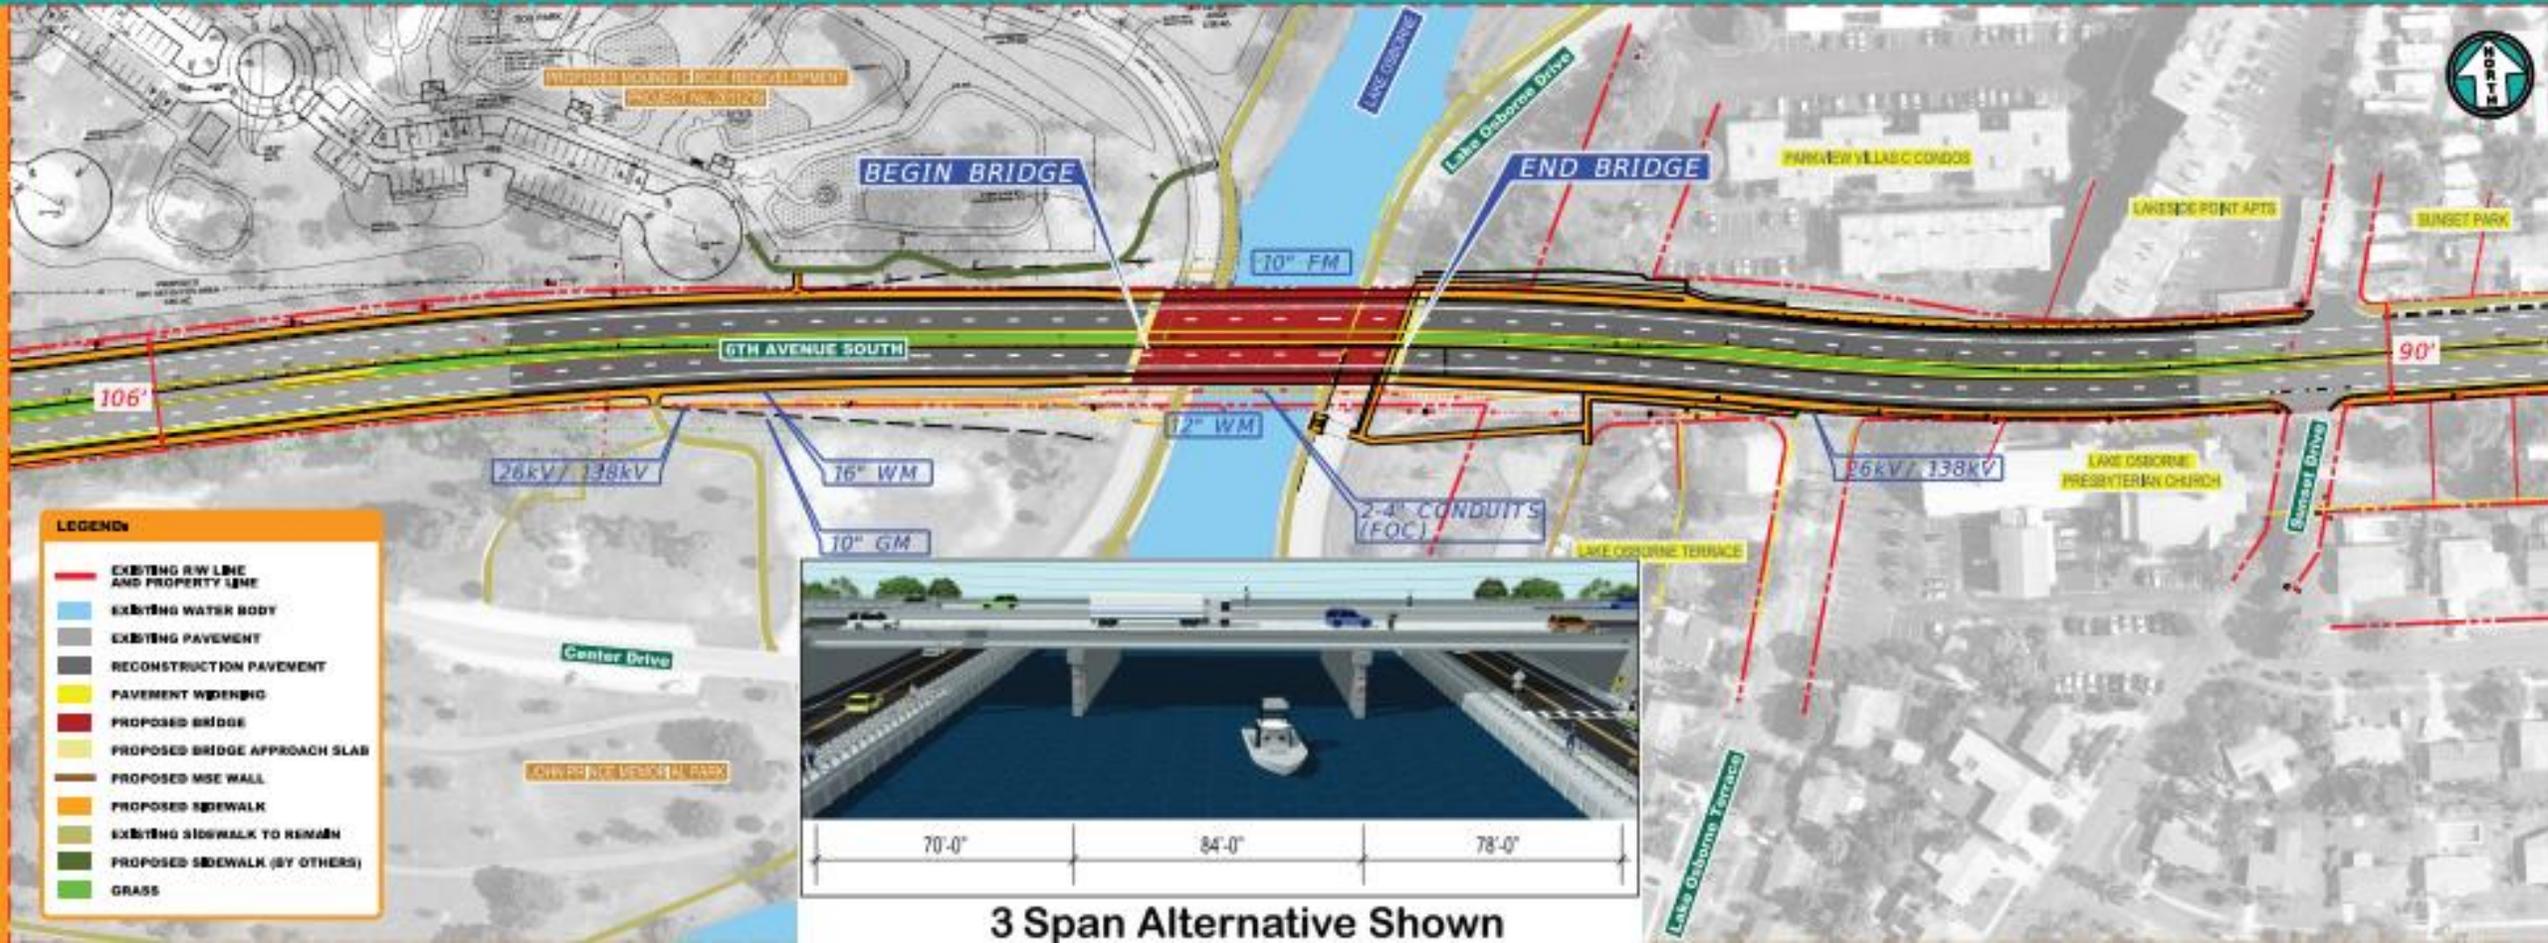
Proposed Bridge Alignment

- Bridge alignment shifted slightly north to avoid transmission lines along south side of 6th Ave.

14' Vertical Clearance

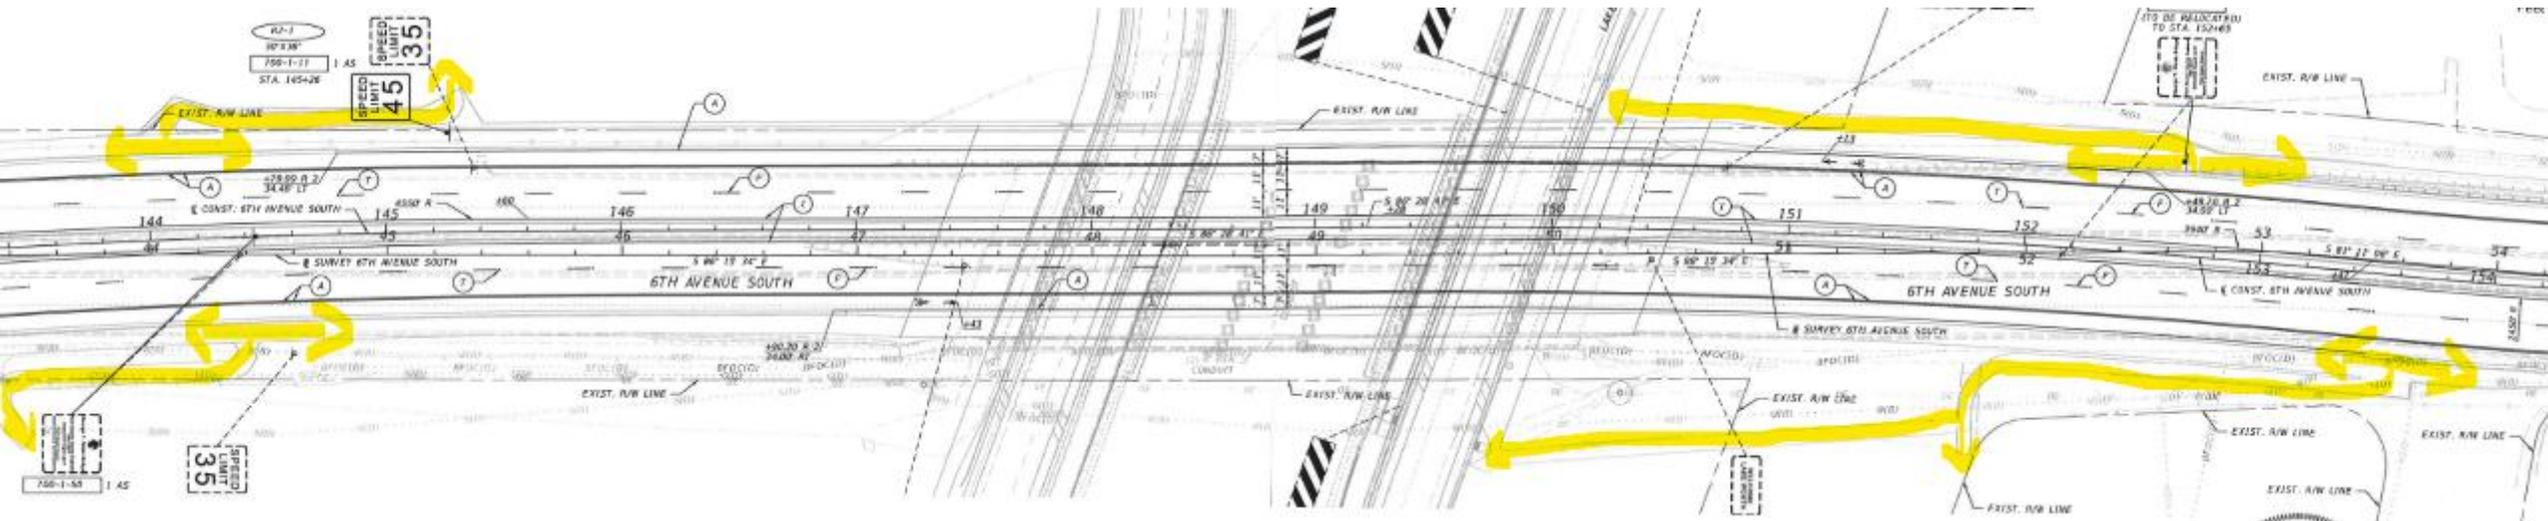
Pedestrian Accessibility

- Proposed pedestrian access in all 4 quadrants of bridge.
- Extend sidewalk on north side to Congress Ave
- Mid Block Crossings on Center Dr and Lake Osborne Dr.

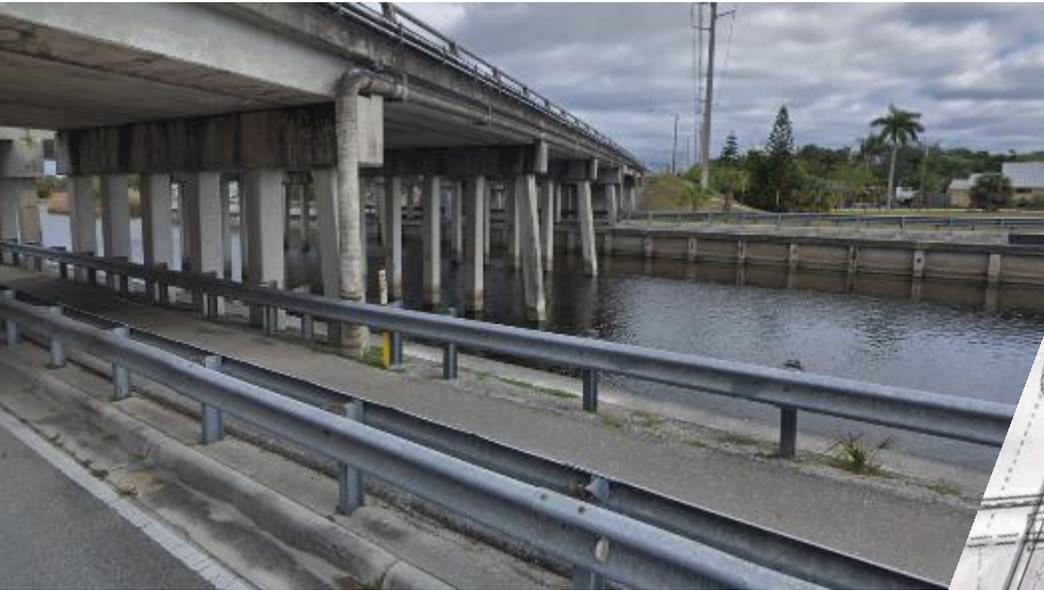
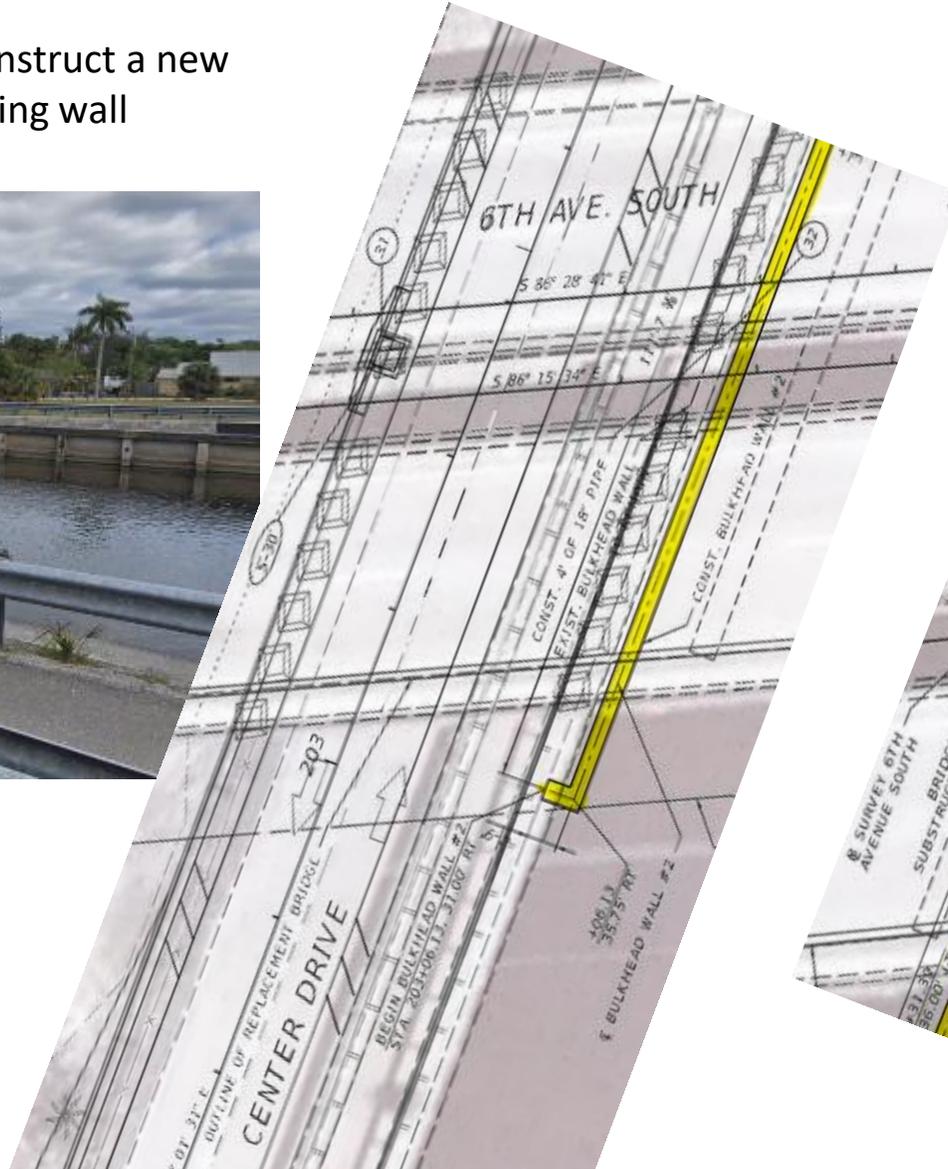
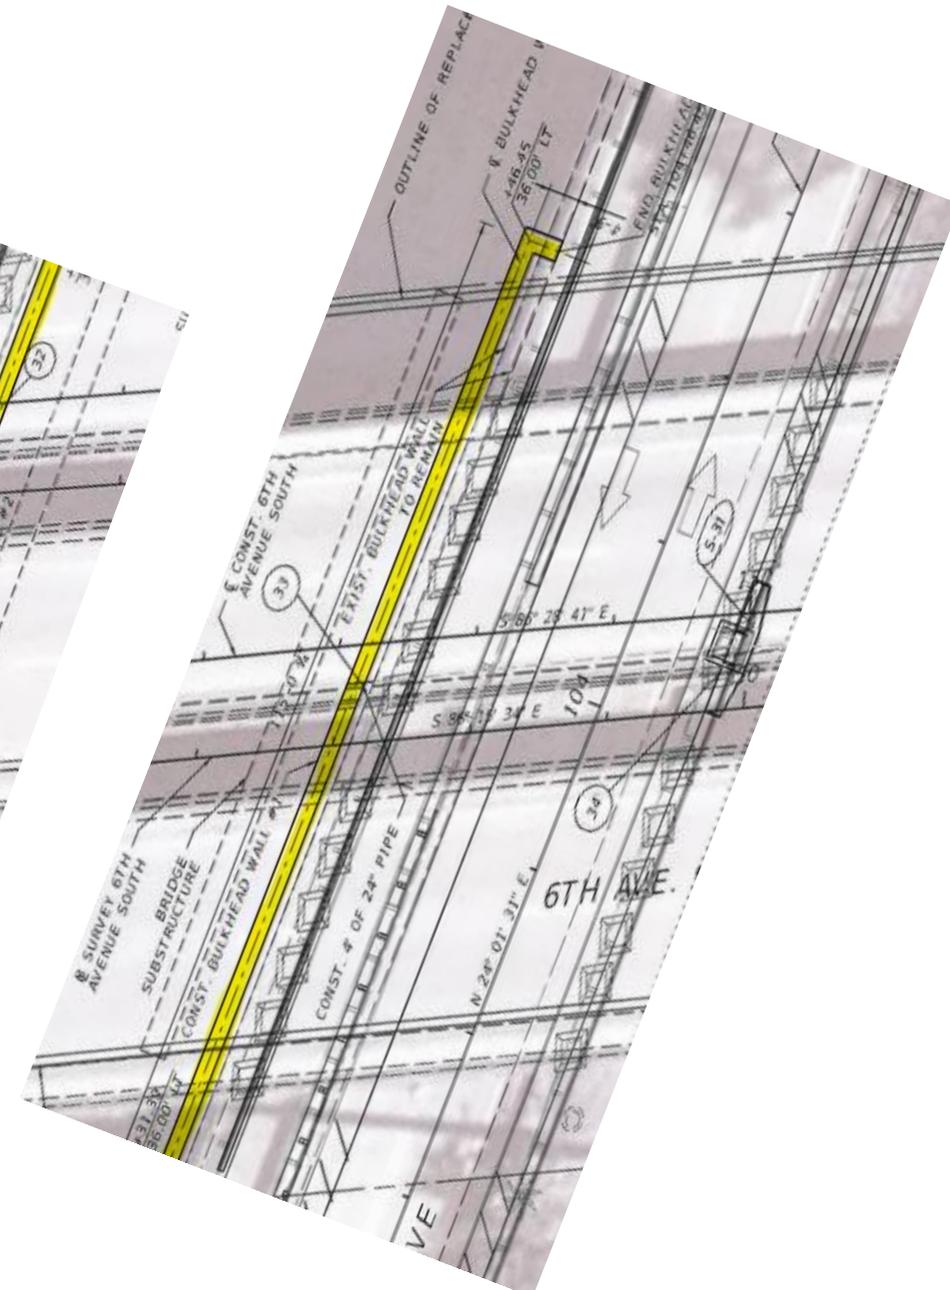
Bulkhead Wall Replacement

- While bridge is removed, we will construct a new bulkhead wall to sure up aging existing wall

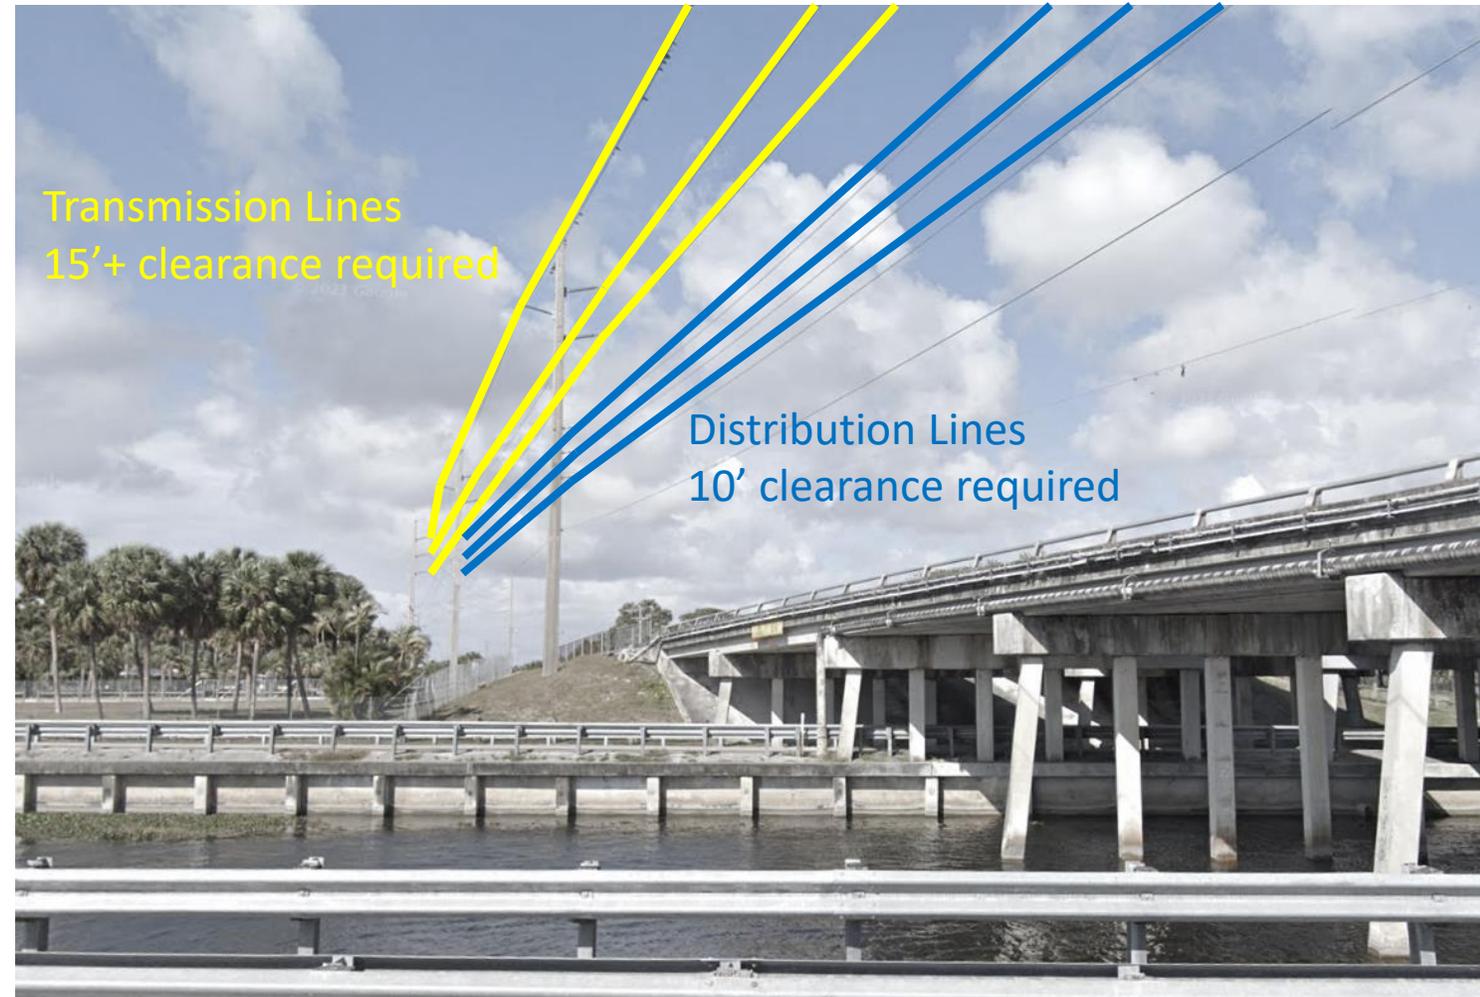
Lake Worth Electric Coordination

- Lake Worth Electric Transmission & Distribution
- Need adequate separation for crane staging
- Currently working with contractor for required separation
