Palm Beach County

RENEWAL/REPLACEMENT PROGRAM ASSESSMENT STUDY STRUCTURAL ELEMENTS

December, 2015

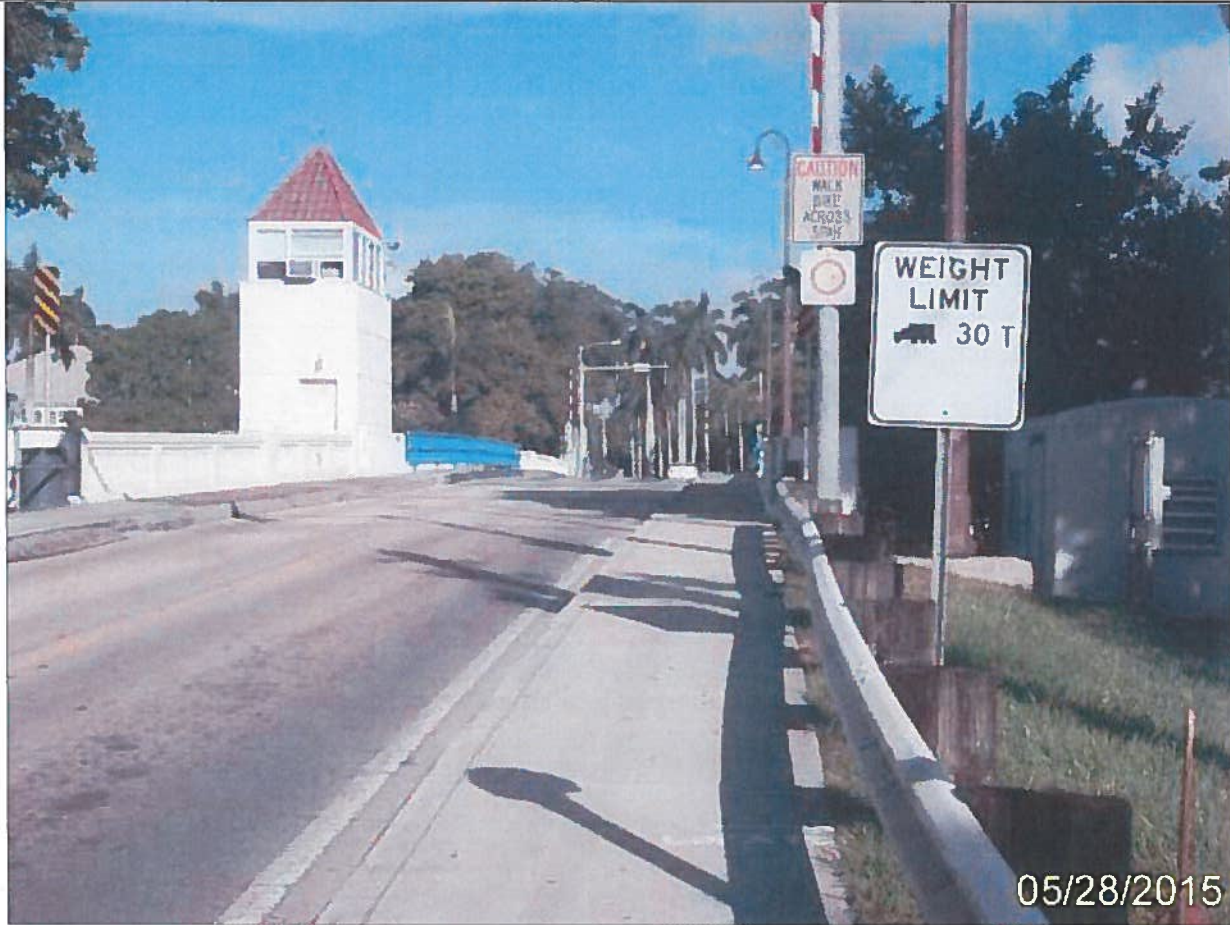
EAST WEIGHT LIMIT SIGN

The east weight limit sign is set too low - NO CHANGE. Refer to photo 59.

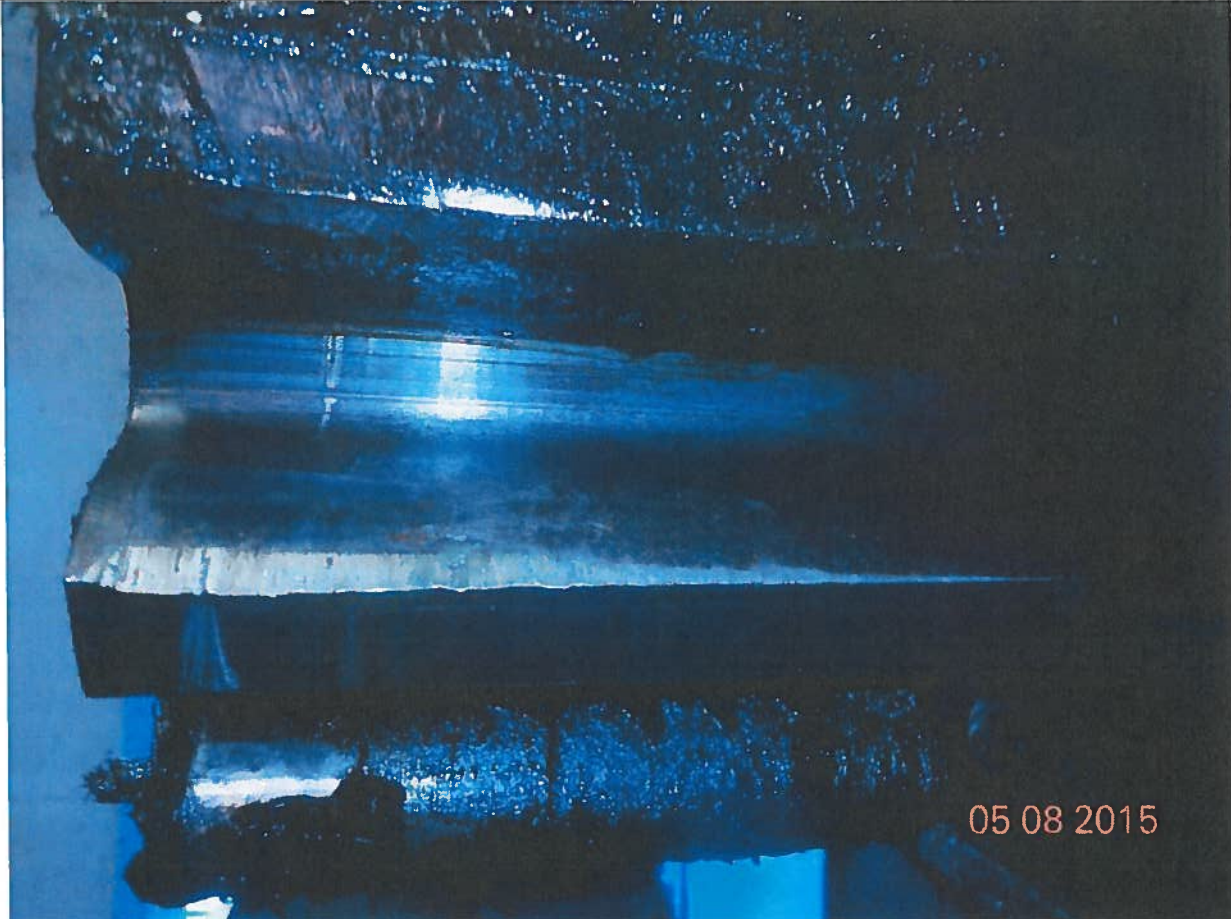
Photo 14 – Unit 0 Element 540 Open Gearing

All pinion teeth exhibit minor scoring and slight flanging on the top lands near the ends of the teeth - NEW. Refer to photo 14

All pinion teeth exhibit minor scoring and slight flanging on the top lands near the ends of the teeth. Near leaf adjacent side shown, others similar

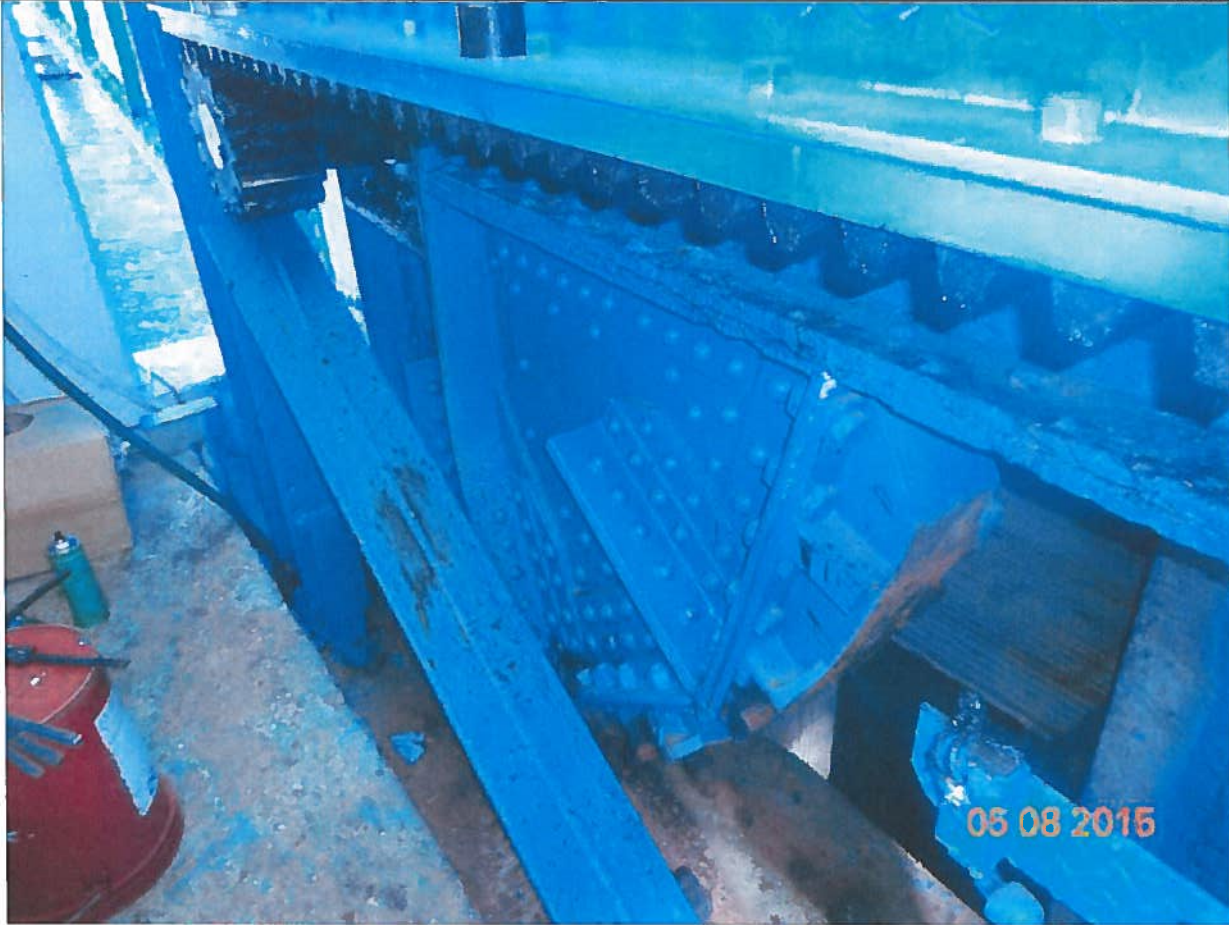
Photo 17 – Unit 0 Element 540 Open Gearing

No drip pan is present underneath the rack and grease is dripping onto the rack frame and concrete floor - NEW. Refer to photo 17.

No drip pan is present underneath the rack and grease is dripping onto the rack frame and concrete floor. Near leaf adjacent side shown, others similar

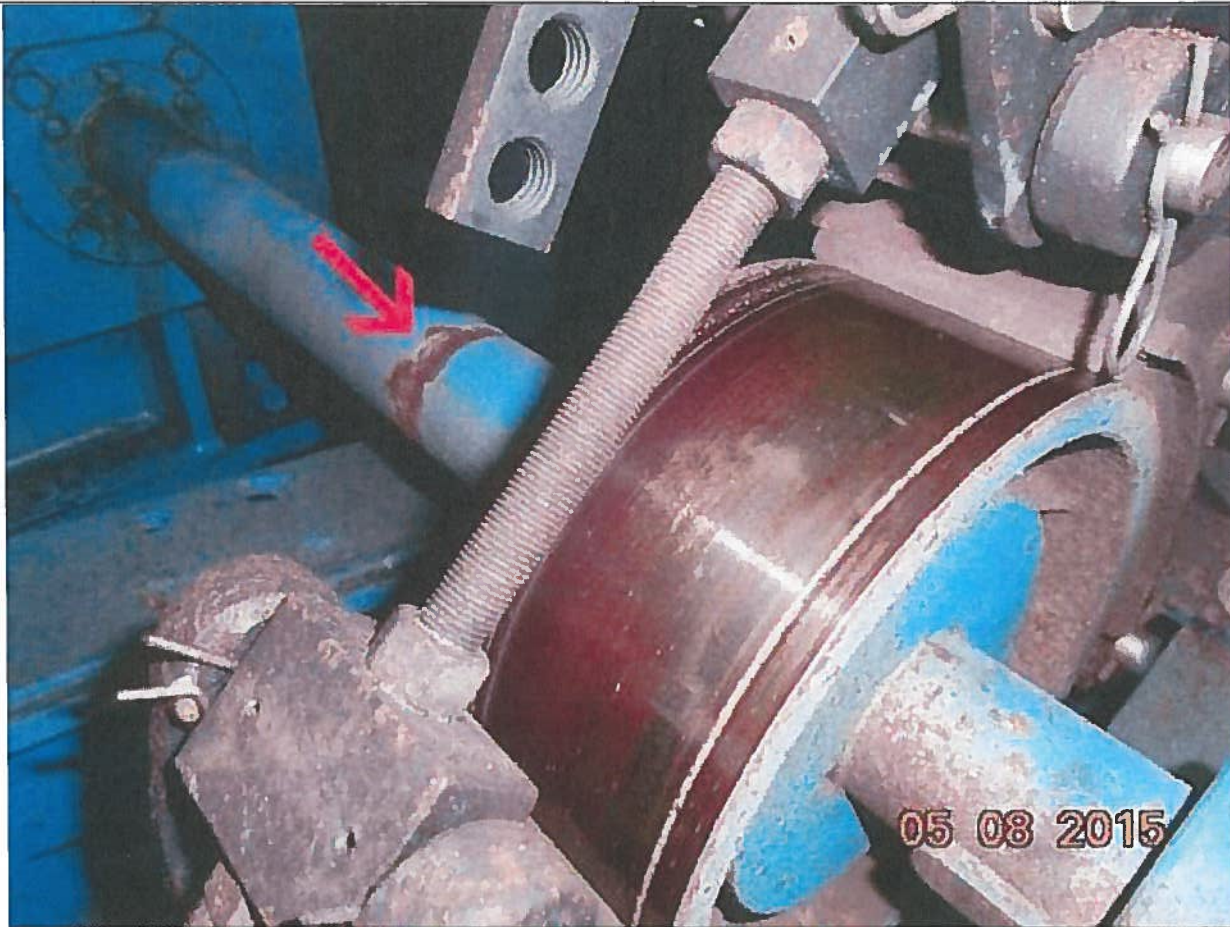
Photo 23 - Unit 0 Element 542 Shafts

The Far leaf reducer input shafts are marked by brake enclosures and corrosion is present on exposed steel. - NEW. Refer to photo 23

Far leaf reducer input shafts are marked by brake enclosures

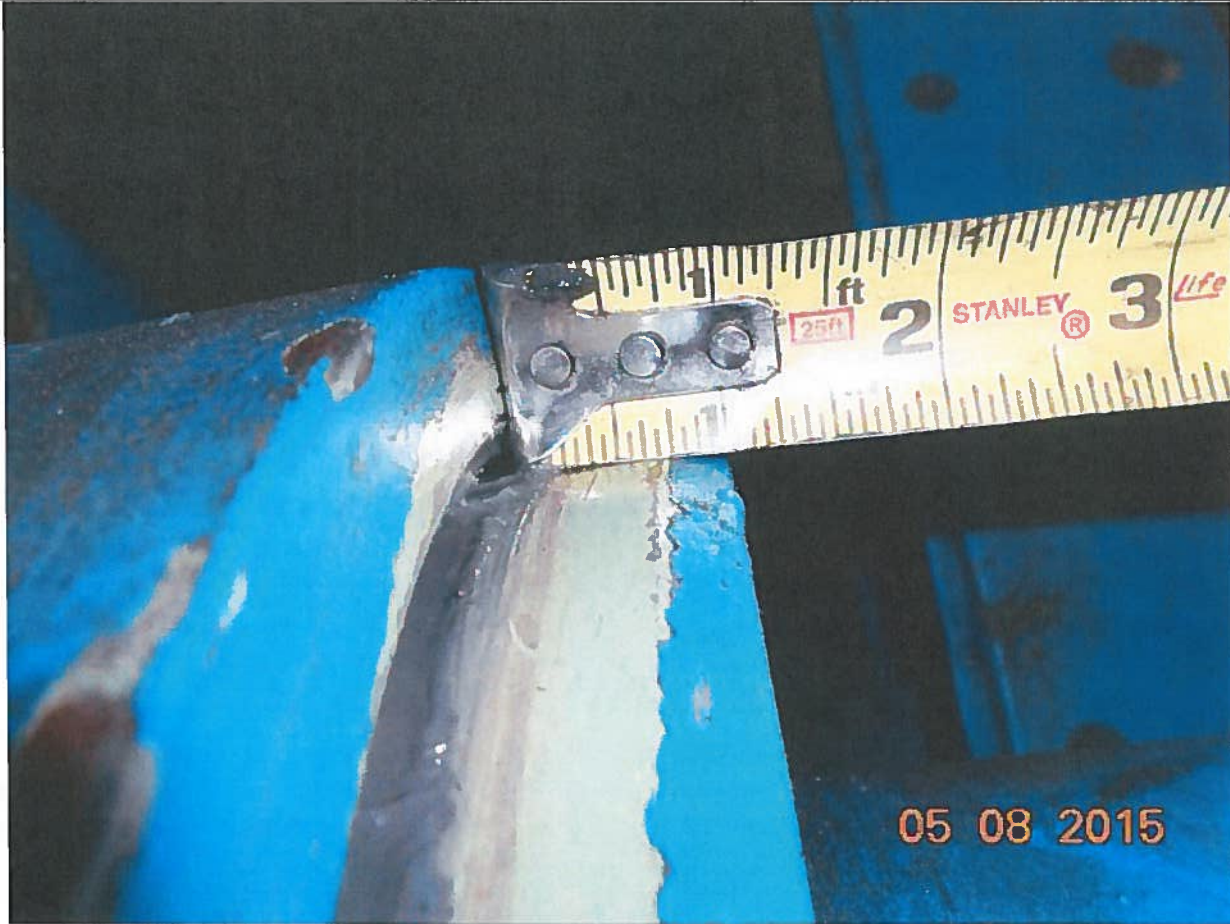
Photo 24 – Unit 0 Element 543 Shafts Brgs and Coupl

Couplings C2 and C4 on both leaves are misaligned. Near leaf coupling C2 shown, others similar

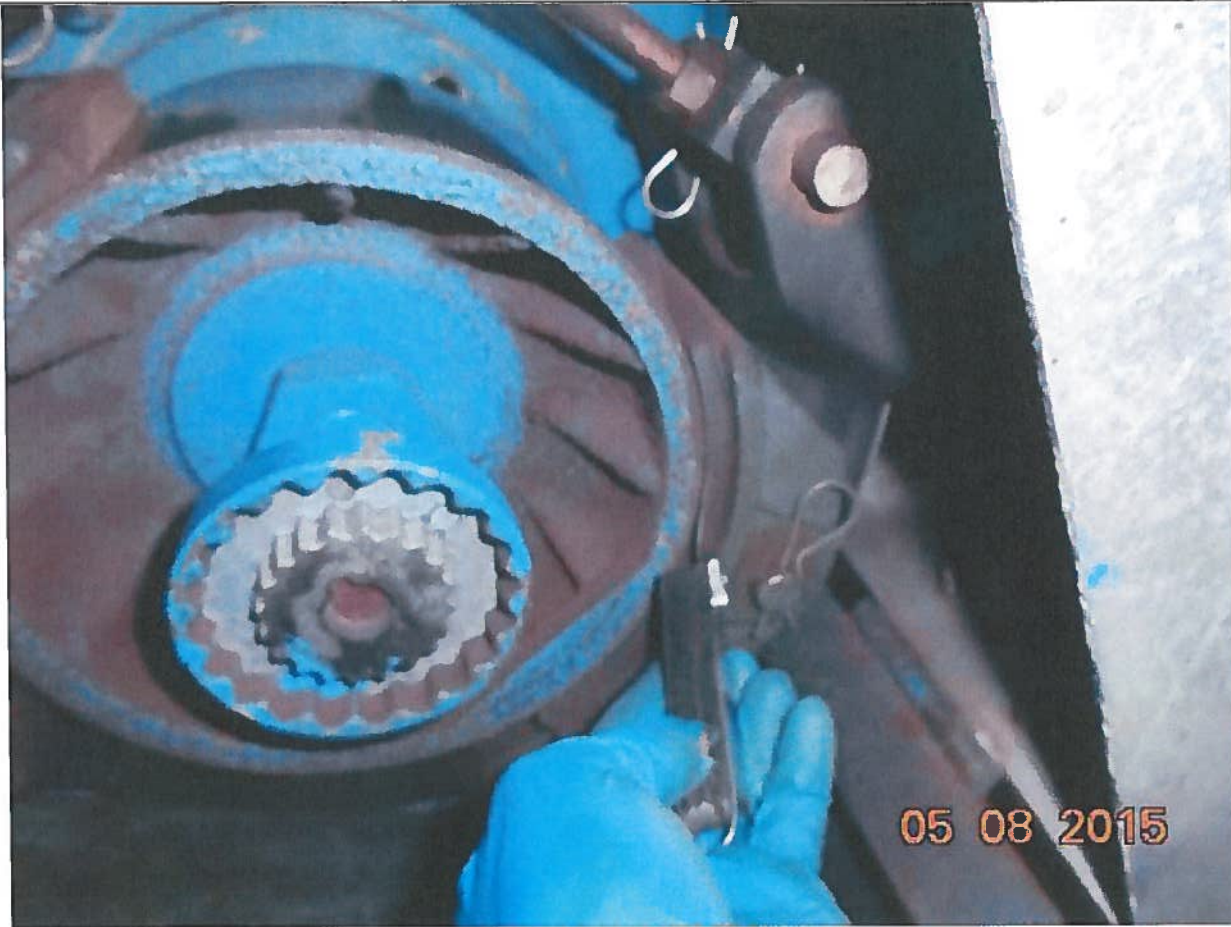
Photo 28 – Unit 0 Element 544 Brakes

Both far leaf brake shoes do not fully engage the drum when set - NEW. Refer to photo 28.

Both far leaf brake shoes do not fully engage the drum when set. Motor brake shown

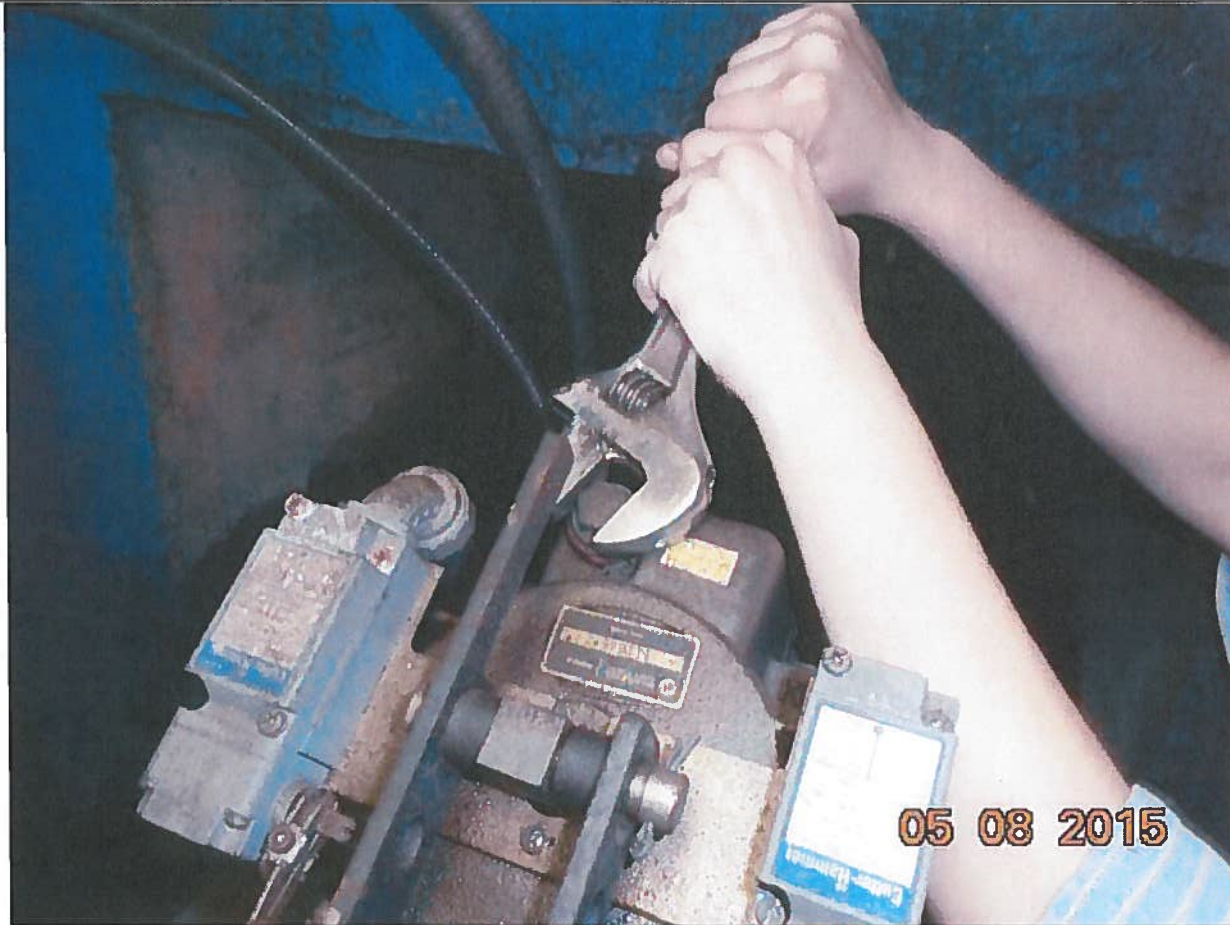
Photo 29 – Unit 0 Element 544 Brakes

The fluid plug for near leaf motor and machinery brakes and far leaf motor brakes could not be removed. Far leaf machinery brake shown

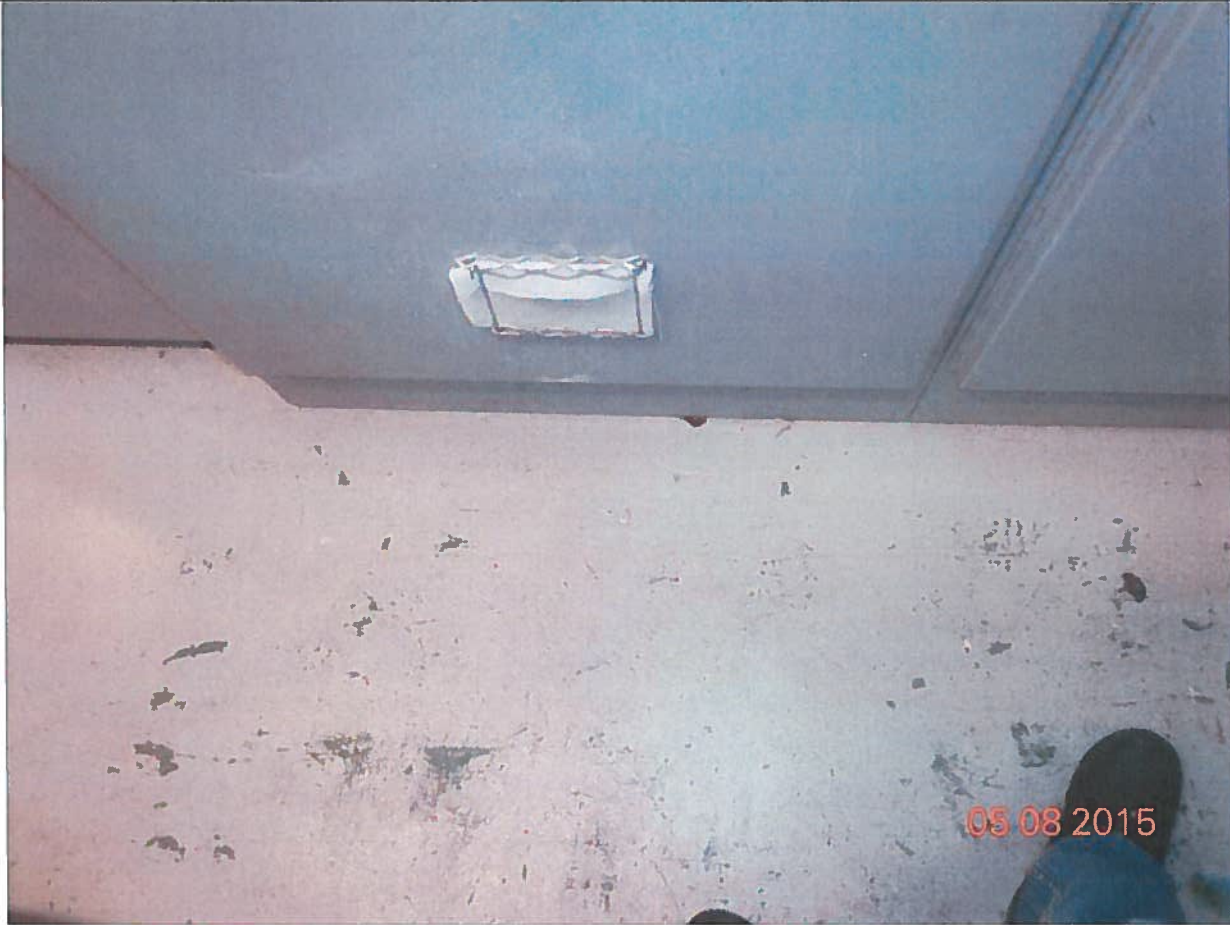
Photo 40 – Unit 0 Element 574 Control Console

Rubber mats have not been provided in front of the control console, motor control cabinet (MCC), main distribution enclosure (MDE) or automatic transfer switch (ATS)

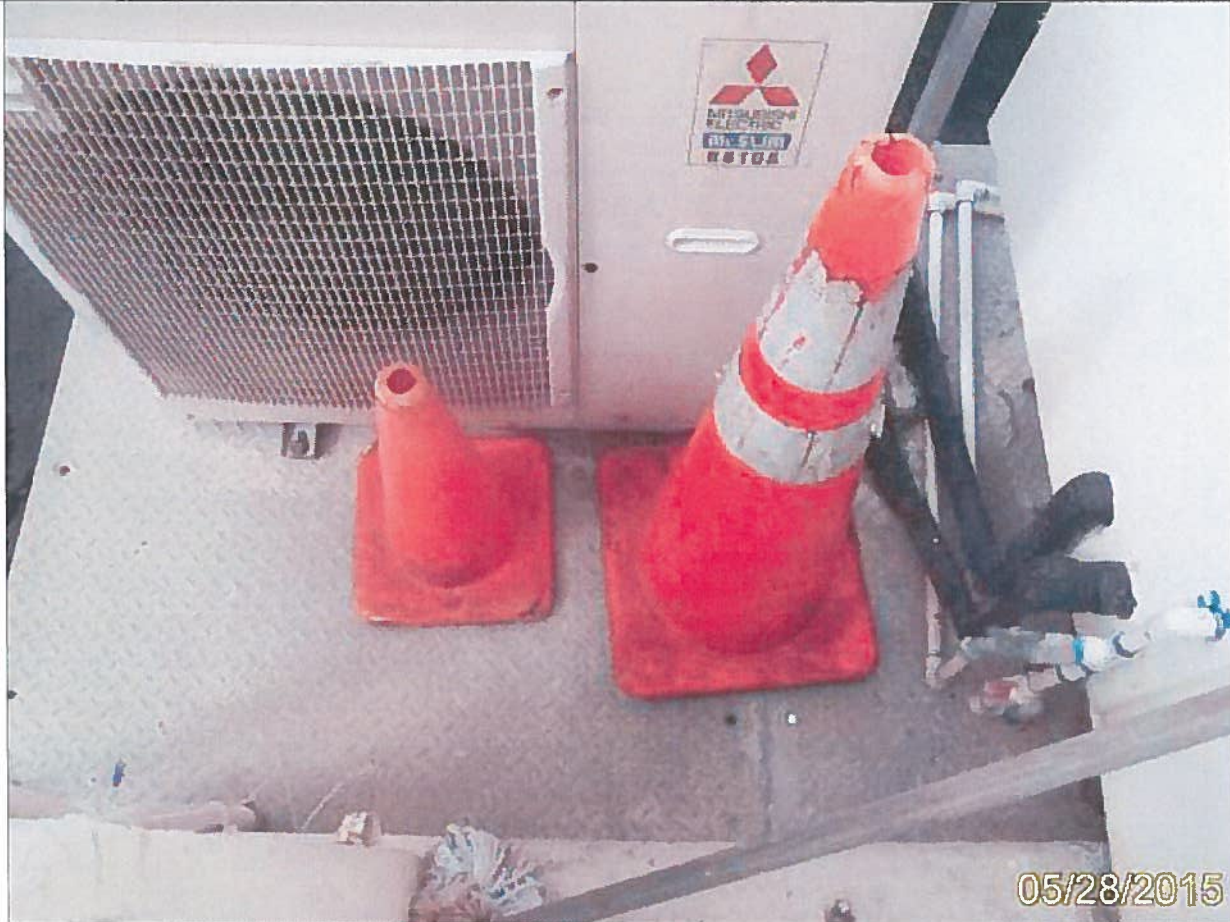
Photo 41 – Unit 0 Element 581 Operators Facilities

Only one standard size traffic cone provided

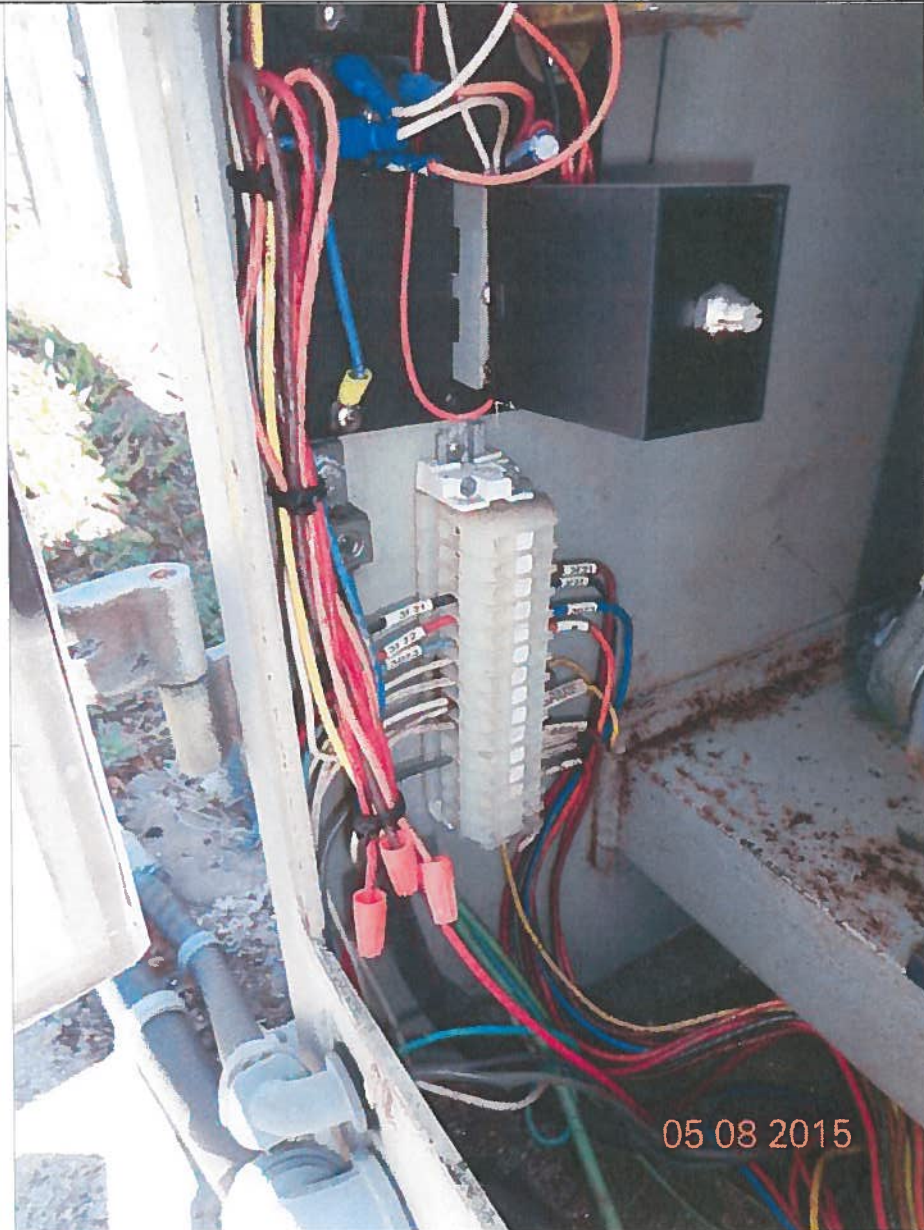
Photo 42 – Unit 0 Element 591 Warning Gates

The northwest (previously northeast) and southwest gates have unterminated wires within the housings (southwest shown in photo)

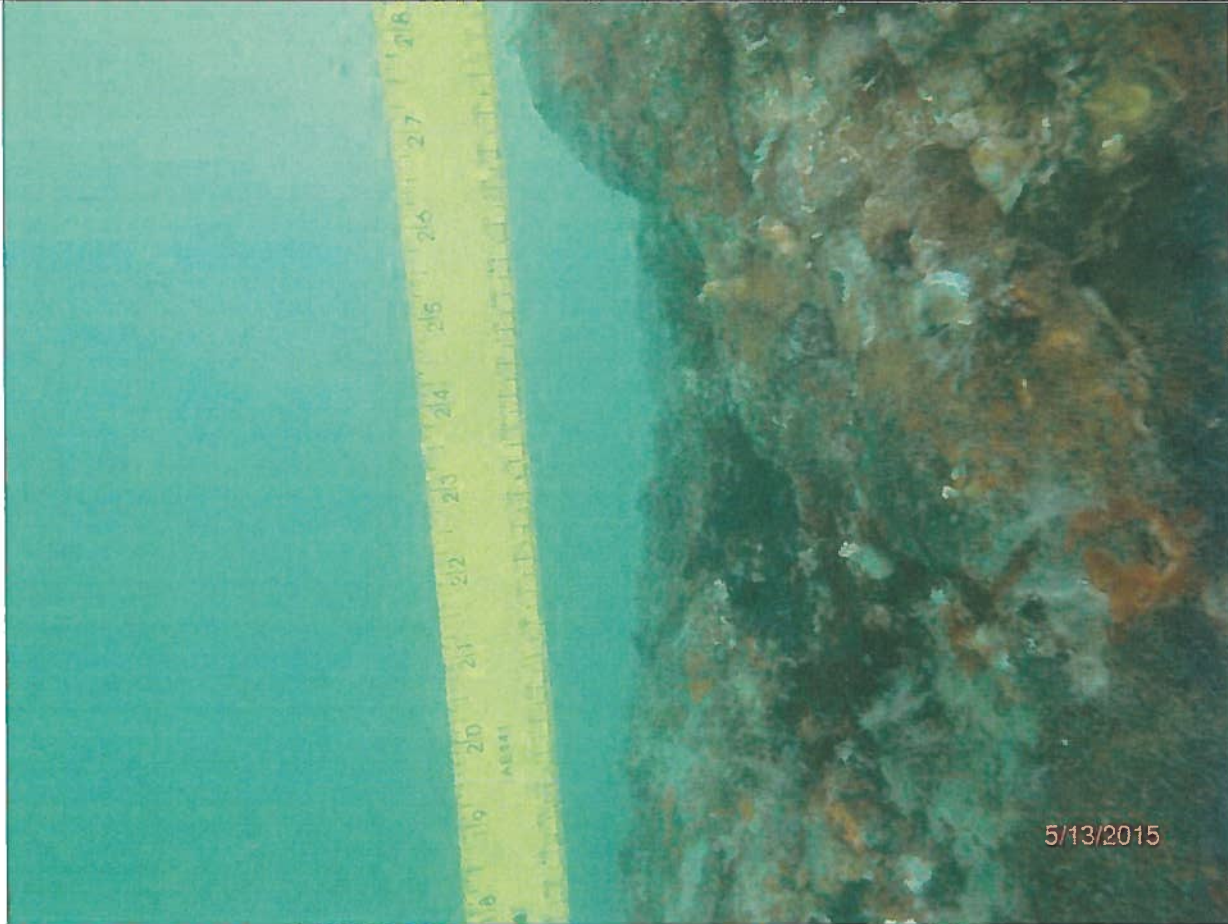
Photo 47 – Unit 0 Element 210 R/Conc Pier Wall

Spall/delamination with exposed steel in the west face of the east wall at Bascule Pier 4

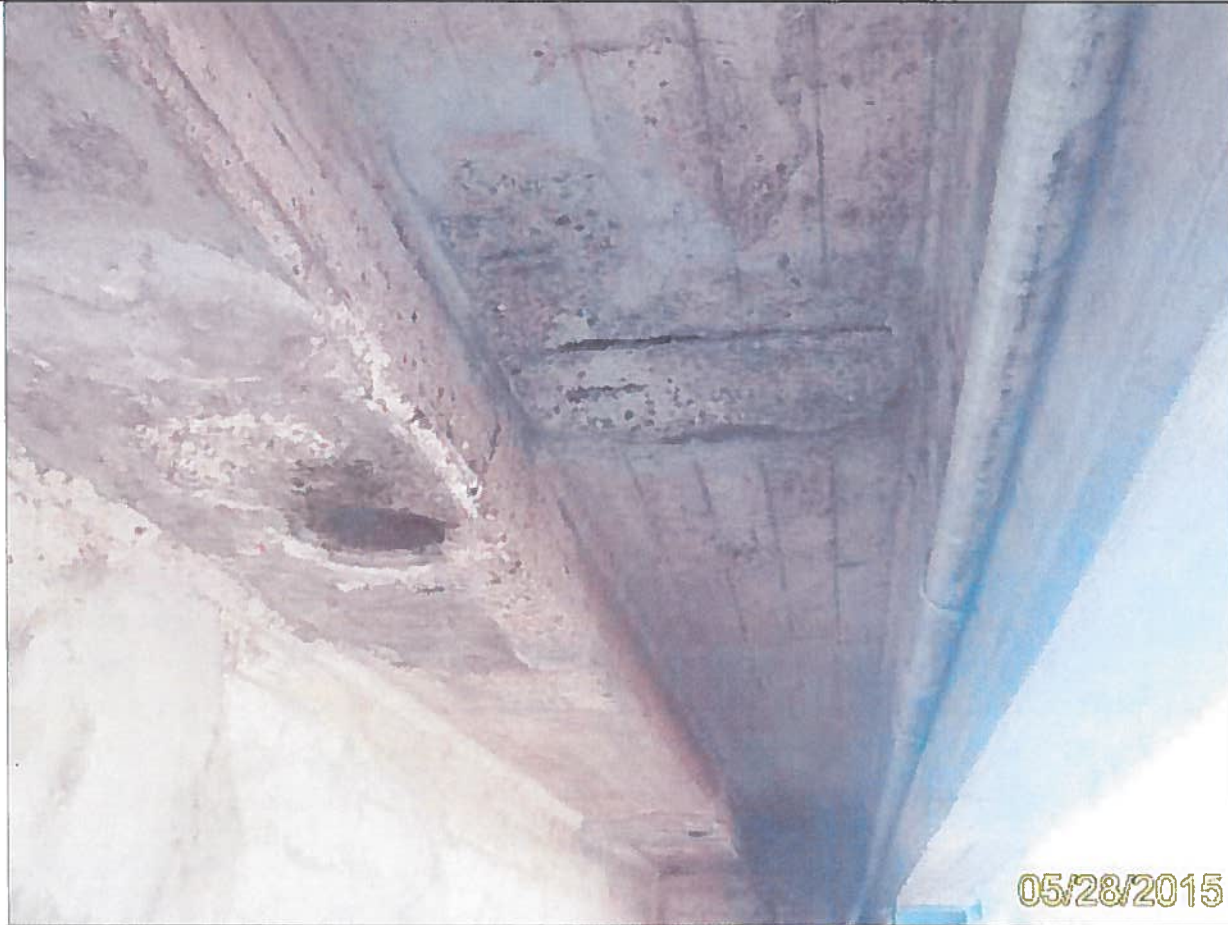
Photo 49 – Unit 1 Element 13 Unp Conc Deck/Asp Ovl

Bay 1-5 has a 2-1/2ft. x 3ft. x 1-1/2in. spalled/delaminated area with five exposed rebar with moderate surface corrosion near mid-span - NO CHANGE. Refer to photo 49.

Spall with exposed rebar in Bay 1-6

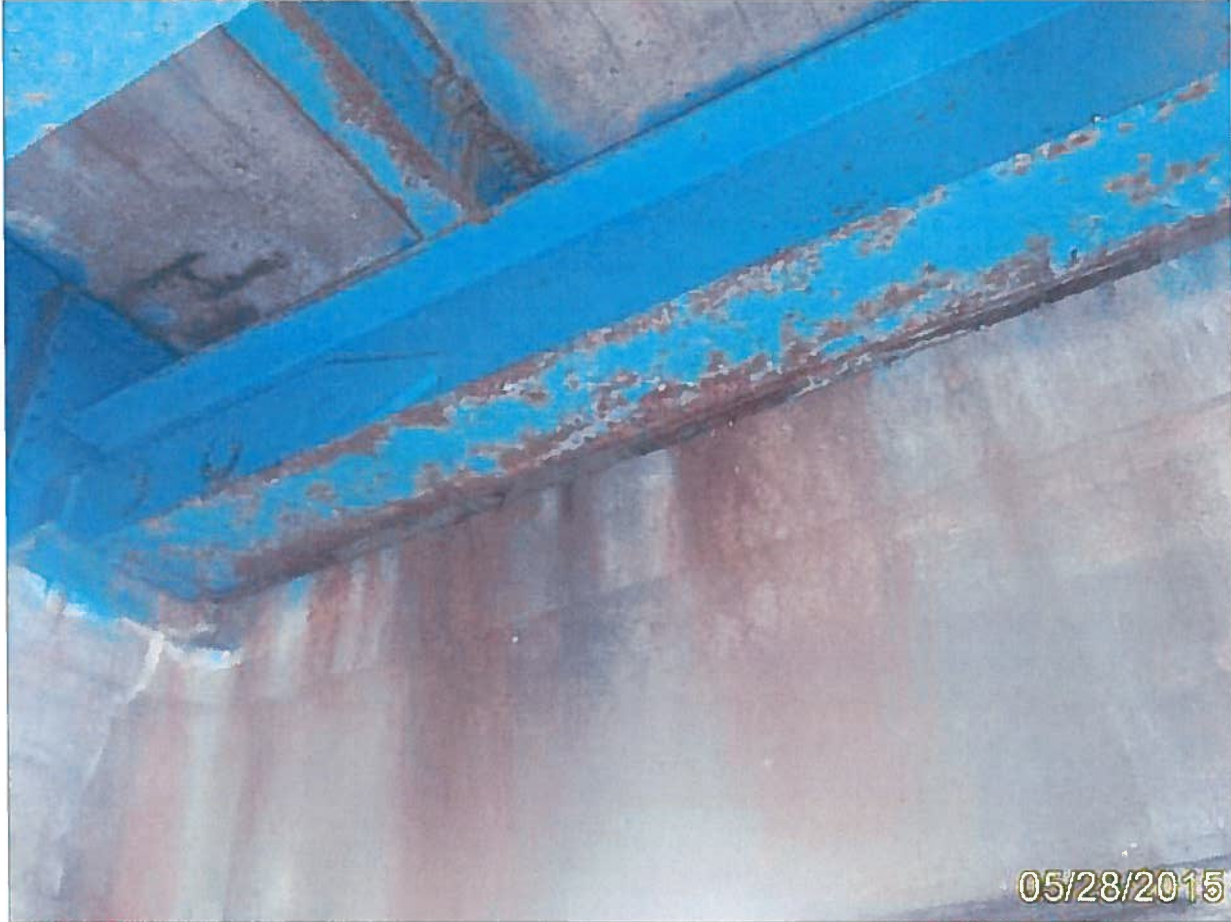
Photo 50 – Unit 1 Element 13 Unp Conc Deck/Asp Ovl

Bay 2-5 has a 3-1/2ft. x 2ft. x 2-1/2in. spall/delamination with exposed rebar having heavy surface corrosion at Pier 2 - NO CHANGE. Refer to photo 50.

Spall with exposed rebar in Bay 2-5

REPAIR RECOMMENDATION:
Refer to photo 49.

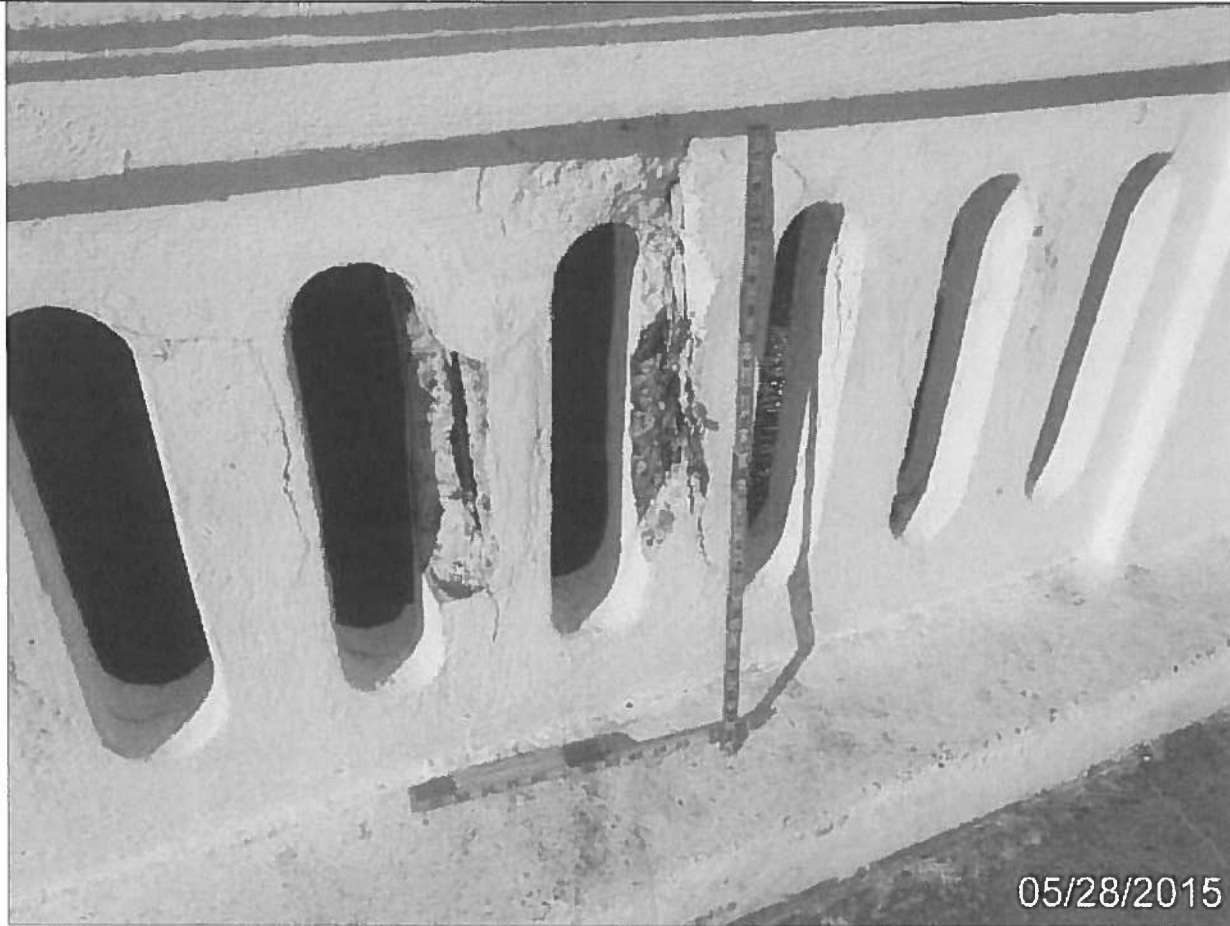
Photo 51 – Unit 1 Element 331 Conc Bridge Railing

The right (south) bridge rail has three spalls up to 1ft. x 6in. x 2in. and several cracks up to 1/32in. wide in the area between Posts 4-1 and 4 - INCREASE. Refer to photo 51.

Spalls between Posts 4-1 and 4-4 Right (south)

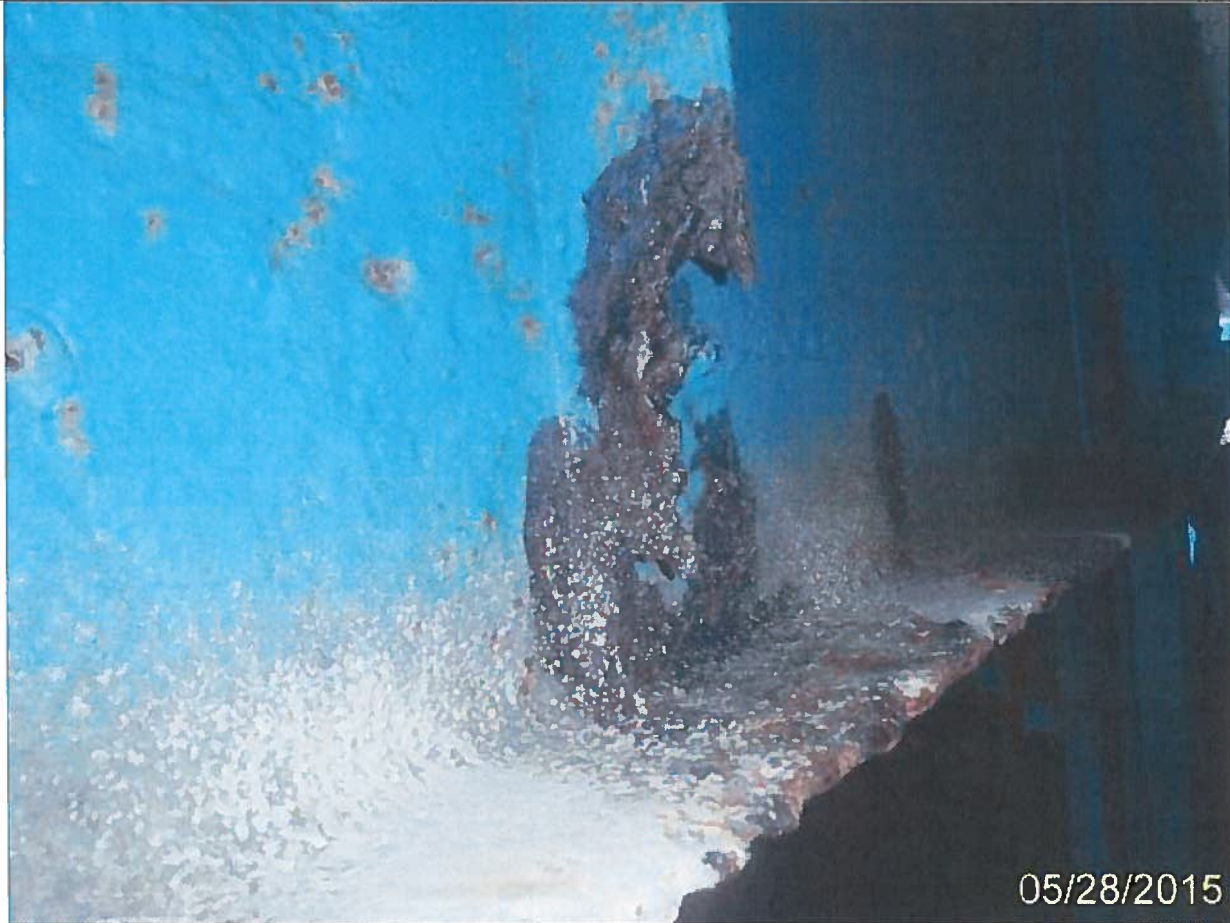
Photo 52 – Unit 1 Element 107 Paint Stl Opn Girder

Main Girders 2-1 and 2-2 have heavy painted-over pitting with 5/8in. remaining section on the bottom exterior flange with areas of moderate to heavy surface corrosion at and in the bascule piers - NO CHANGE. Refer to photo 52.

Corrosion and on MG 2-2 bottom south flange

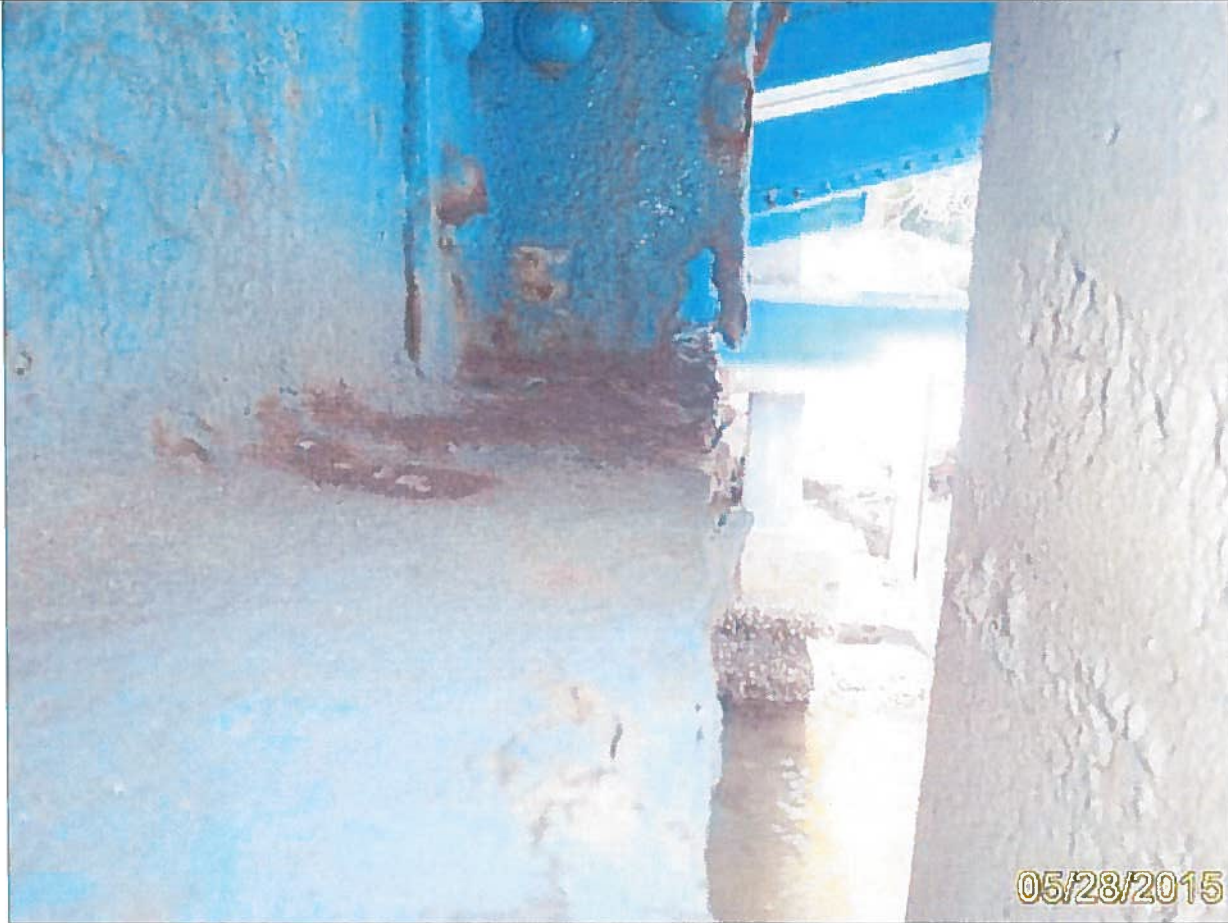
Photo 53 – Unit 1 Element 107 Paint Stl Opn Girder

Main Girder 2-2 has a 2ft. long area of moderate to heavy corrosion with knife-edging in the top and bottom south flanges, just outside the bascule pier - NO CHANGE. Refer to photo 53.

Corrosion and loss of section on MG 2-2 and its vertical stiffeners

REPAIR RECOMMENDATION:
Refer to photo 52.

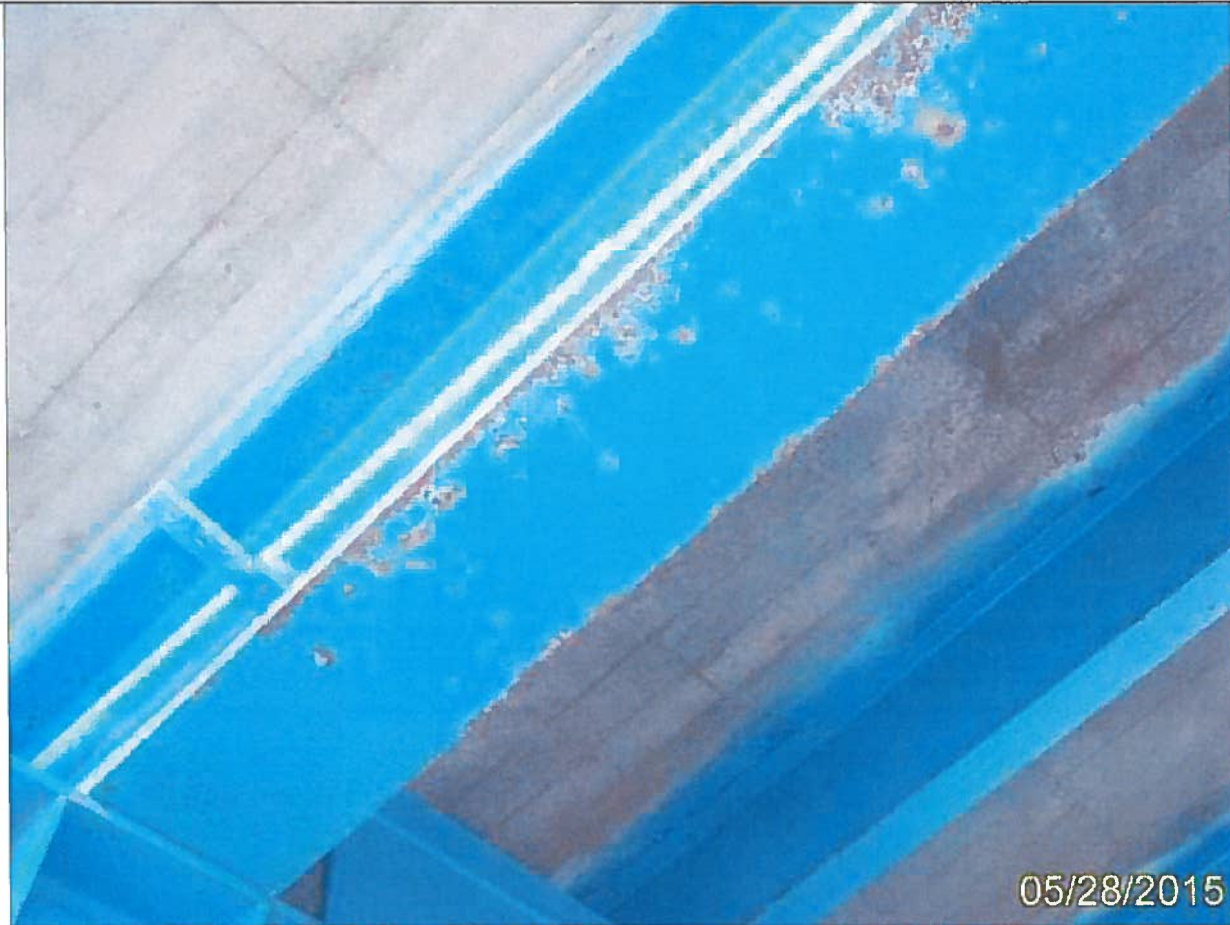
Photo 54 – Unit 1 Element 107 Paint Stl Opn Girder

Main Girders 2-1 and 2-2 have areas of light to moderate surface corrosion along the bottom edges of the bottom flanges - NO CHANGE. Refer to photo 54.

Typical corrosion on the approach span main girders

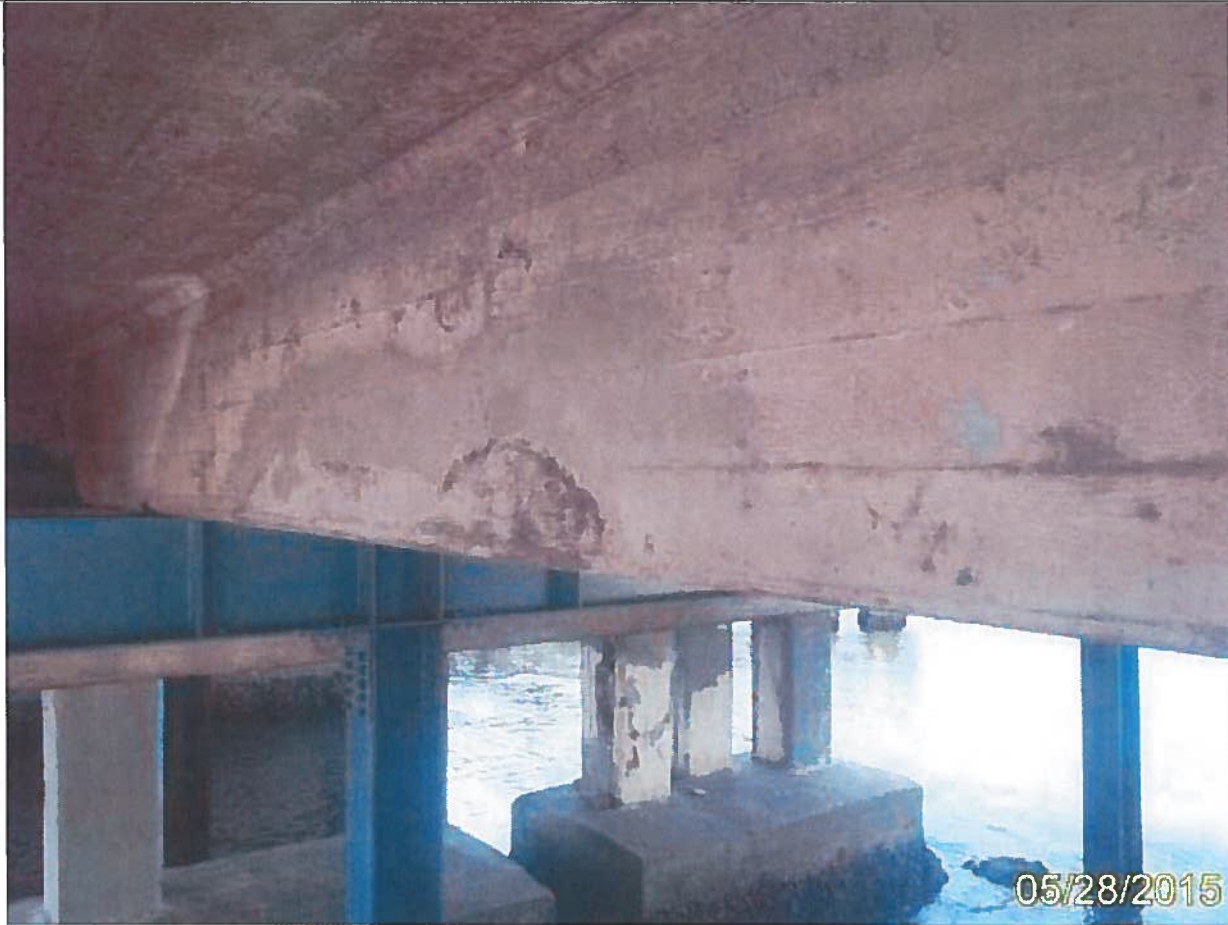
Photo 55 – Unit 1 Element 110 R/Conc Open Girder

Beams 1-1, 1-2 and 1-3 each have one delamination up to 3ft. long x 6in. wide in the lower north edge near the 3/4 point - NO CHANGE. Refer to photo 55.

Delamination in the bottom north edge of Beam 1-3

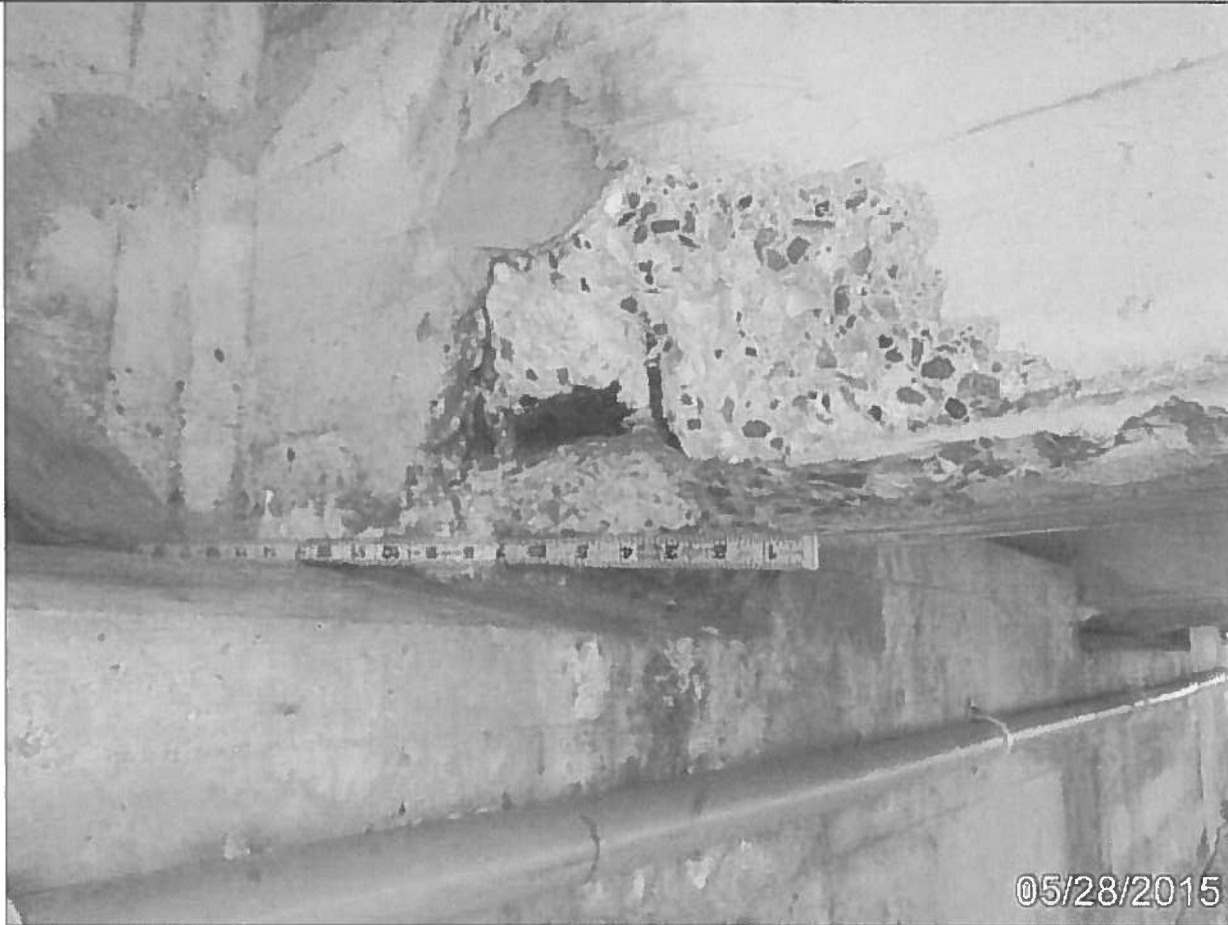
Photo 56 – Unit 1 Element 110 R/Conc Open Girder

Beam 1-5 over Abutment 1 has a 2ft. x 16in. x 2-1/2in. spall/delamination with exposed and moderately corroded rebar in the bottom south edge, and a 20in. x 14in. delamination in the north edge - INCREASE. Refer to photo 56.

Spall with exposed rebar in Beam 1-5 at Abutment 1

REPAIR RECOMMENDATION:
Refer to photo 55.
