Palm Beach County

RENEWAL/REPLACEMENT PROGRAM ASSESSMENT STUDY STRUCTURAL ELEMENTS

December, 2015

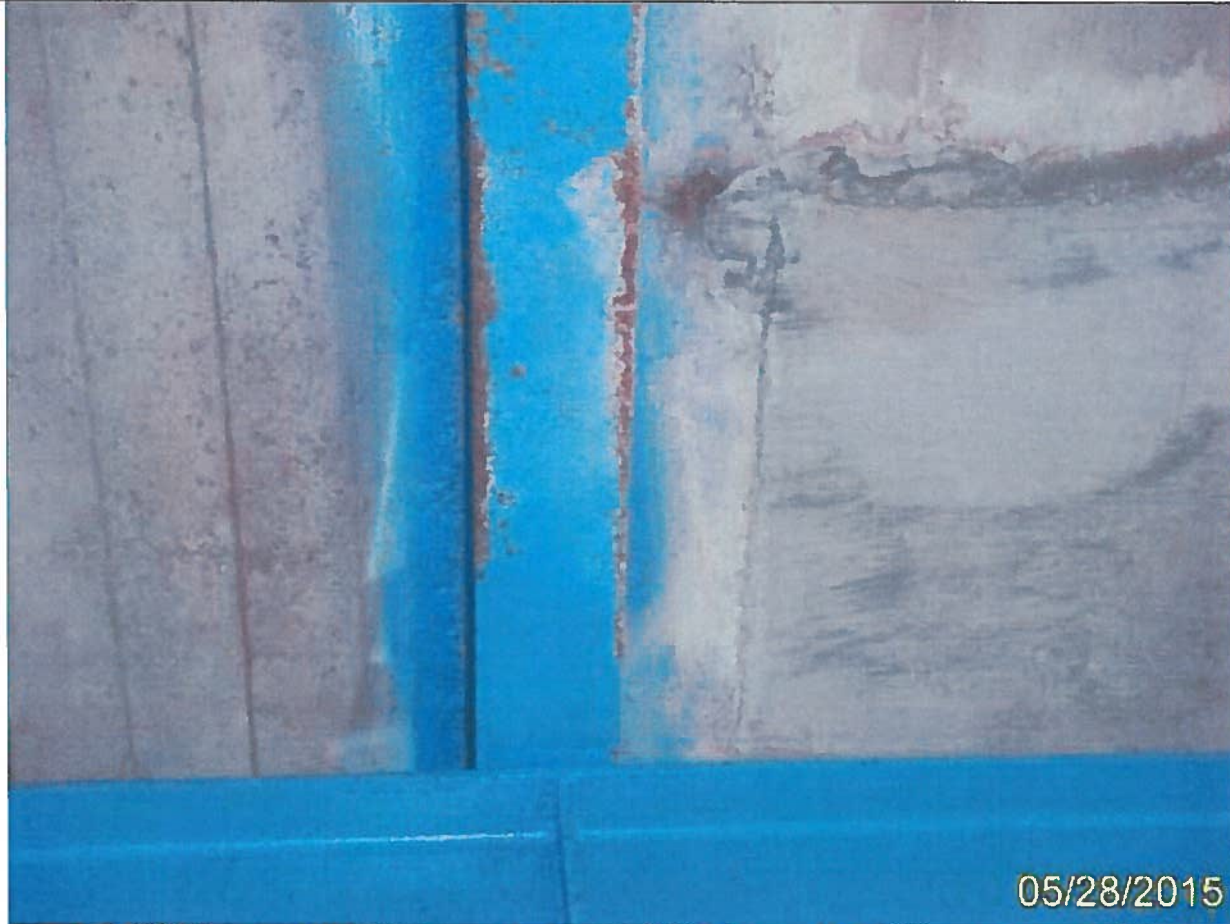
Photo 57 – Unit 1 Element 113 Paint Stl Stringer

The bottom exterior flanges of the sidewalk stringers have moderate to heavy corrosion and knife-edging along their length - NO CHANGE. Refer to photo 57.

Corrosion on the Span 2 stringers

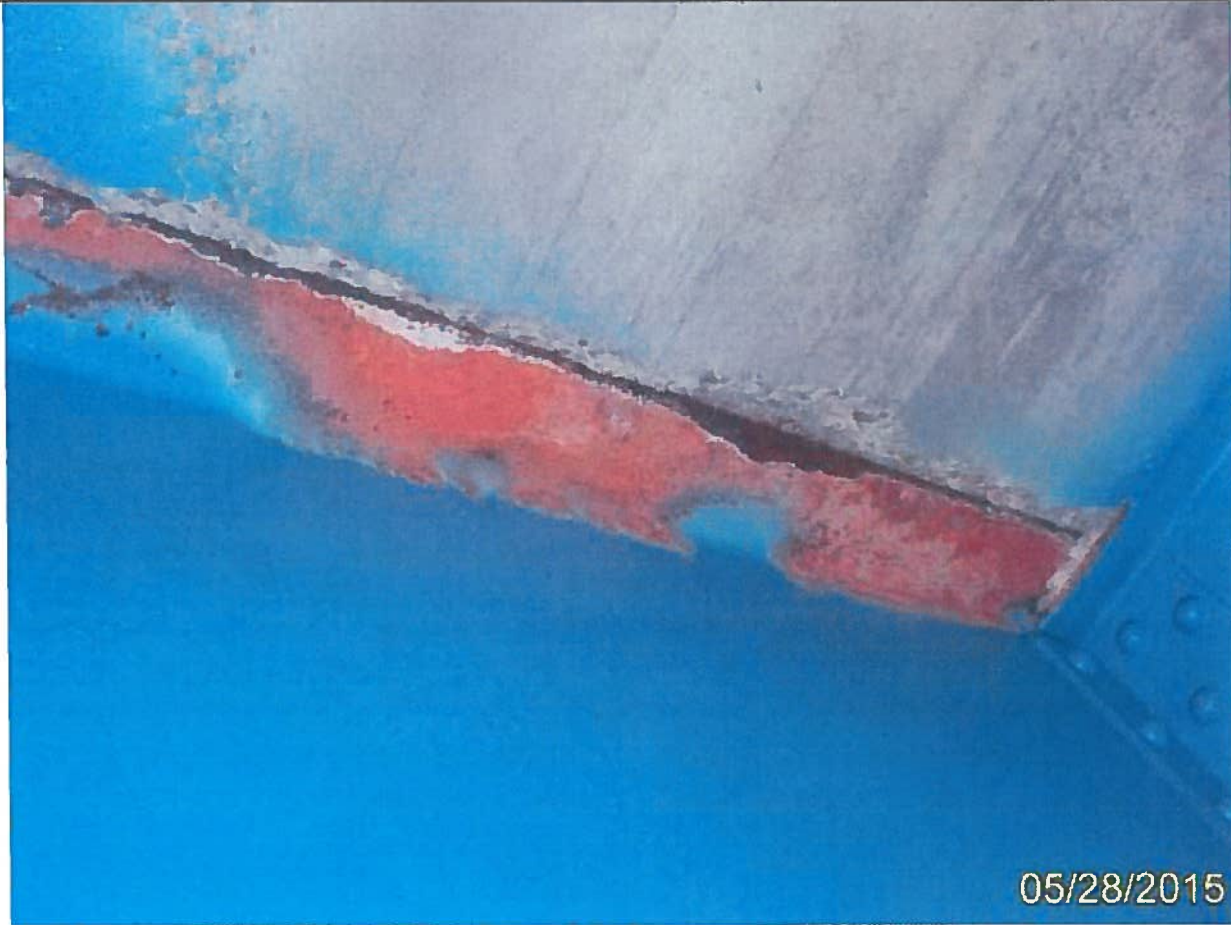
Photo 58 – Unit 1 Element 152 Paint Stl Floor Beam

Floor Beam 4-2 has areas of heavy corrosion up to 1ft. 4in. x 4in. in the top west flange in Bay 4-5 and in the top east flange in Bay 4-4 - NO CHANGE. Refer to photo 58.

Corrosion on the top east flange of Beam 4-2 in Bay 4-4

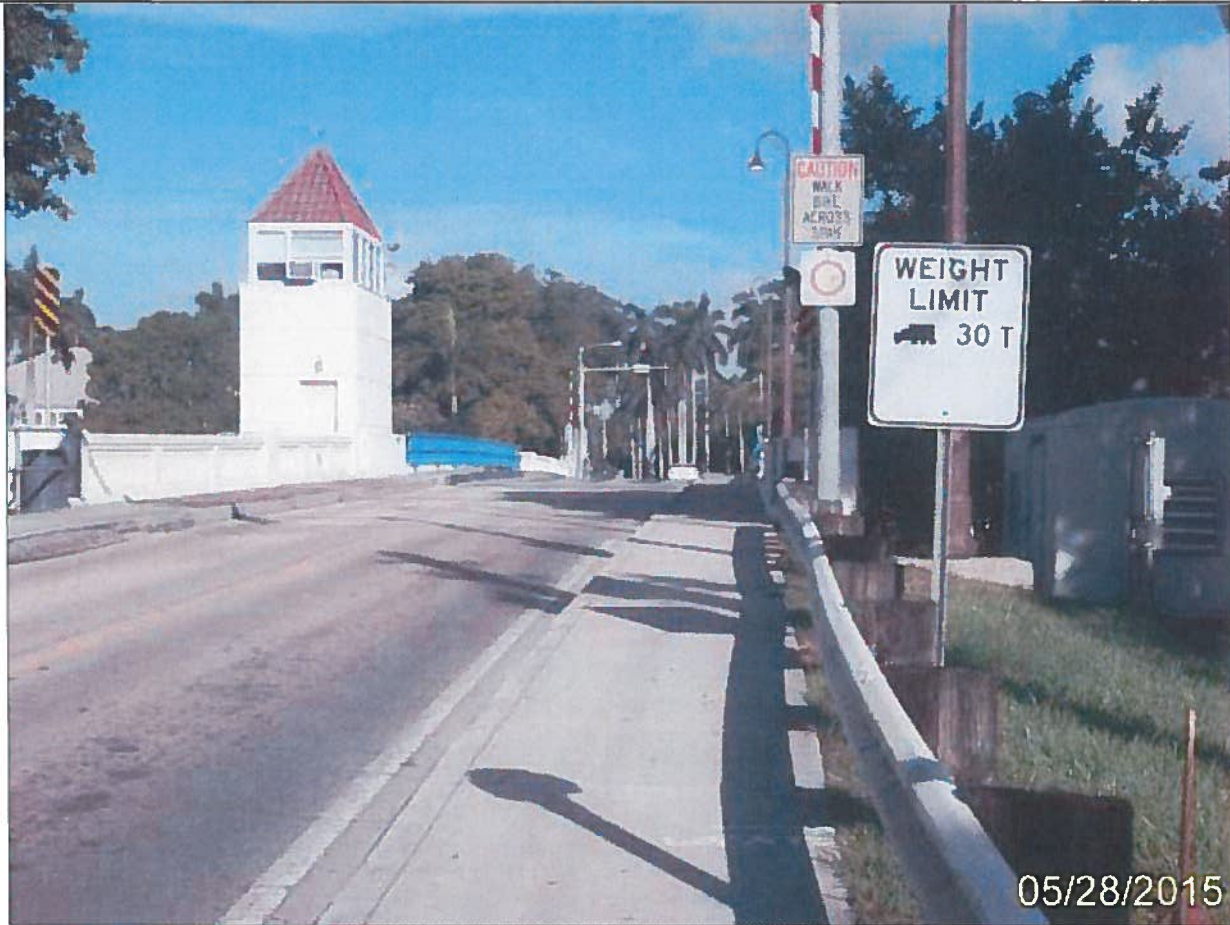
Photo 59 – Unit 1 Element152 Paint Stl Floor Beam

The east weight limit sign is set too low - NO CHANGE. Refer to photo 59.

East weight limit sign set too low

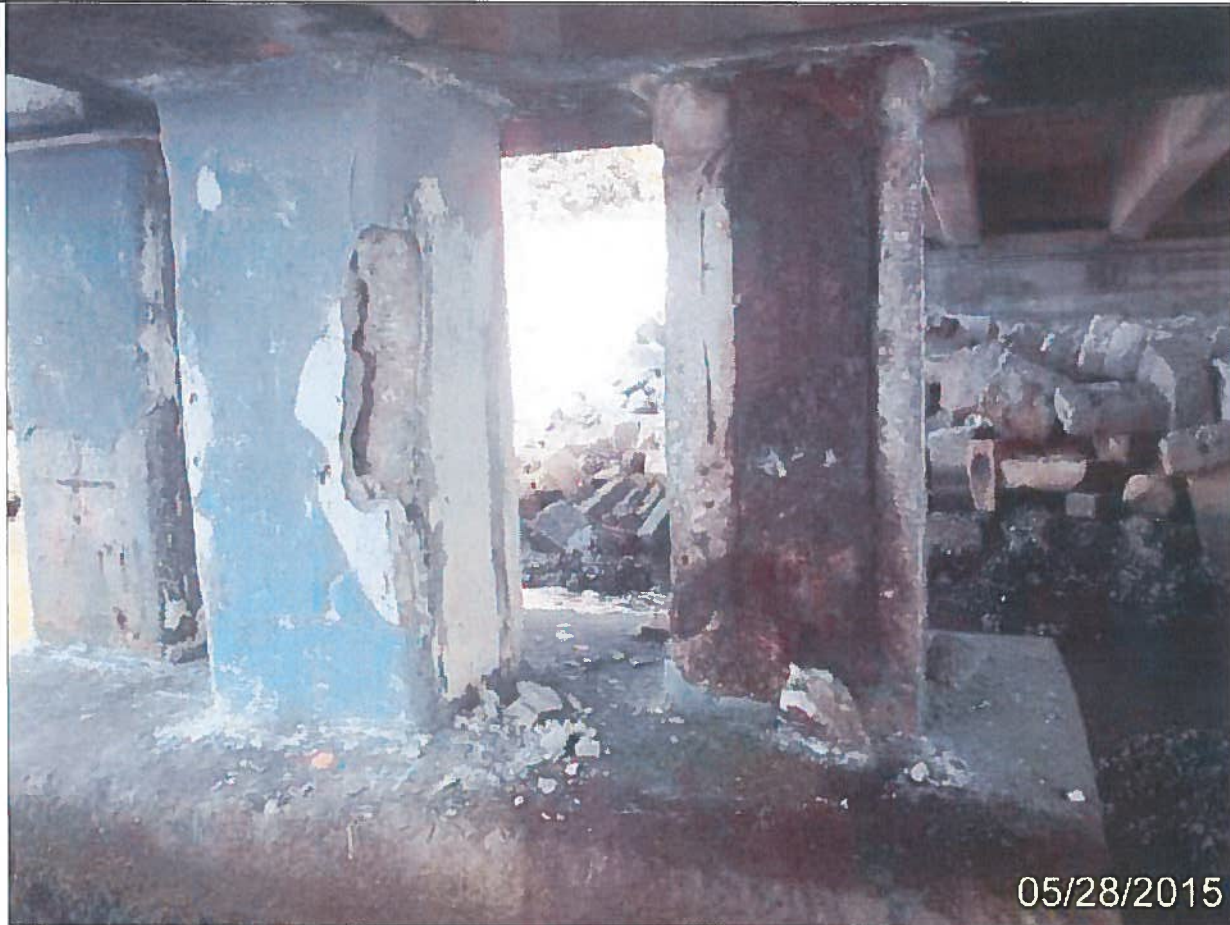
Photo 60 – Unit 1 Element 202 Paint Stl Column

Pile 2-6 is exposed up to 3ft. high x flange width on the east face and the northwest flange is exposed up to 2ft. high with heavy laminating corrosion and approximately 0.07in. section remaining in a 1ft. high area approximately 2ft. down from the cap in both areas - NO CHANGE. Refer to photo 60.

Heavy corrosion, section loss and spalled jacket at Pile 2-6

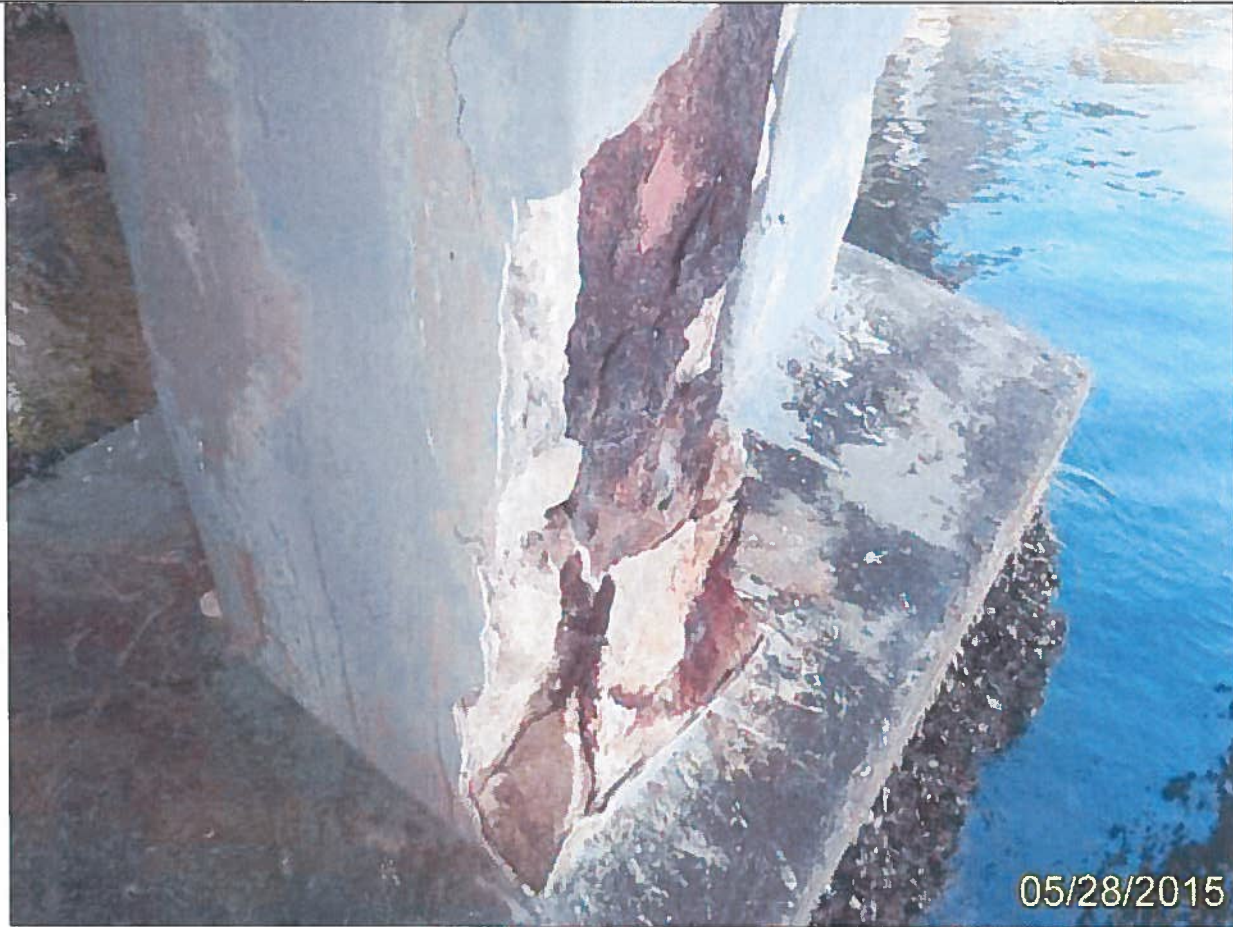
Photo 61 – Unit 1 Element 202 Paint Stl Column

Pile 5-8 is exposed on the west face in a 3ft. 6in. x 1ft. 9in. area and has a 4in. x 3in. area of 100% section loss in the southwest flange 2ft. below the cap. The remaining exposed flange appears 1/2in. thick; however, when the laminating corrosion on the outside face and the pack rust on the inside face were removed the flange thickness was found to be 0.05in. - NO CHANGE. Refer to photo 61.

Section loss in the flange of Pile 5-8 and spalled encasement

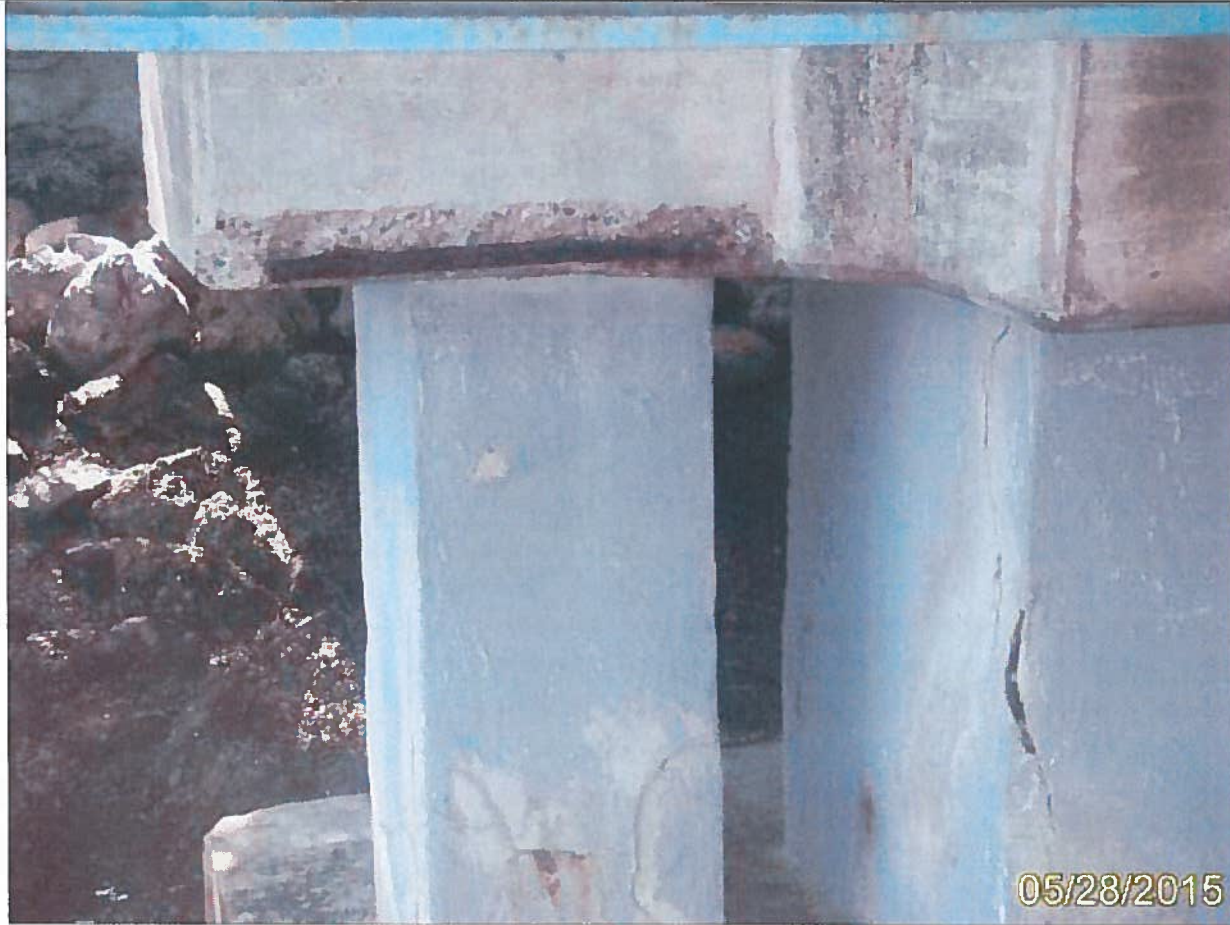
Photo 62 – Unit 1 Element 234 R/Conc Cap

The Bent 5 cap has a 2ft. 6in. x 7in. x 2in. spall with exposed rebar with 1in. remaining section in the bottom west edge over Pile 5-1 - NO CHANGE. Refer to photo 62.

Spall with exposed rebar in the bottom west edge of the Bent 5 cap at Pile 5-1

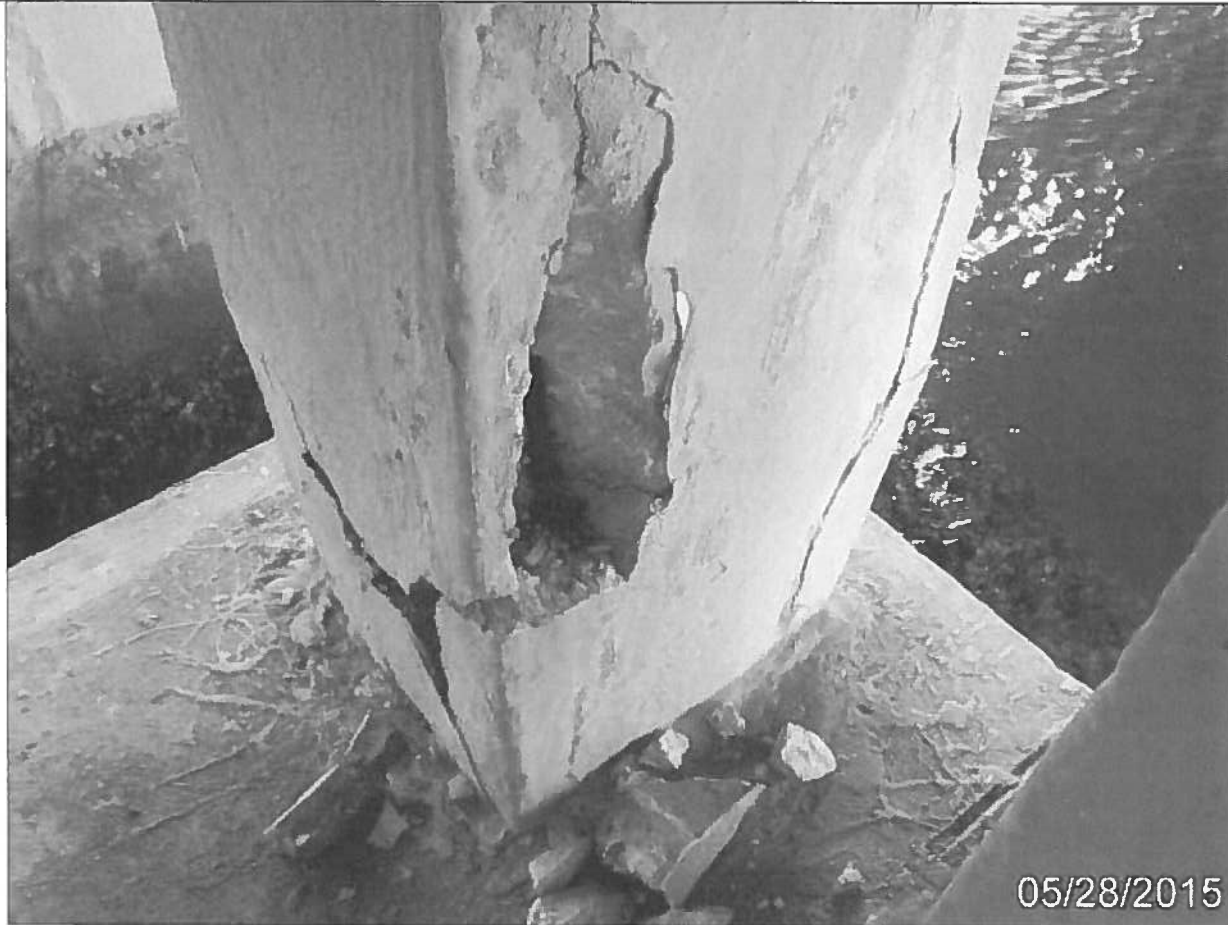
Photo 63 – Unit 1 Element 298 Pile Jacket Bare

Pile Jacket 5-6 is delaminated throughout with a 1ft. x 5in. x 4in. spall in the northeast corner and a 1ft. x 10in. x 5in. spall in the southwest corner exposing the H-pile - NO CHANGE. Refer to photo 63.

Spalls and cracks in Pile Jacket 5-6

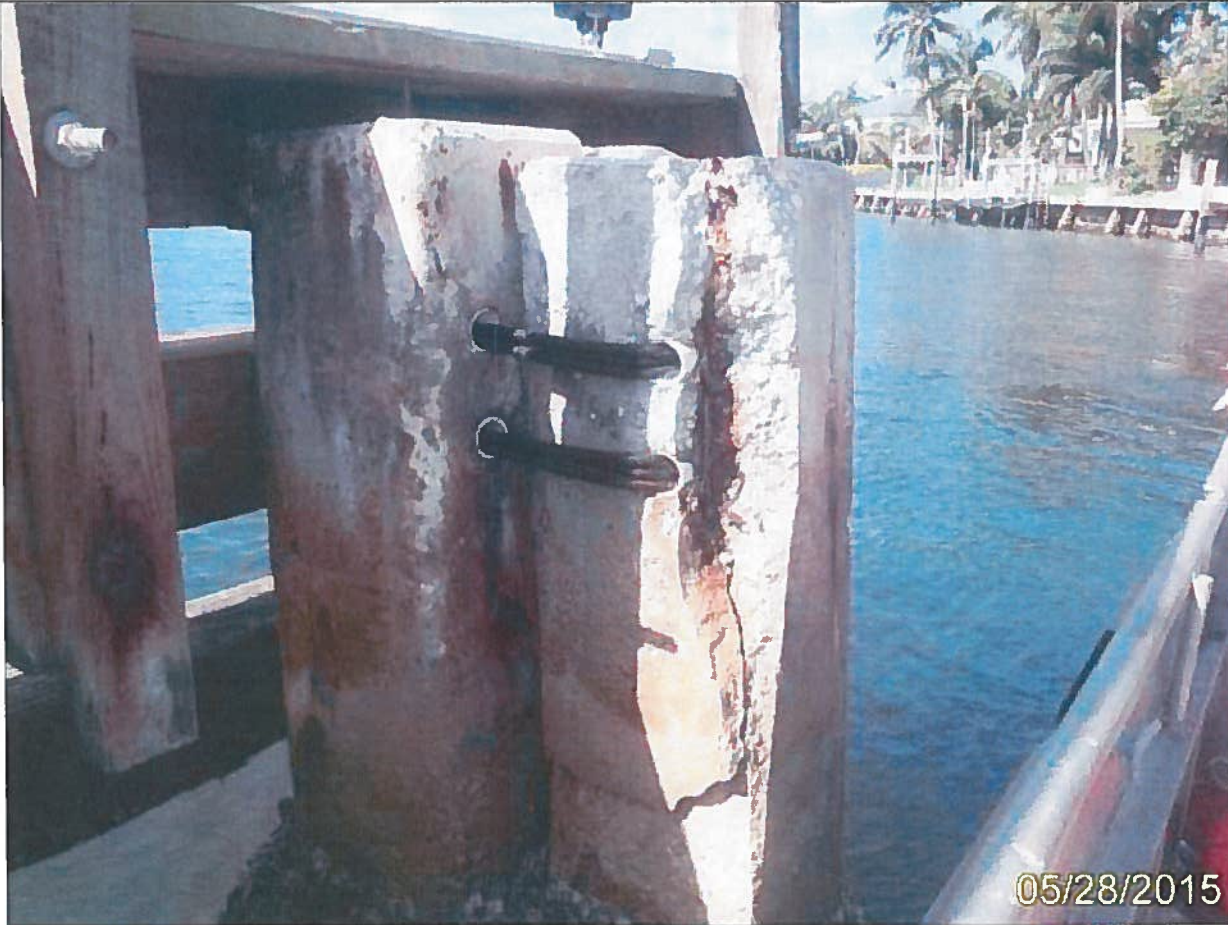
Photo 64 – Unit 1 Element 387 P/S Fender/Dolphin

Sixty five piles (33 on east and 32 on west; field verified) have vertical cracks up to 5ft. long x 1/8in. wide and delaminations/spalls up to 4ft. x 18in. x 5in., several with exposed steel and corrosion staining at or near the corners above the waterline - INCREASE. Refer to photo 64.

Typical spalls and delaminations in the fender piles

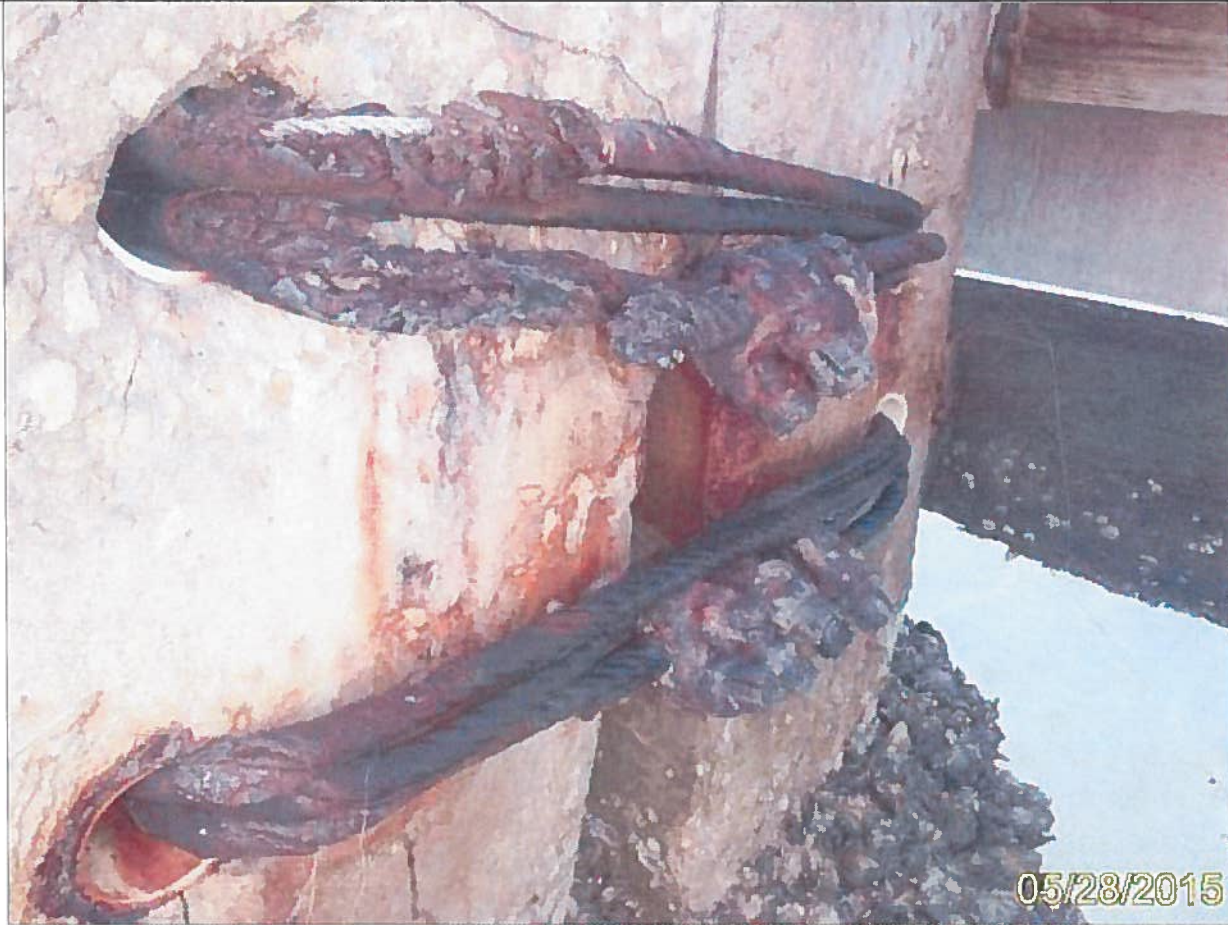
Photo 65 – Unit 1 Element 387 P/S Fender/Dolphin

The lower cable connectors and fasteners have heavy to severe corrosion, many with parted cables with 50% section remaining - NO CHANGE. Refer to photo 65.

Corroded fender cable wraps and hardware.

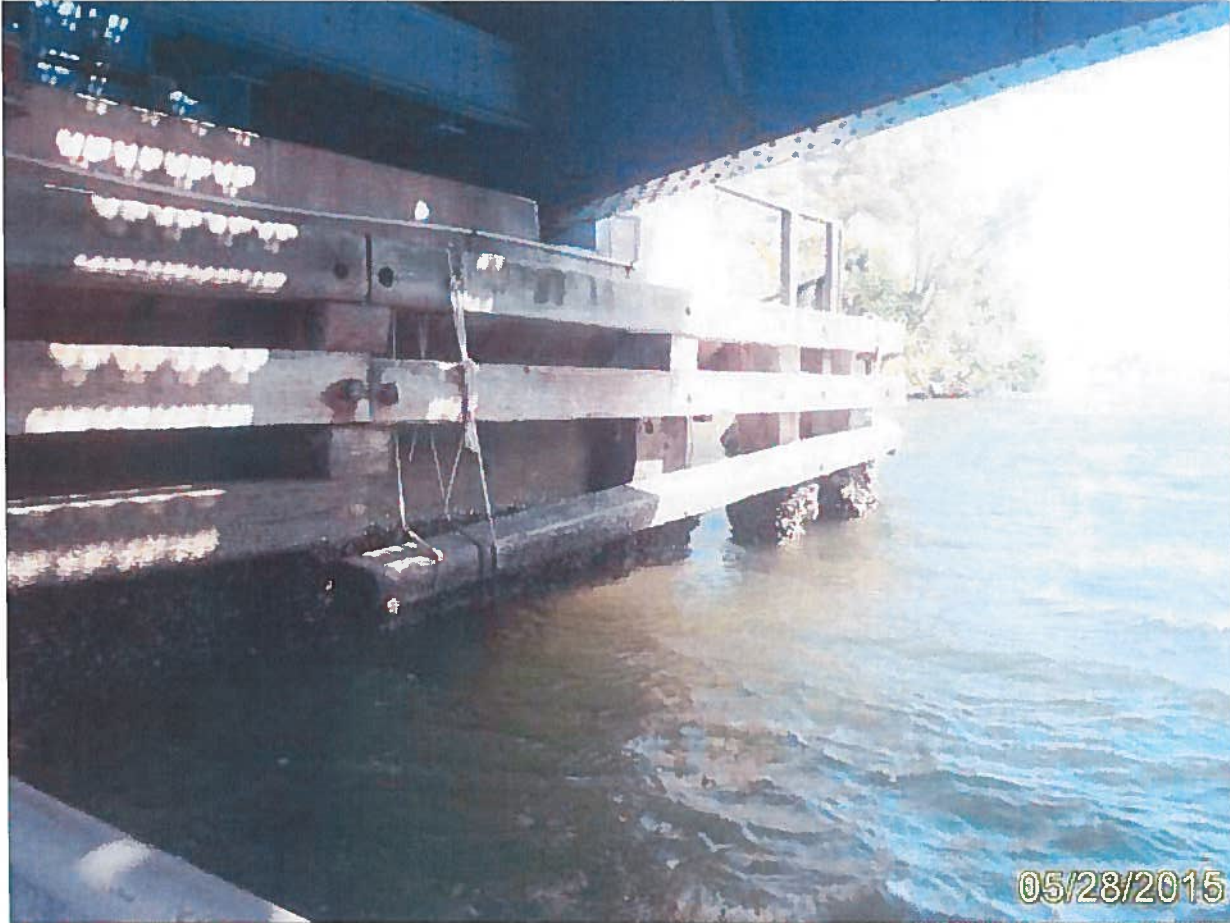
Photo 66 – Unit 1 Element 387 P/S Fender/Dolphin

West Fender: The third wale from the north is only attached with one bolt and is tied in place with a rope - NEW. Refer to photo 66.

Third wale from the north end of the west fender not properly attached

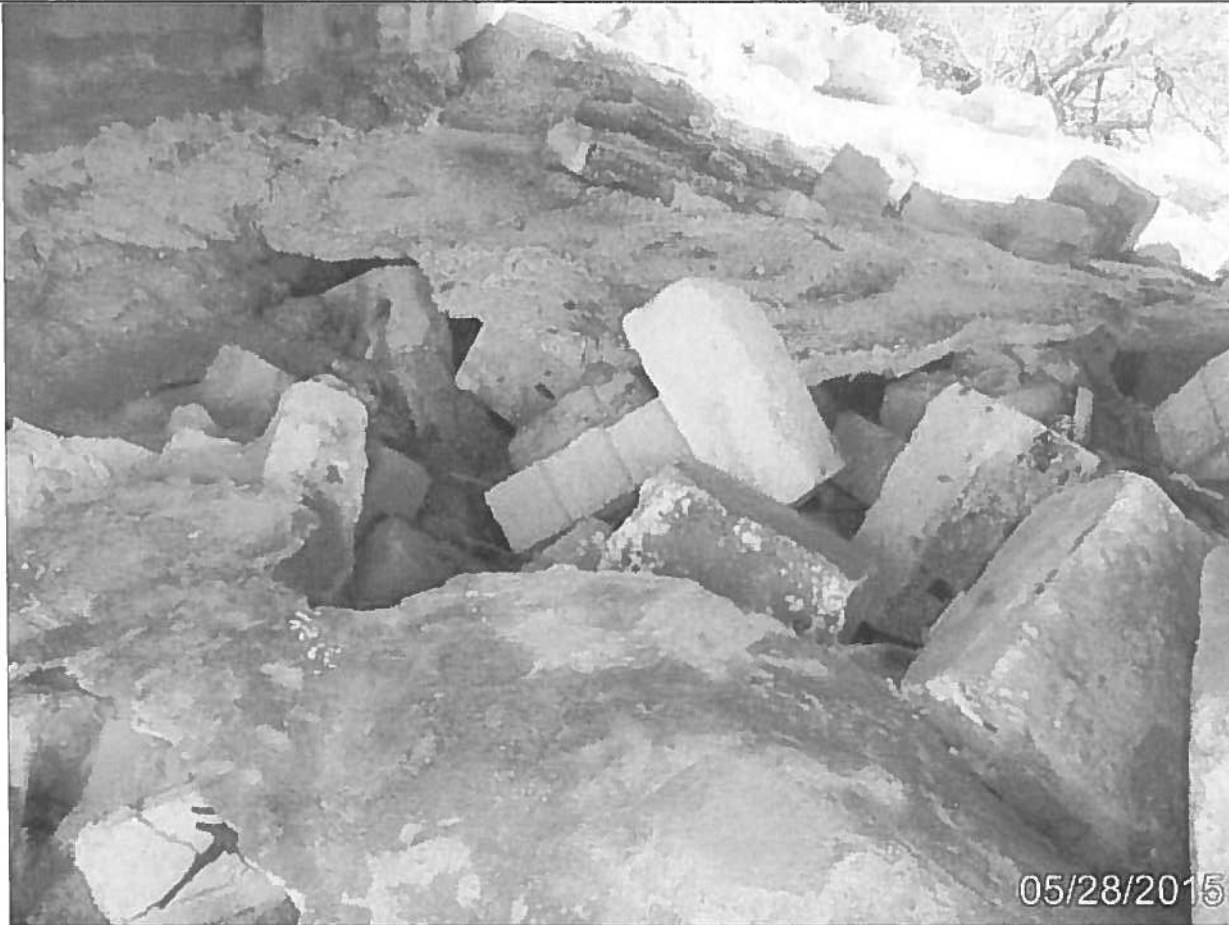
Photo 67 – Unit 1 Element 396 Other Abut Slope Pro

At the west slope protection there are areas of collapsed and missing grout over the broken concrete and sand cement rip-rap - NEW. Refer to photo 67.

Collapsed and missing grout at the west slope protection
