U.S. Department of Housing and Urban Development
Office of Policy Development and Research

***WATER INTRUSION EVALUATION
FOR CAULKLESS SIDING,
WINDOW, AND DOOR SYSTEMS
WATER INTRUSION - LABORATORY TESTING RESULTS***

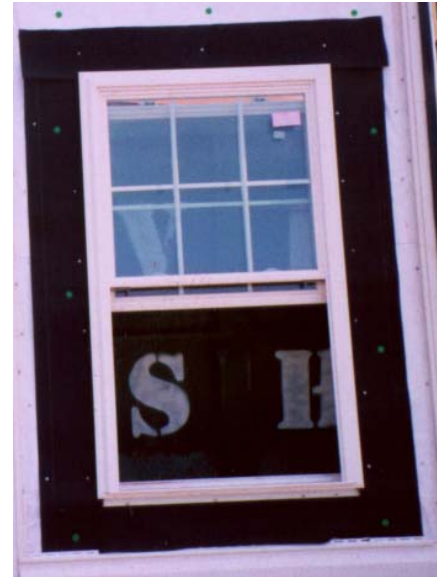
Figure 3
Flashing Detail

Test walls were constructed using best construction practices; studs on 24-inch centers, 7/16-inch oriented strand board (OSB) sheathing, exterior weather barrier and flange-mounted welded vinyl windows equipped with integral j-channels. Careful attention was paid to head, sill, and side flashing details. This was accomplished with 10-inch wide strips of 30-pound building felt attached with button-cap nails (see Figure 3). The bottom flashing was installed before the window so that the framing could be protected. Next, the window was installed. The window flanges were set in 100 percent silicon caulk. The side flashing was then installed so that it covered the window flange and overlapped the bottom flashing. Finally, a slit was cut in the weather barrier above the window. The felt flashing was inserted under the weather barrier and over the top window flange and side flashings. With the exception of the caulkless fiber cement test wall, the siding was installed as per manufacturer specifications.
